Analysis of Fatigue Life Estimate for the M119 Cradle Assembly with a Gouge Cut Defect

Caitlin Weaver, Robert K. Terhune, Brian Peterson

2012 NDIA Joint Armaments Conference, Seattle, WA

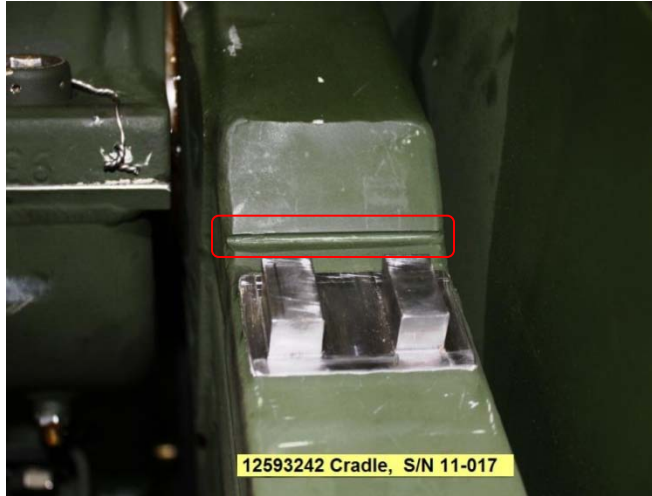
- During the manufacturing process in 2011, 46 M119A2 systems were manufactured with a tooling groove defect in the 12593242 Cradle.
- The worst case tooling groove was 0.071-in deep and 2.300-in long, spanning the full length of the channel.

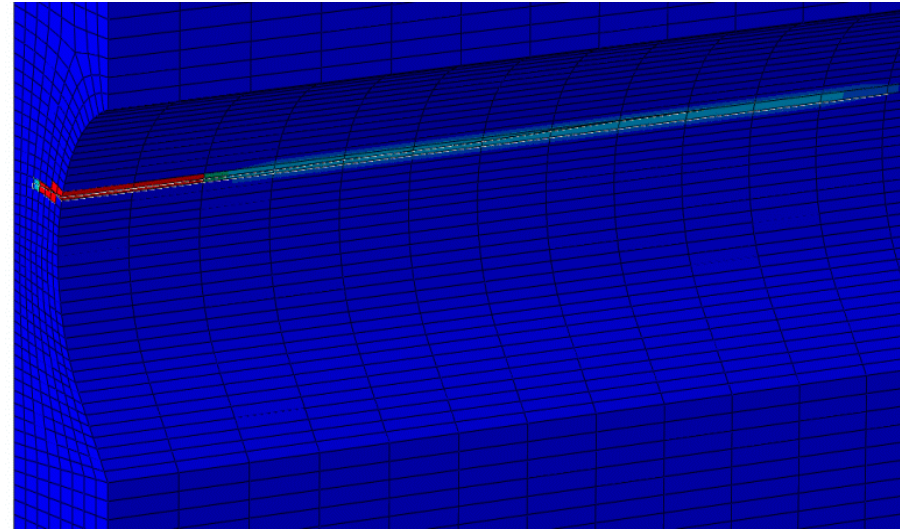
Crack at t=0s

Crack at t=1s

- The crack grows along the x- and z- direction.
- Crack propagation is similar to the crack initiation case.
- Crack is partial or surface cracking, not a complete through crack (based on the color values).
