# West Fertilizer Explosion Source Energy and Structural Damage

Presented by  
**Ben Harrison, P.E.**  
*Technical Director  
ABS Group*

**August 9, 2018**

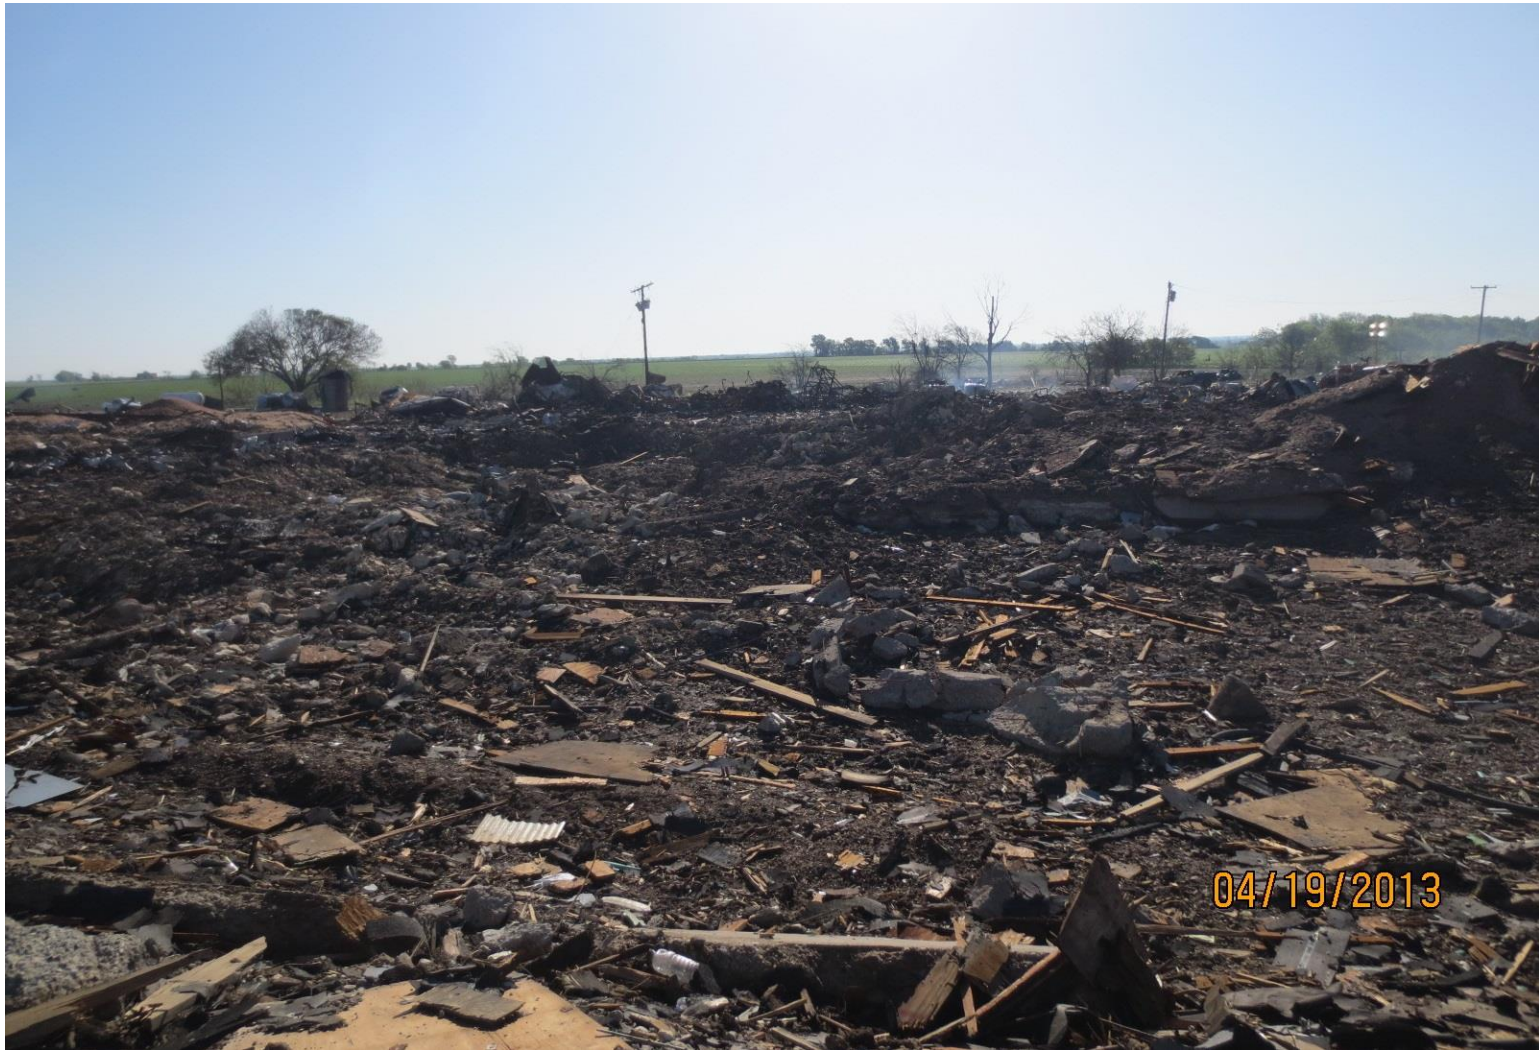
Production Building - Crater

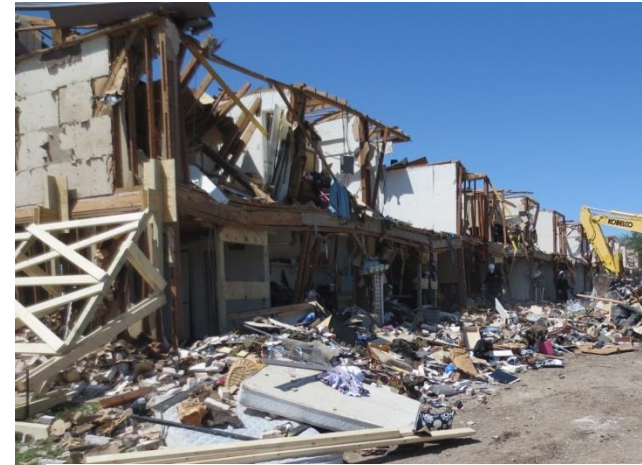
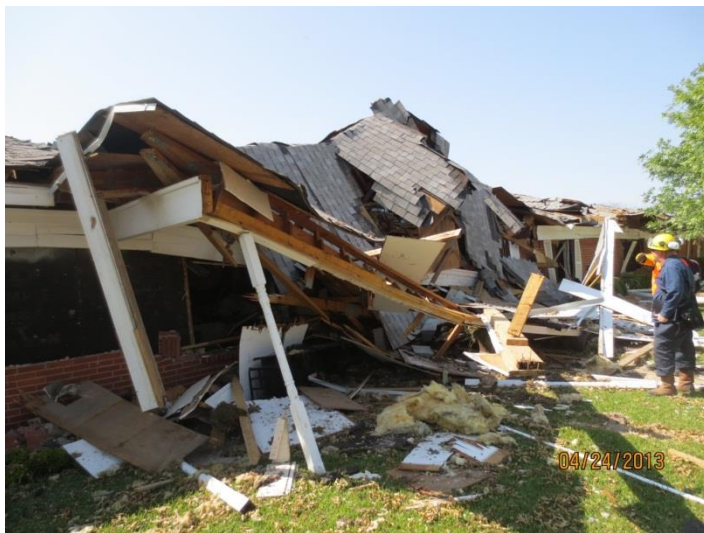
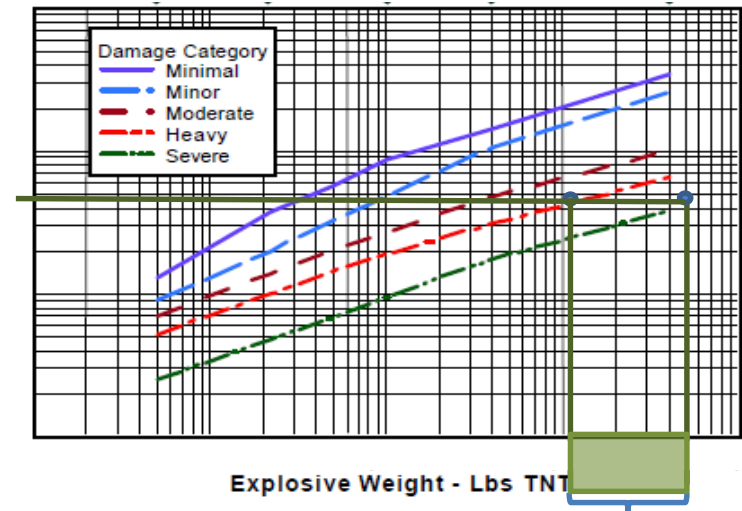
Figure A-8. A-12

# Damage Assessments Utilizing ETL 1110-3-495

Standoff Distance - Feet

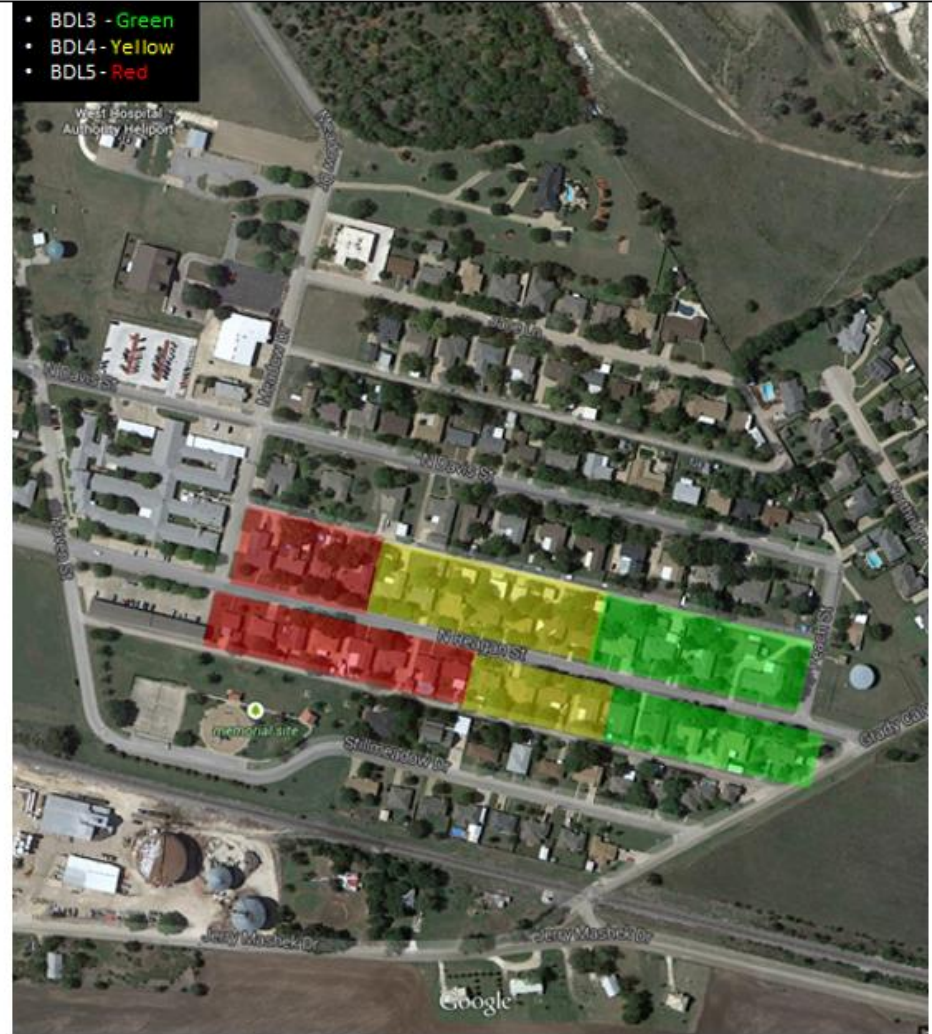
# Residential Damage from FACET3D & CFD

**BDL 5:** Reflected wall has collapsed. Other walls and roof have substantial plastic deformation that may be approaching incipient collapse.

**BDL 4:** Reflected wall components are collapsed or very severely damaged. Other walls and roof have permanent damage requiring replacement.

**BDL 3:** Reflected wall components sustain permanent damage requiring replacement, other walls and roof have visible damage that is generally repairable.

- **Charge Weights Consistent with Residential Damage on Reagan St.**

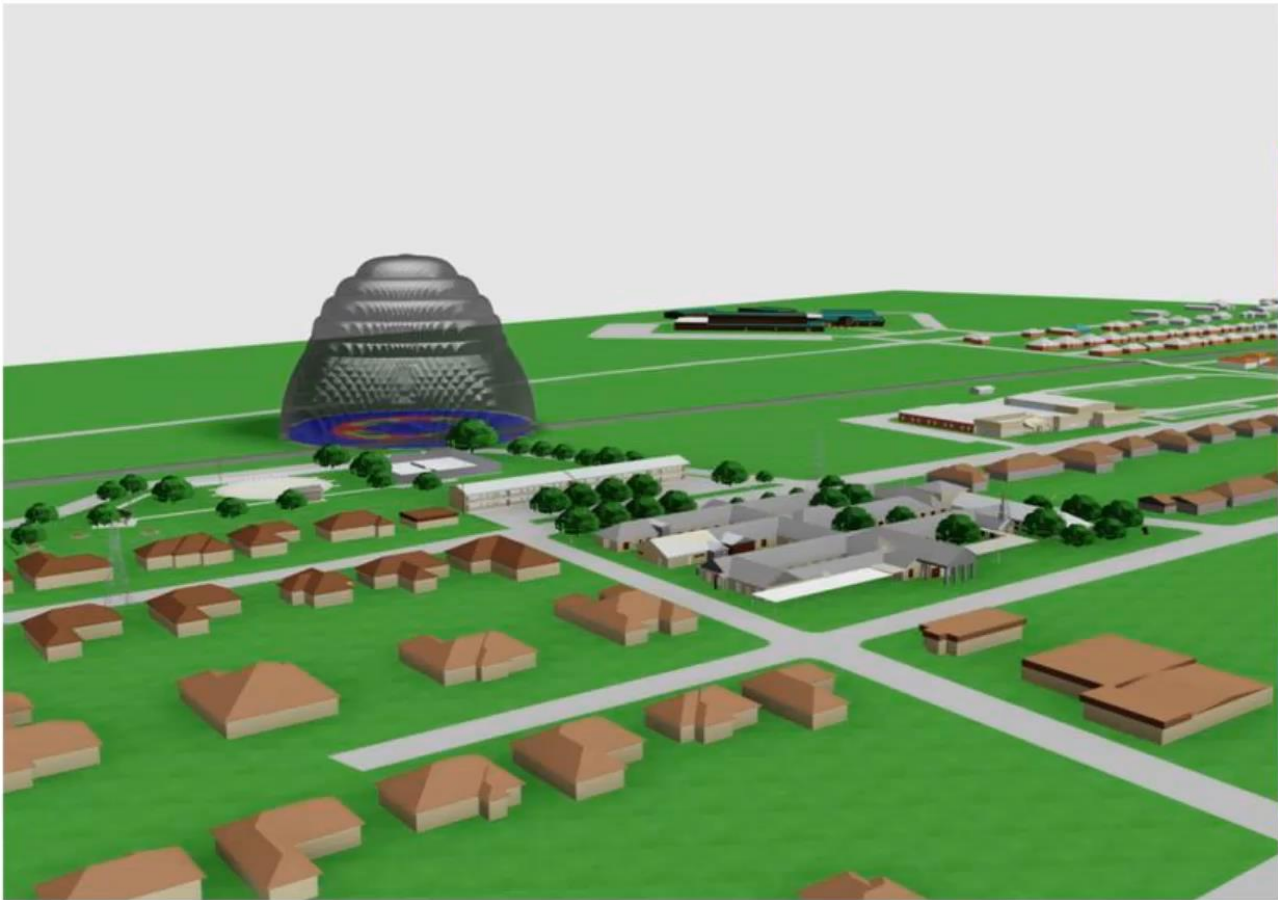
# CFD Simulation – from West

0.030s
