Ammonium Nitrate – its Behaviour in a Fire, and Recent Changes to the Fire Code

Presentation at the IESSE Conference

Dr. Noël Hsu

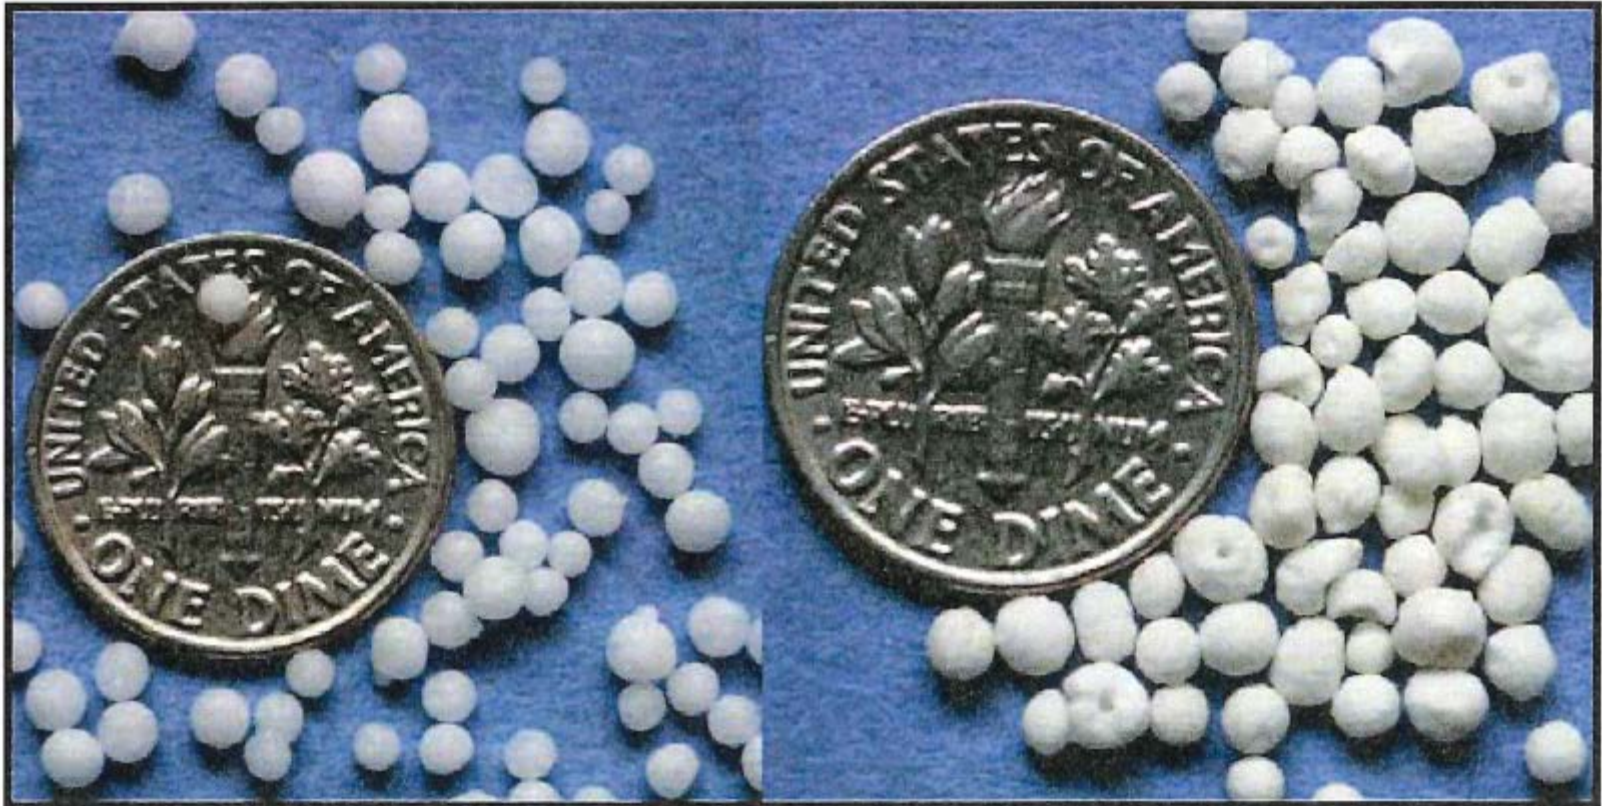
2 Main Physical Forms of AN

FGAN

TGAN

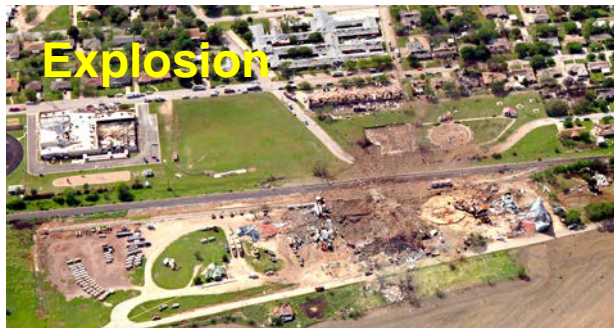
West

Call made to 911

Flames observed

Firefighter arrives on scene

Engine 1 asked Engine 2 to hookup to hydrant

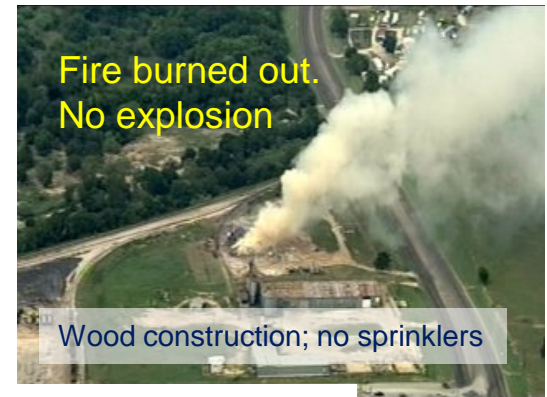
Call made to 911

Firefighter arrives on scene

Bryan Fire Dept on scene

½ mile evacuation ordered

As the building became more involved the roof collapsed and an explosion occurred.

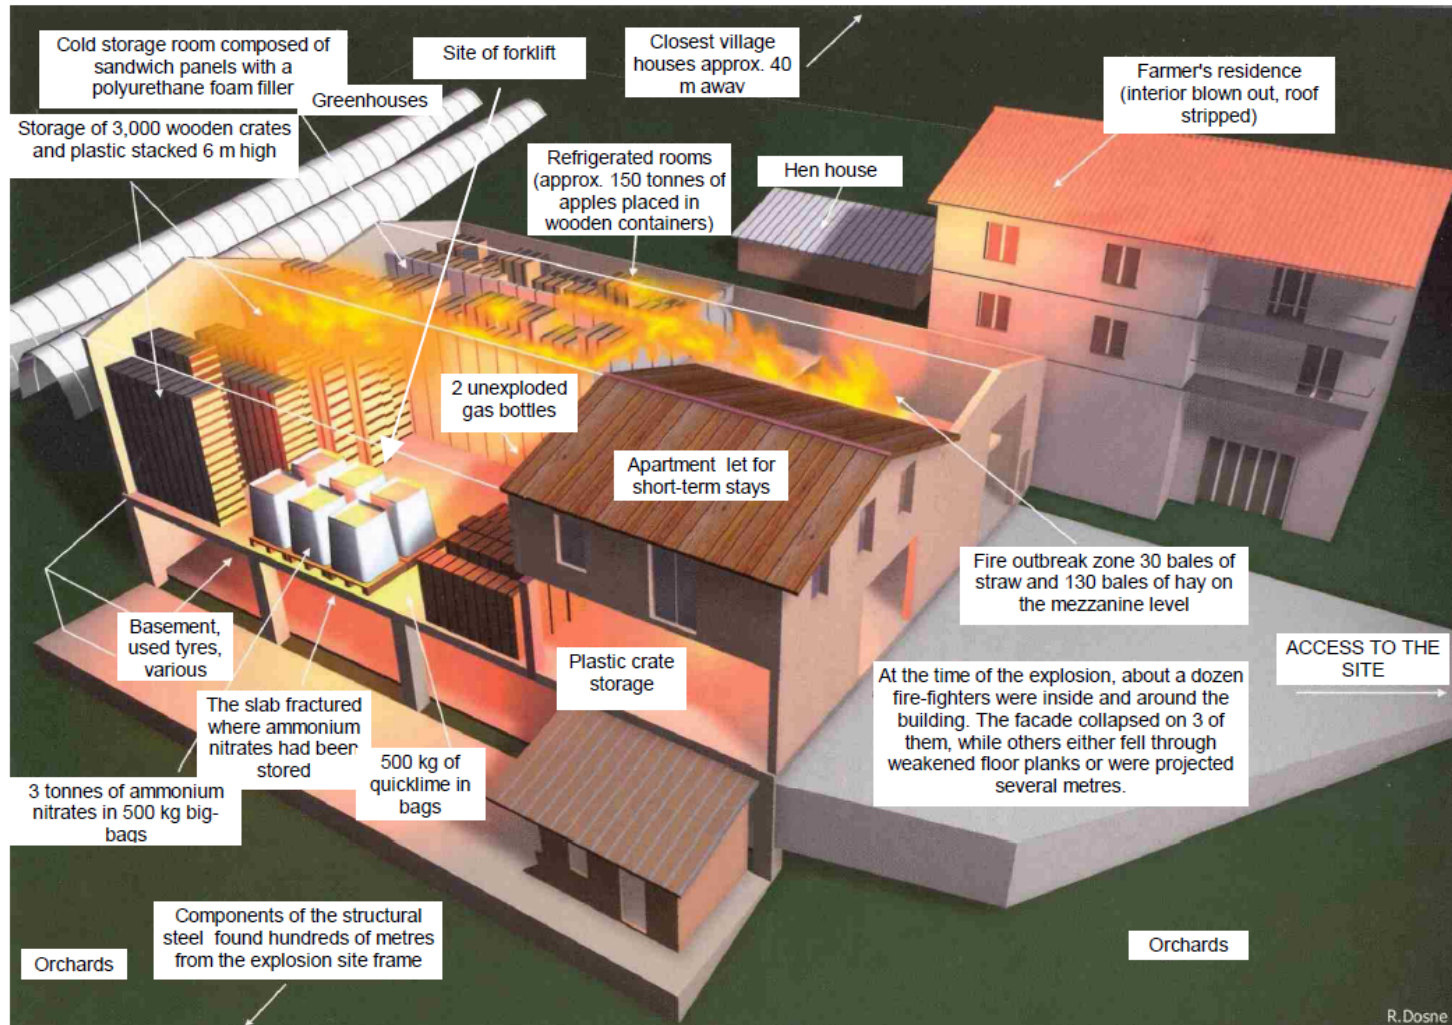
Fire in Farmhouse in Saint Romain-en-Jarez

Explosion of ammonium nitrate solution inside the barn (drawing by René Dosne, "Face au Risque", issue 399, January 2004)

Large portion of barn roof already collapsed.
Hissing sound heard followed by powerful explosion

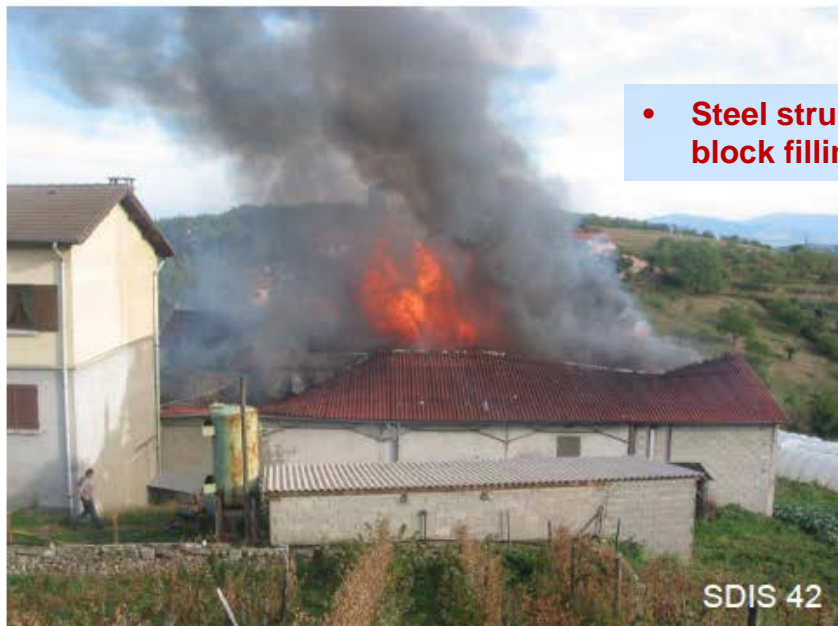
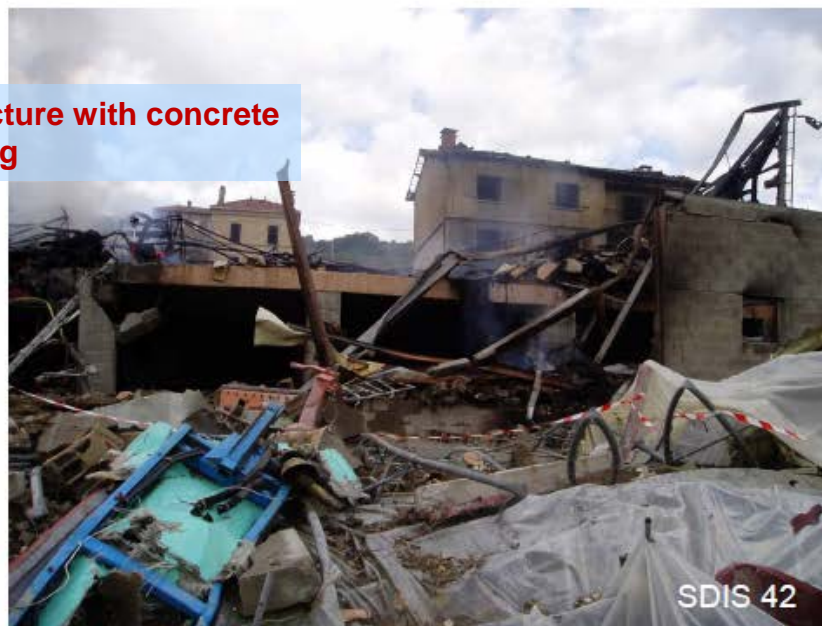
- **Steel structure with concrete block filling**

- **18 Firefighters injured**
- **3 Gendarme, slightly hurt**
- **5 bystanders, slight injuries**

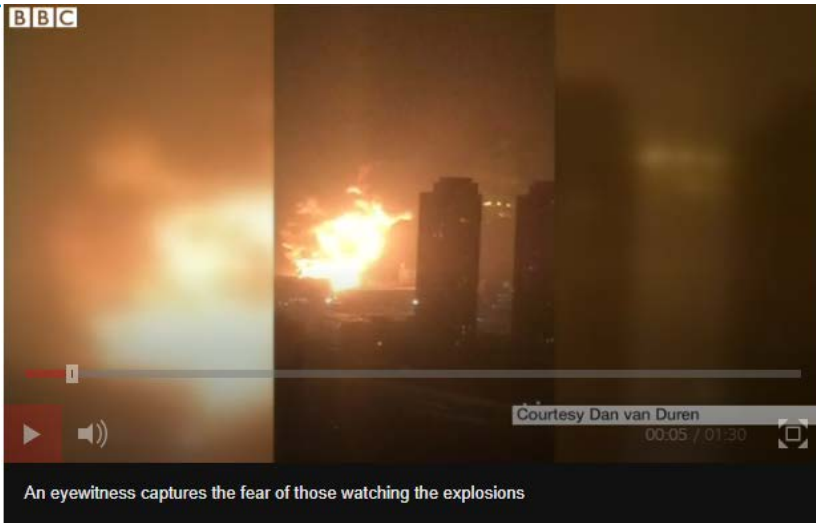
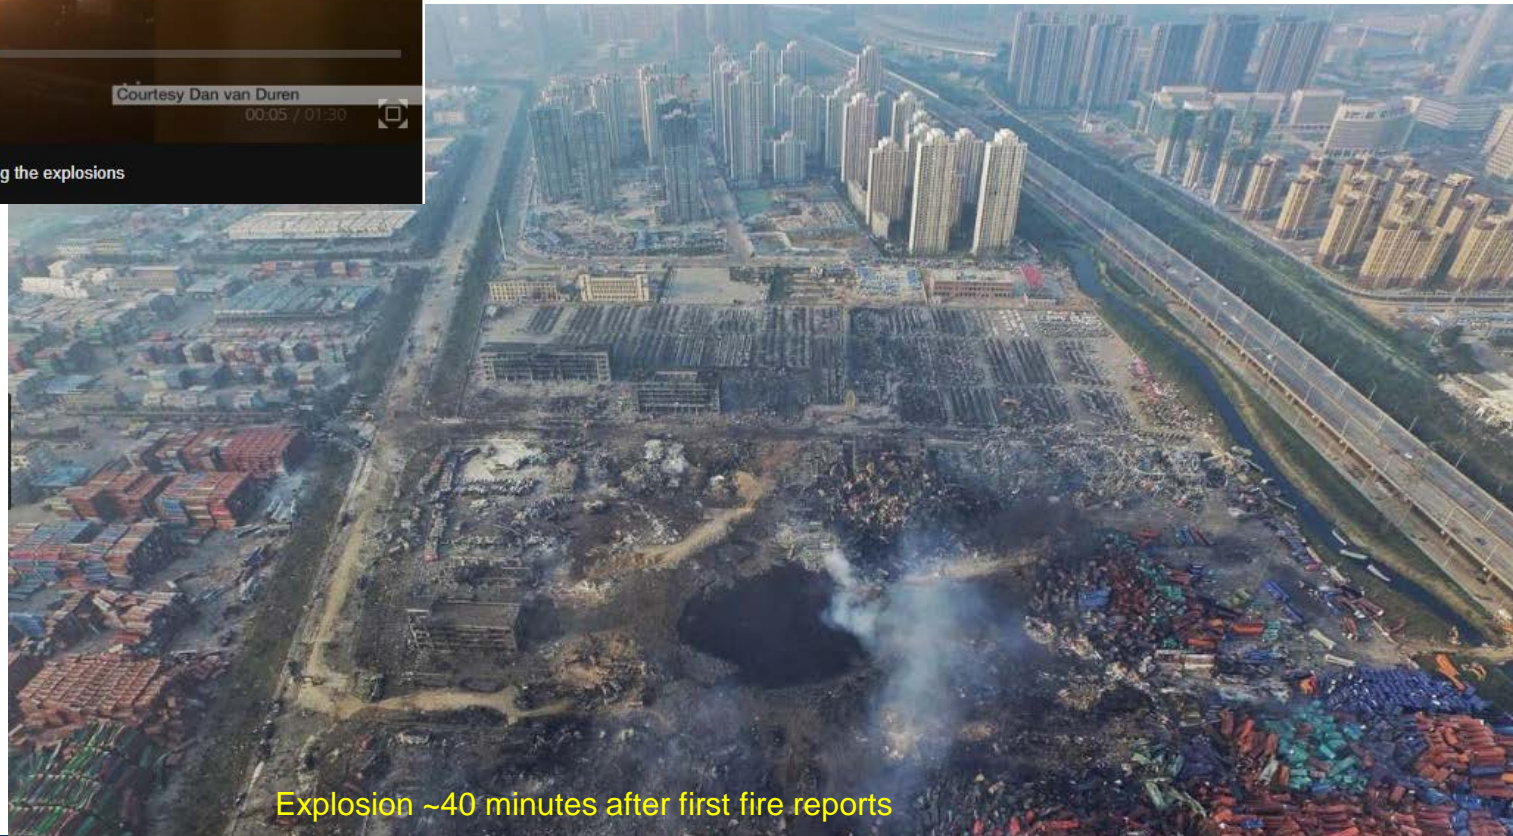
Tianjin Port

August 12, 2015

Explosion ~40 minutes after first fire reports

- use of combustible materials of construction,
- no sprinkler requirement
- no zoning requirement
