SAND2011-3603C

Ceramic Capacitor Failures and Lessons Learned

Presented to the 55th Annual NDIA Fuze Conference
Salt Lake City, UT

May 25, 2011

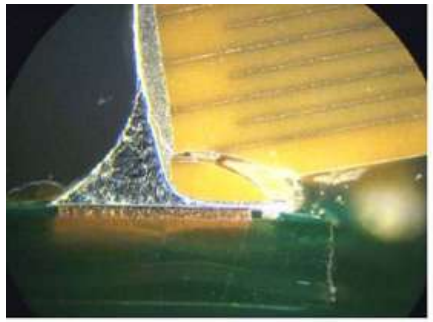
Example MLCC flex crack

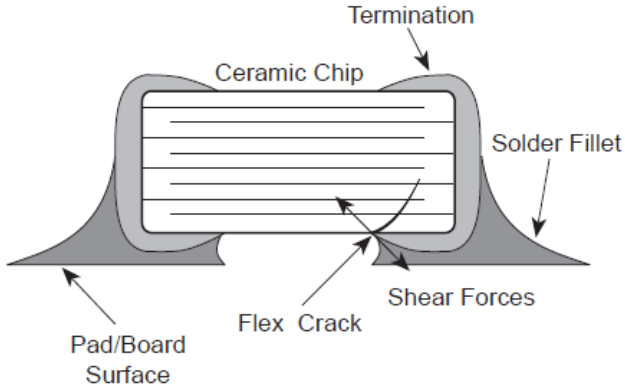
Diagram of an MLCC flex crack

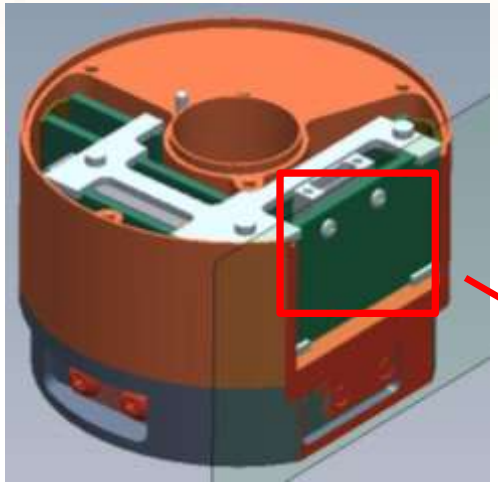
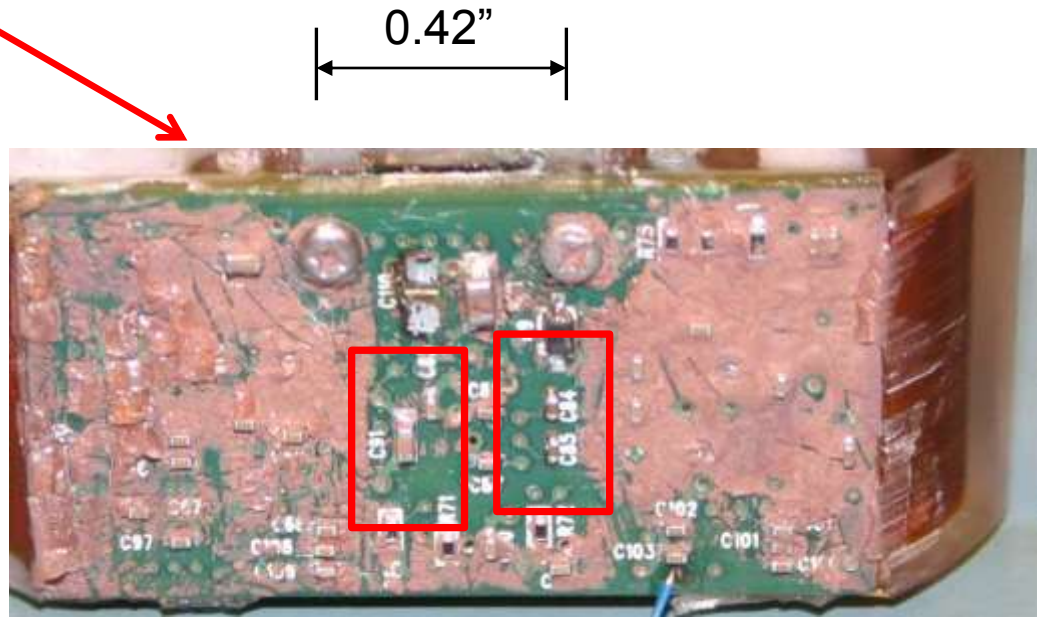
Locations of failed capacitors

The dominant failure mode was capacitor failure in a very specific region of the back side of one rigid section of PCB.

Capacitor C91 failed shorted 3 times while capacitors C84 (or C85) failed open once.

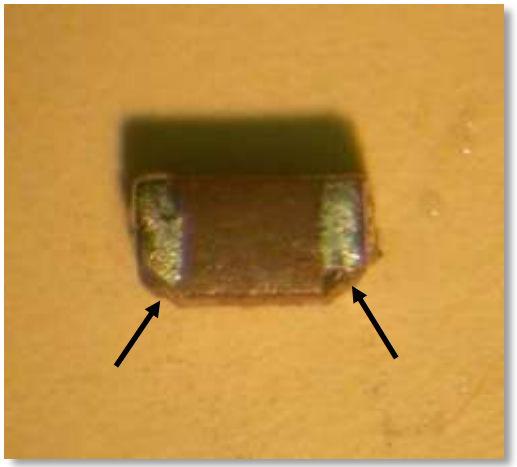
Damage to the capacitor is at the corners where the capacitor is soldered to the PCB

The capacitor is a COTS, 0603-package, X7R dielectric component

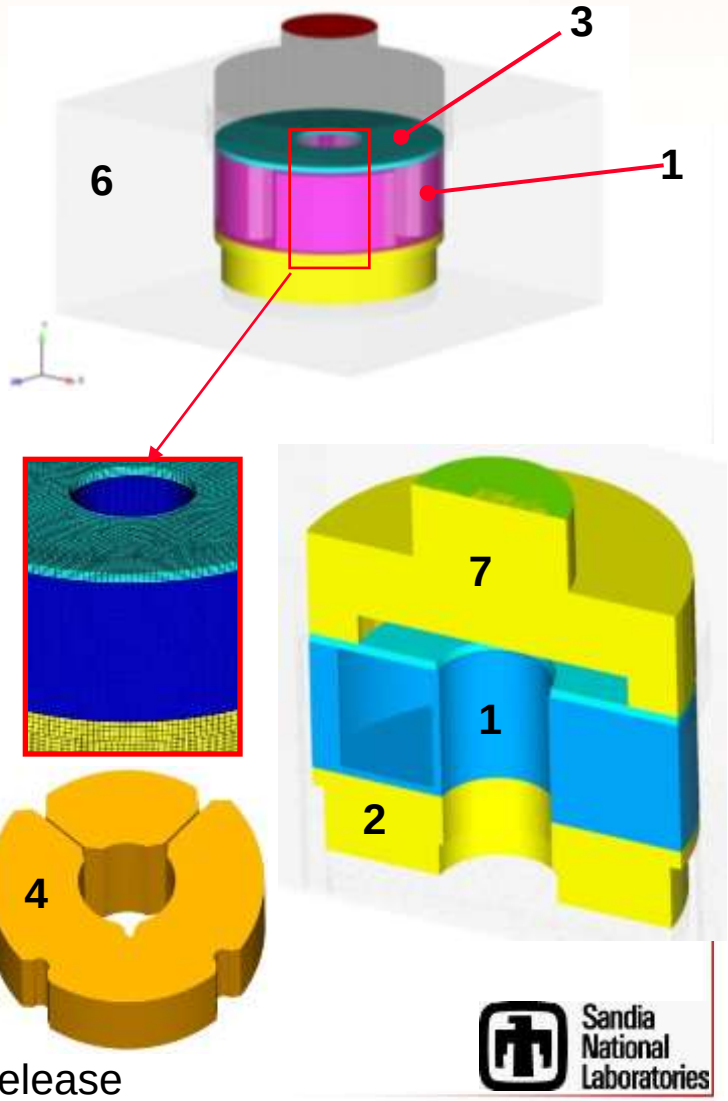
A simplified model with no PCB was developed to look at stresses in the potting material

- Full 3D Hex Element model
- 7 Material Blocks
- Nodes = 480K
- Elements = 400K
- Element Length < 0.020-inch

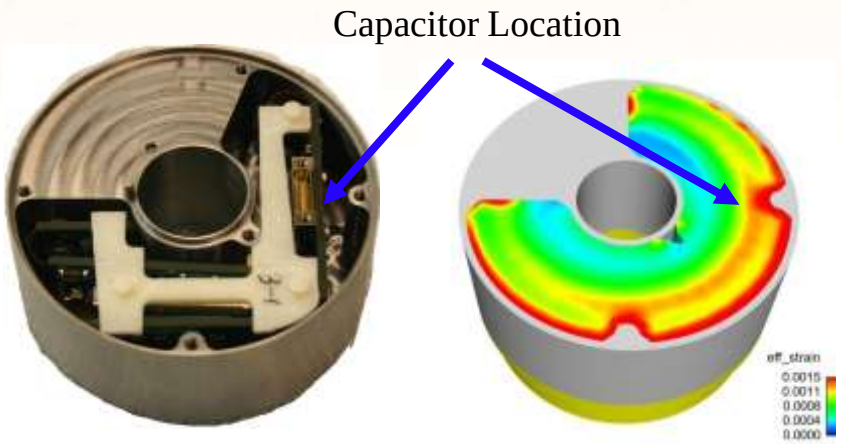
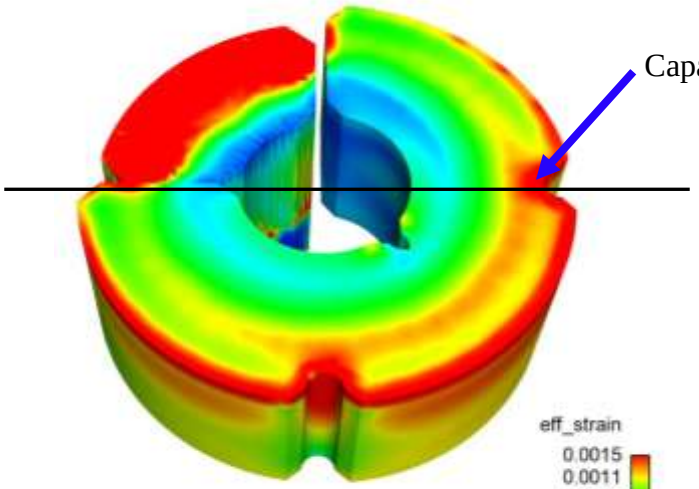
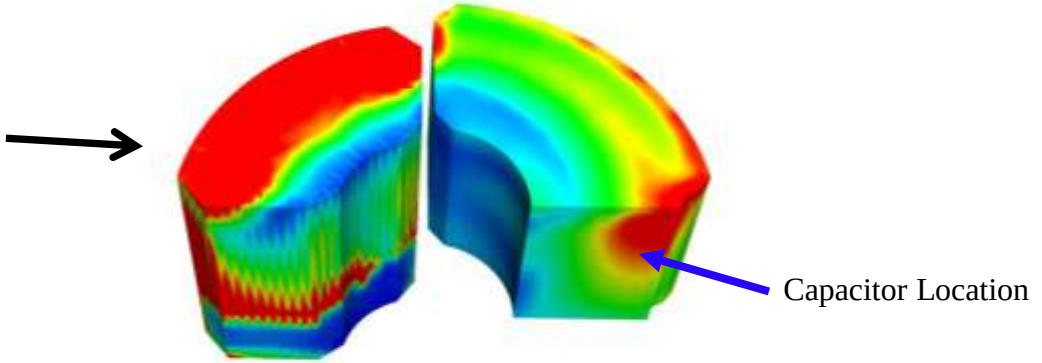
Static Loading Results

- No yielding in potted 3DDR housing
- High stress in potting near lid
- Main potting maximum effective strain = 1500με
- ***High strain at capacitor location***

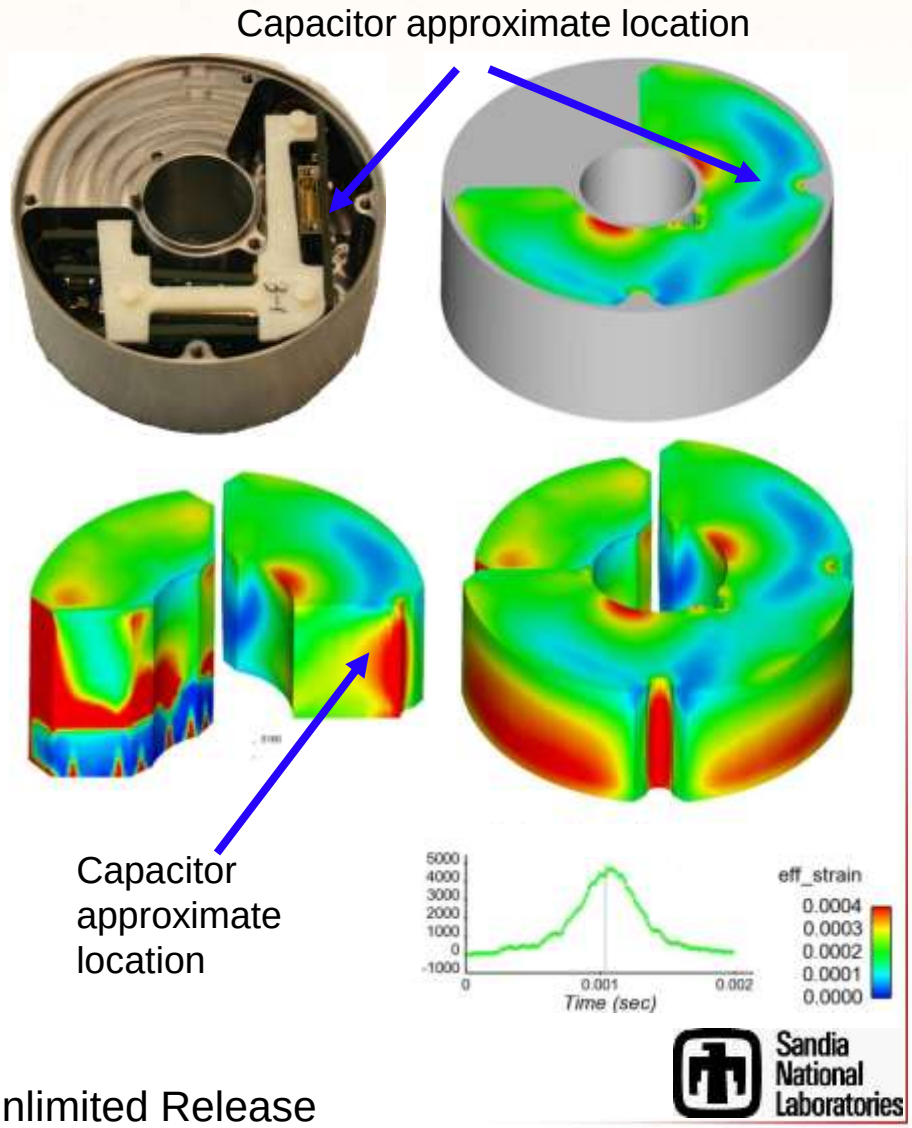
Dynamic Loading Results

- Acceleration loading applied at bottom of fixture
- No yielding in potted 3DDR housing
- High stress in potting propagate from bottom up
- Main Potting Maximum effective strain = 400με
- ***Noticeable strain at capacitor location***

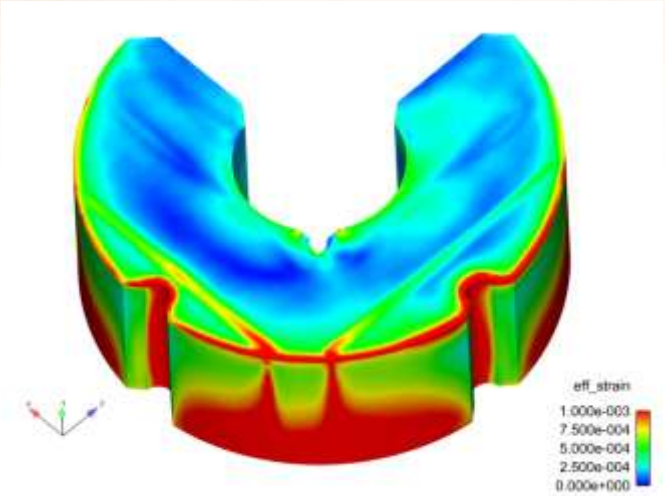
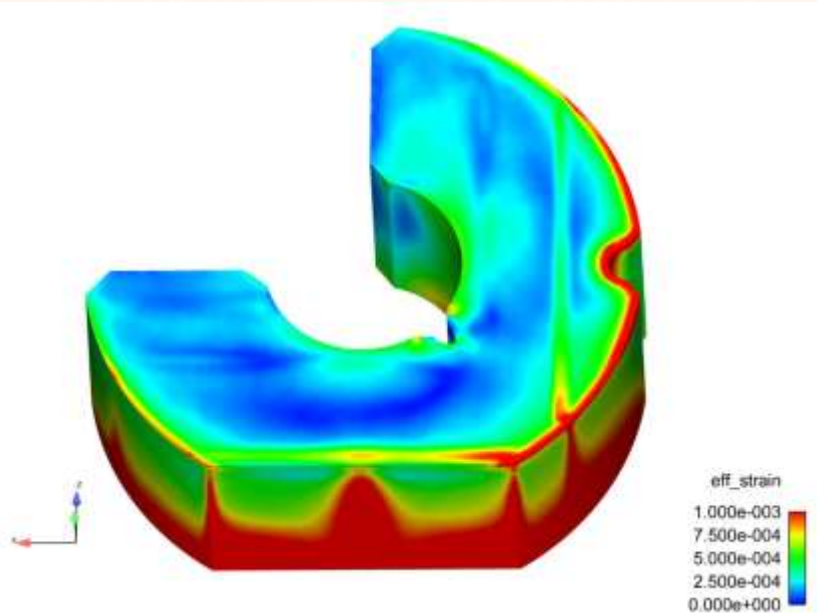
High Fidelity Model Results

- Results based on a measured acceleration input
- Model results show that there is a strain of approximately 500με at the surface of the PCB near where the capacitors failed
- Strain is not enough* to break the capacitor off the PCB in one test – modeling matches experiment

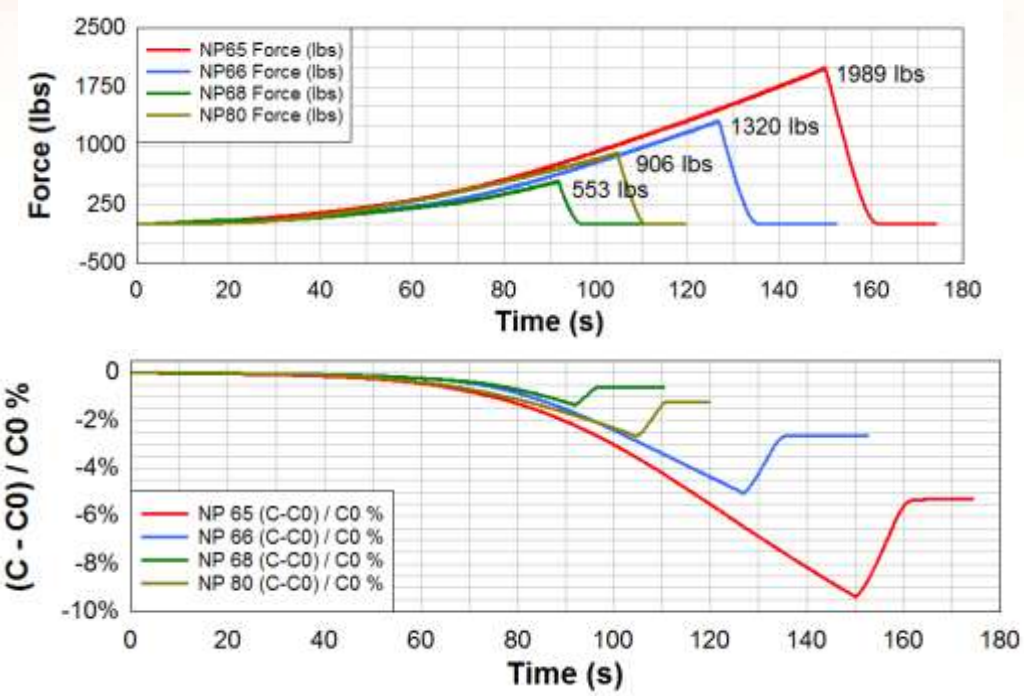
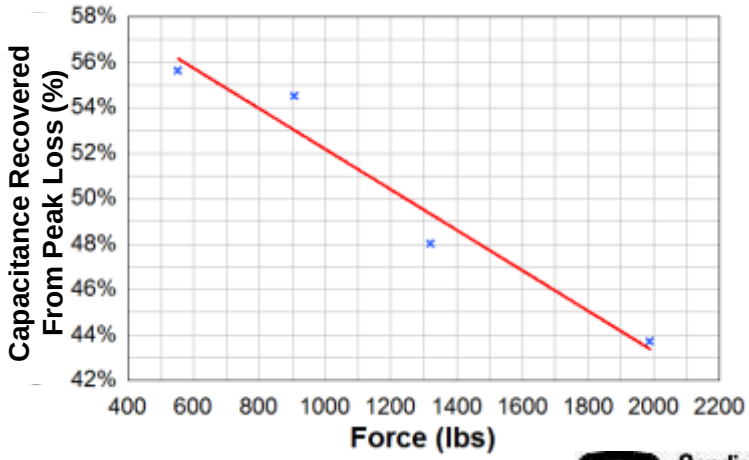
Capacitance Recovery

One dielectric showed reduced capacitance after mechanical compression

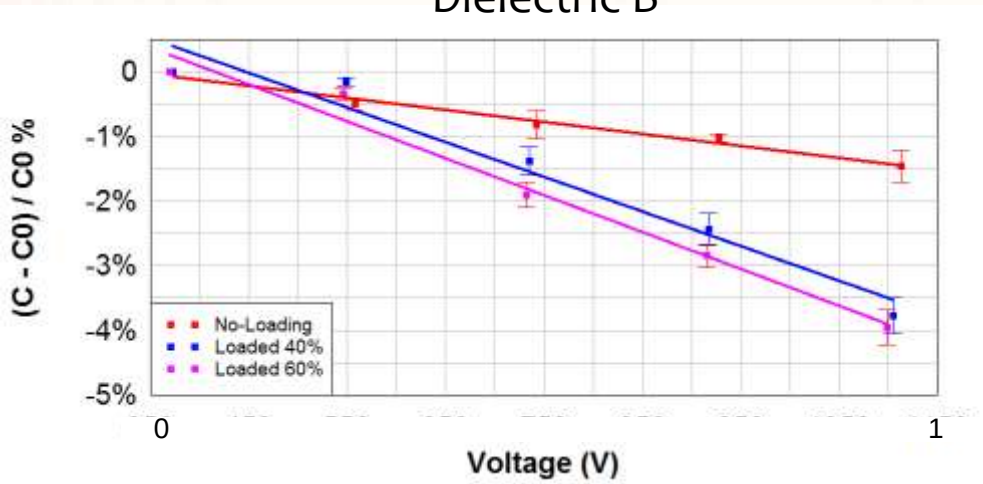
- Dielectric B showed a diminished capacitance when compressed
- Dielectric C showed a diminished increase in capacitance when compressed
