HIGH PRECISION METAL FORMING

Mr. Jerry Dickson, US Army AMCOM

Mr. Bill Baschnagel, Creare, Inc.

Mr. Albert Tatka, US Army TACOM-ARDEC

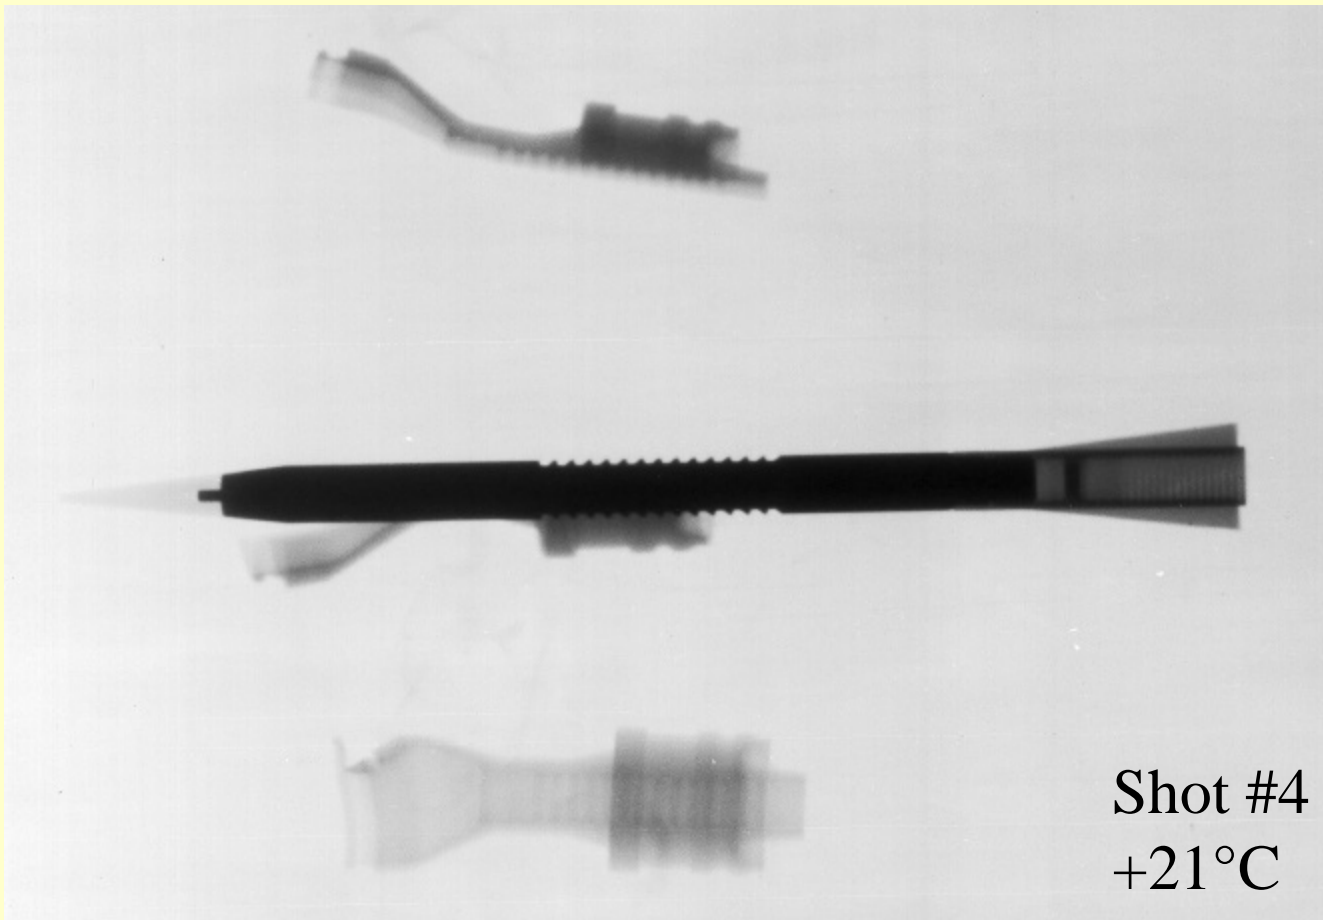
Molded Sabot Projectile

- During forming, die set not closing in parallel
- Inspection noted that aft section slightly oversized
- Thought not to have dramatic effect on finished assembly
- Twenty four sets fabricated
- Aft scoop machined, heat treated and cleaned
- Finished parts provided to GD-OTS to anodize and assemble into M919 cartridges

- Oversized aft DIA resulted in excessive spin
- Excessive spin may have contributed to structural failures noted
- Buttress teeth survived launch
- Additional effort required to optimize
- Process could have direct benefit to other DoD programs
