Marmet Lock & Dam

Automated Instrumentation Assessment

Summer / Fall 2004

2005 Tri-Service Infrastructure Conference
August 4, 2005

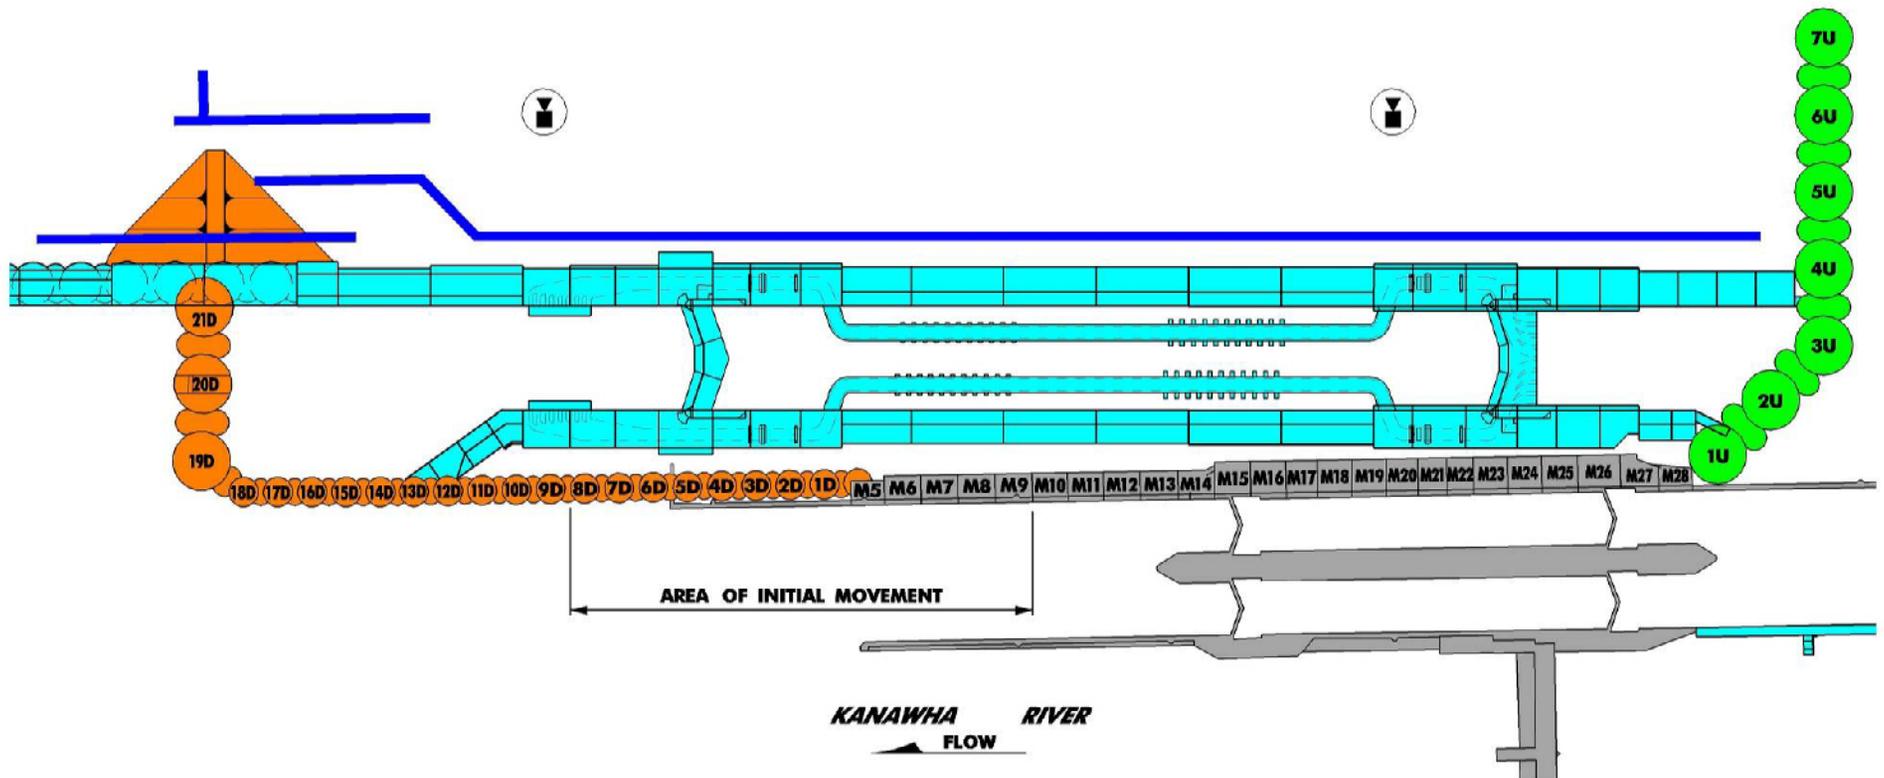
Cofferdam Area

Deep Seated Sliding Occurs

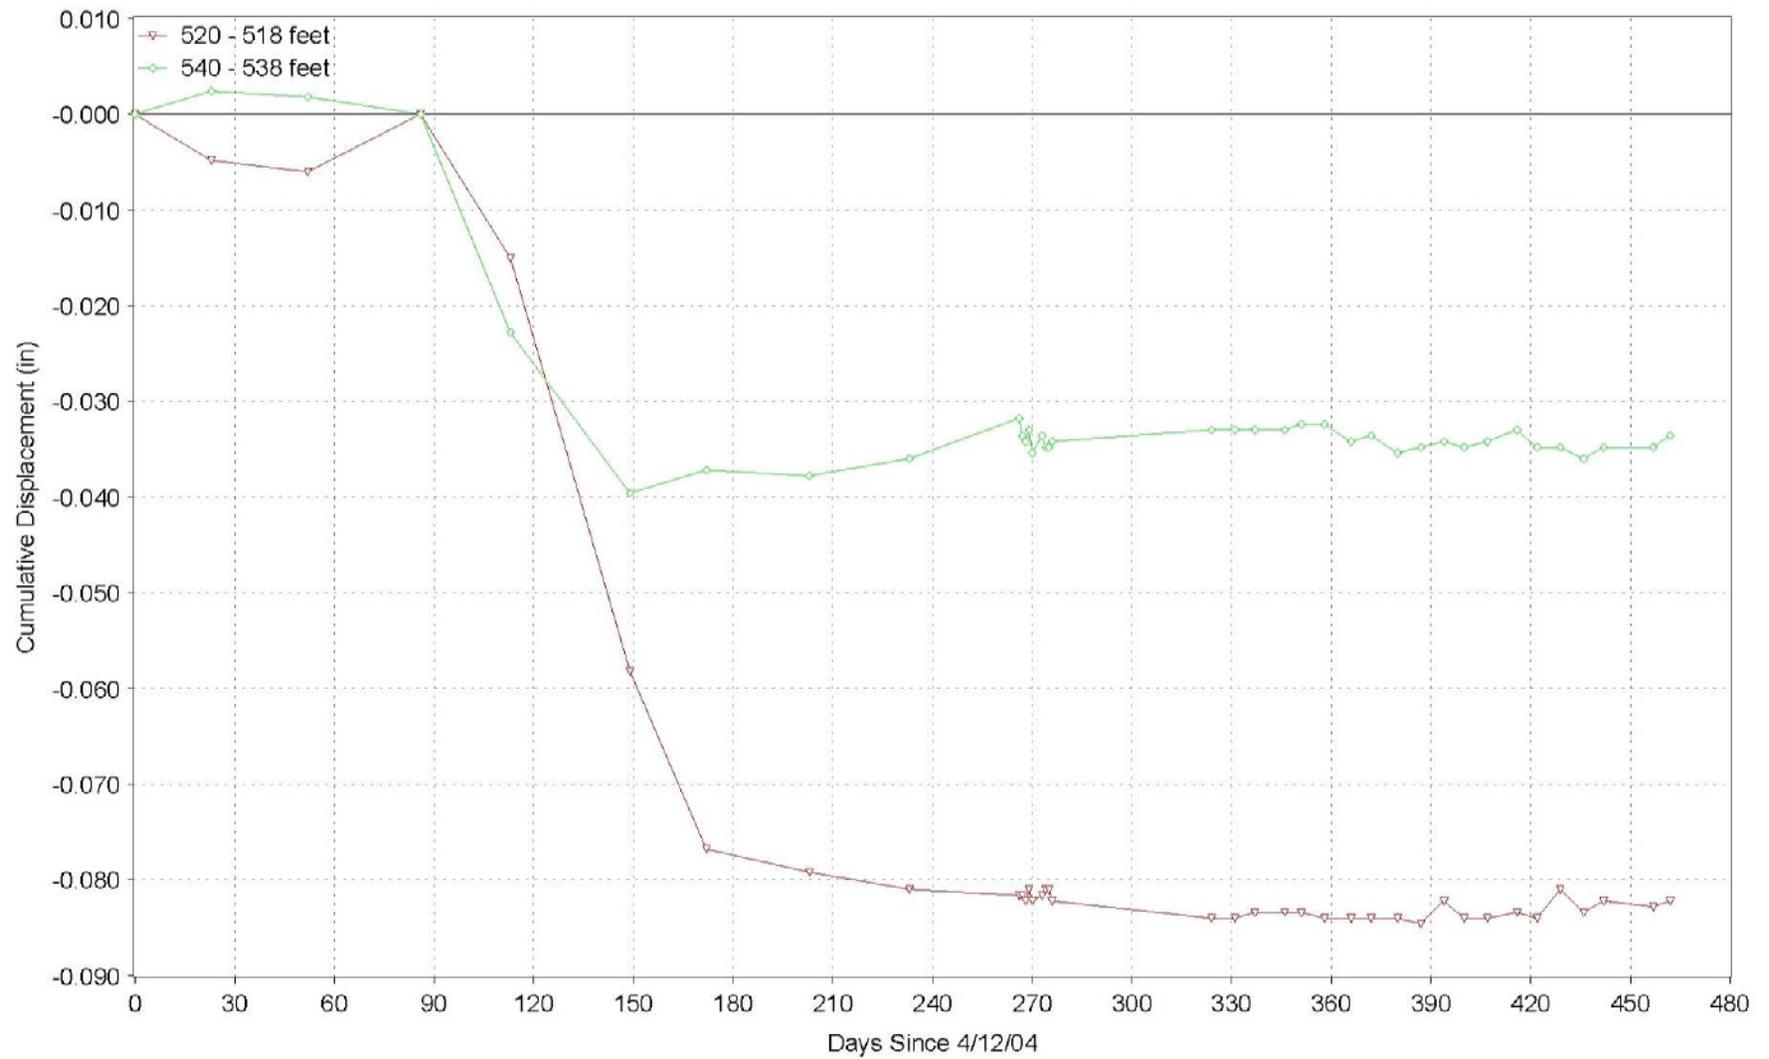
MARMET 6D-P, A-Axis

- Contractor Provides COE With Portable Inclinometer Graphs Indicating Movement In Foundation Below Several Monoliths And Cells
- Movement Elevations Correlated With Previously Identified Weak Seams And Occurred In Four Consecutive Weekly Readings
- Movement Was Recorded In Graphs For A Number Of Adjacent Cells And Monoliths
- Movement Was Oriented Landward And Occurred A Few Weeks After Blasting And Excavation Of Adjacent Foundation Rock Had Begun
- Rate Of Movement Was Consistent And Linear (0.01" To 0.02" Per Week)
