Design, Construction and Seepage at Prado Dam

**Douglas E. Chitwood, P.E., G.E.
Embankment Engineer, Prado Dam**

Prado Dam

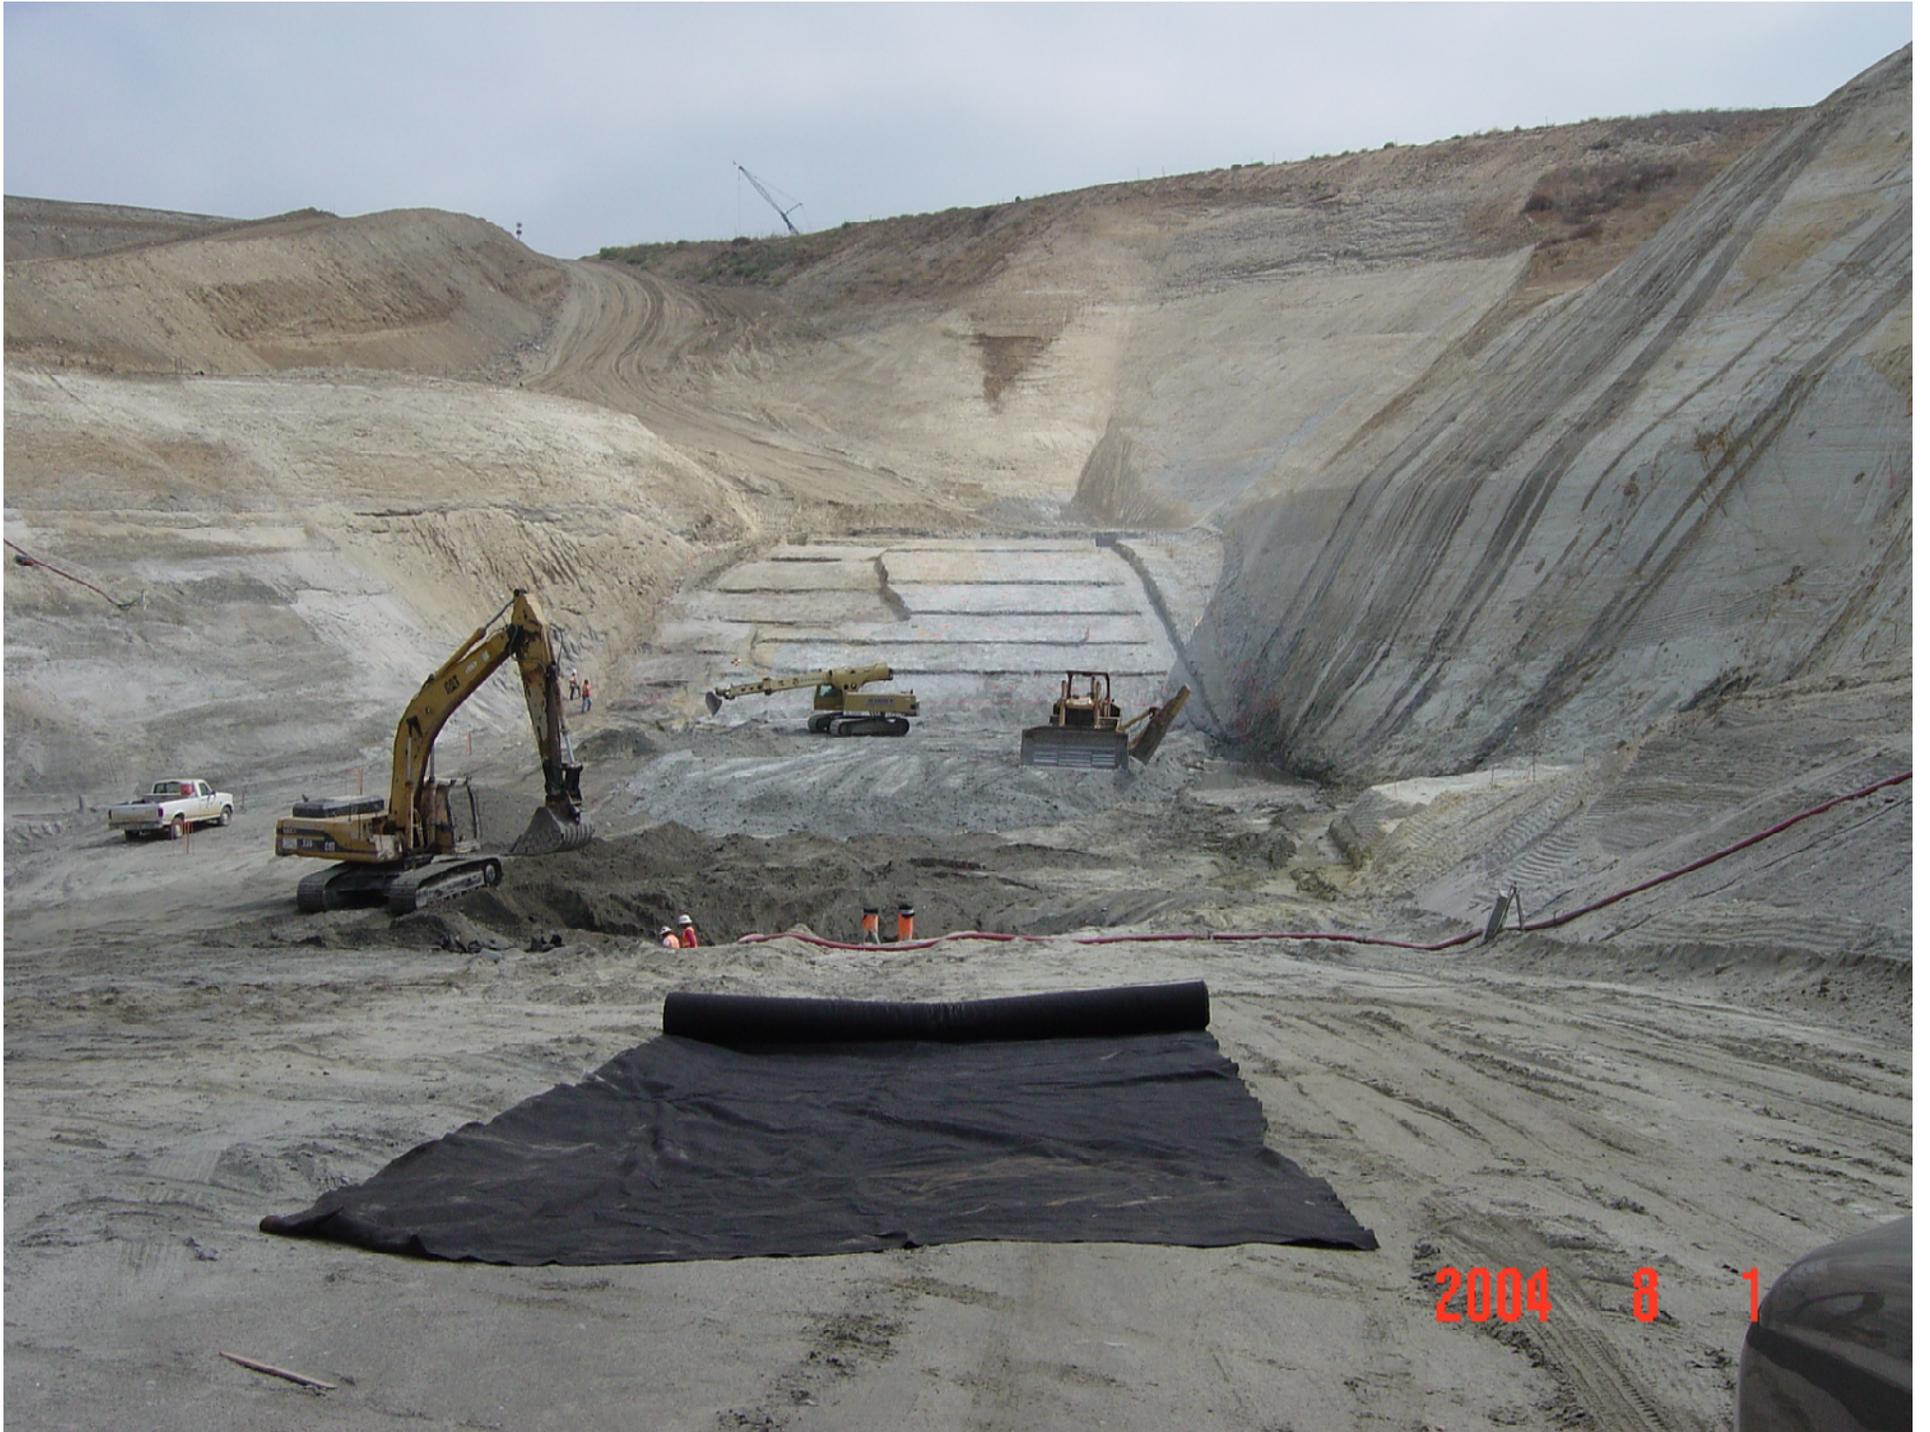
2004 8 1

- **2 gpm of seepage**
- **Water cloudy, but not muddy**
- **Flow rate, clarity constant**

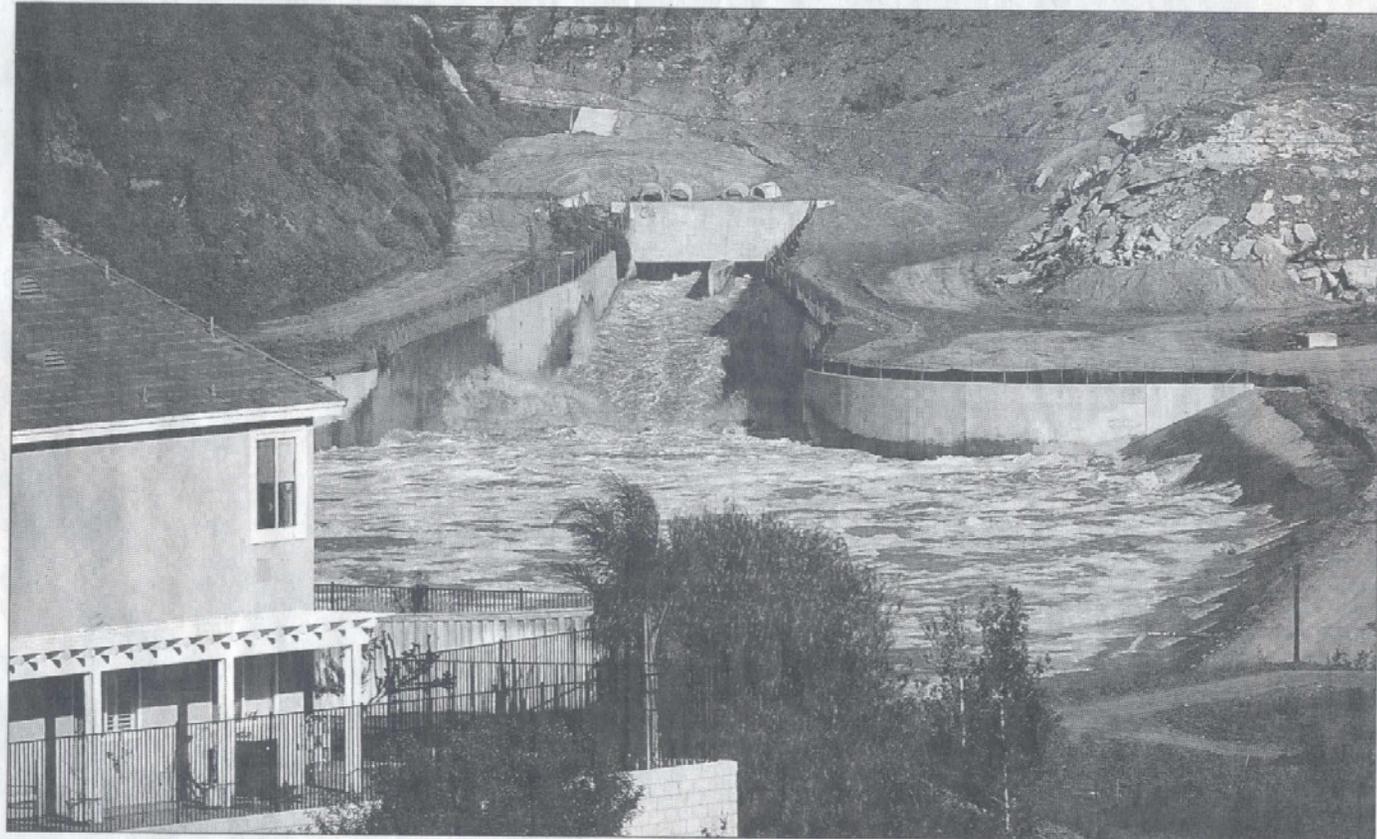
An outlet Prado Dam releases water at high capacity Friday, when a leak at the dam caused evacuations of more than 2,000 in nearby homes. The leak, in the face of the dam, developed after heavy flow from the recent storm filled a pit is normally placing pressure on the dam.
