J.T. Myers Dam Major Rehab

John T. Myers Dam Rehab

Major Areas of Concern for J.T. Myers Dam

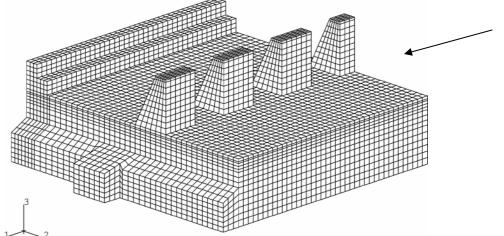
Global 3-D F.E. model of ½ stilling basin gate bay w/ baffle blocks and reinforcement features

FE model data output vs. field data and model tests
