Evaluation and Repair Of Blast Damaged Reinforced Concrete Beams

MAJ John L. Hudson P.E.

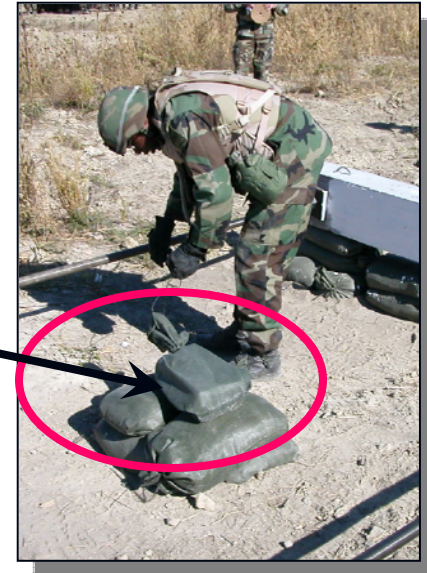
Set 2 after detonation of charge

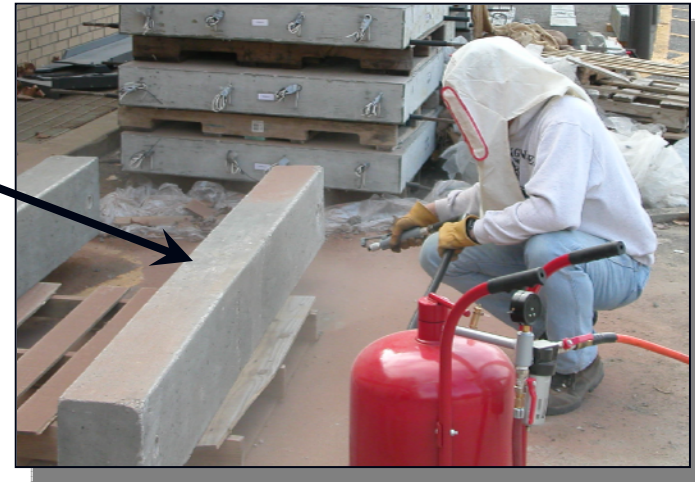
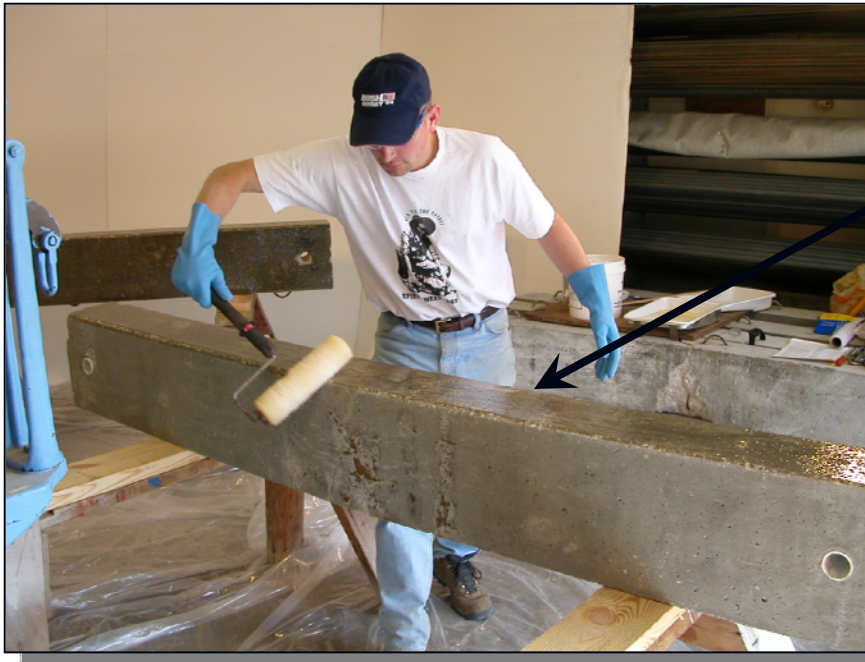
Beams 2B and 4A were sandblasted prior to application of the FRP Primer to remove any surface contaminants

One coat of MBrace Primer was applied to each beam using a short nap roller

The primer cured for approximately 18 hours resulting in a clear, shiny, slightly tacky surface.

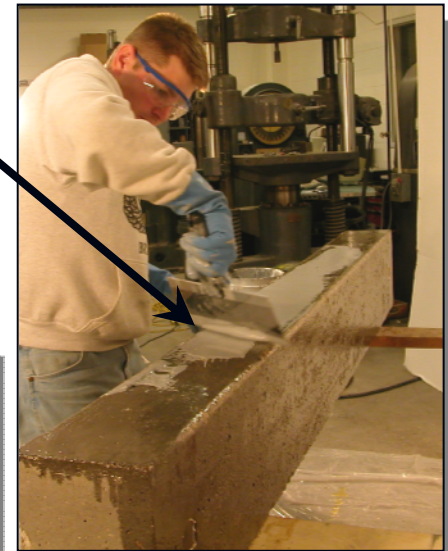
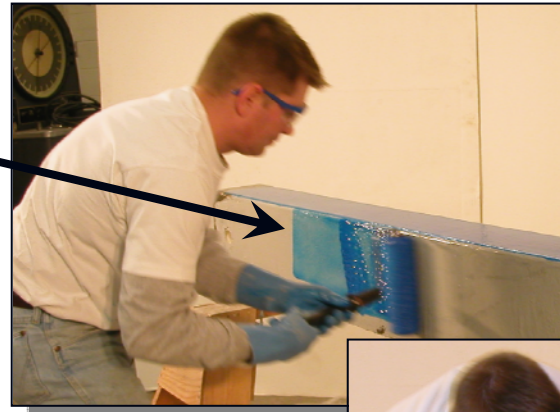
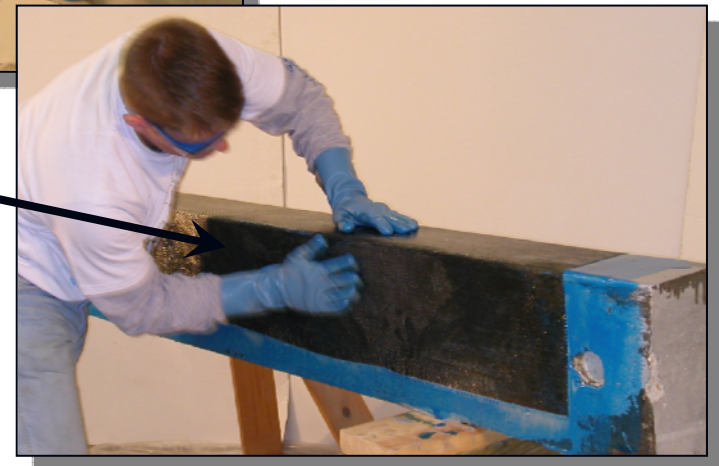
The MBrace Putty is applied in a thin coating to smooth the surface of the beam.

The MBrace Putty cured for approximately six hours before the saturant was applied.

The MBrace Saturant was applied to each beam using a medium nap roller.

The first layer of carbon fiber fabric was applied running parallel to the beam's primary axis. This layer of fabric provided tensile reinforcement to the beams.

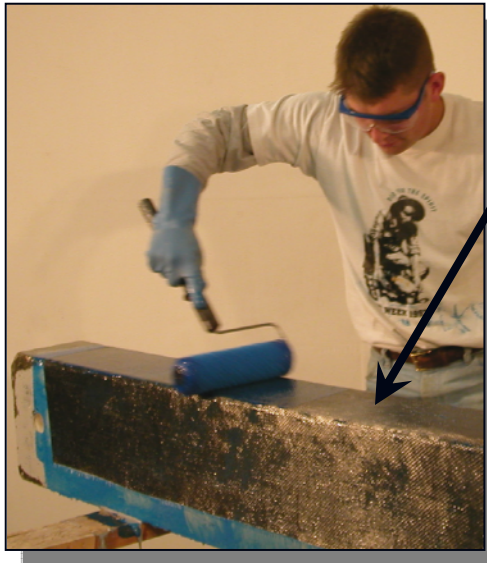
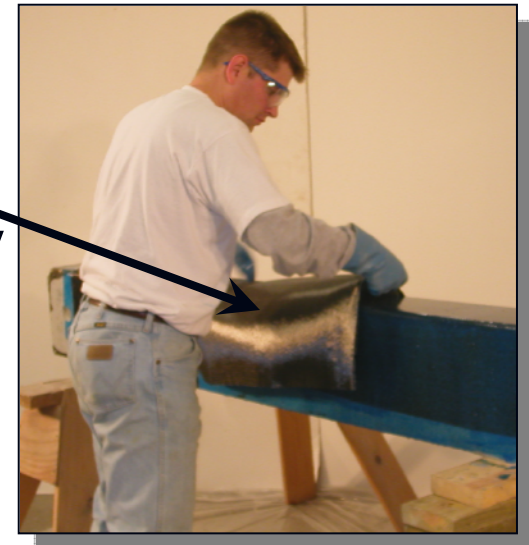
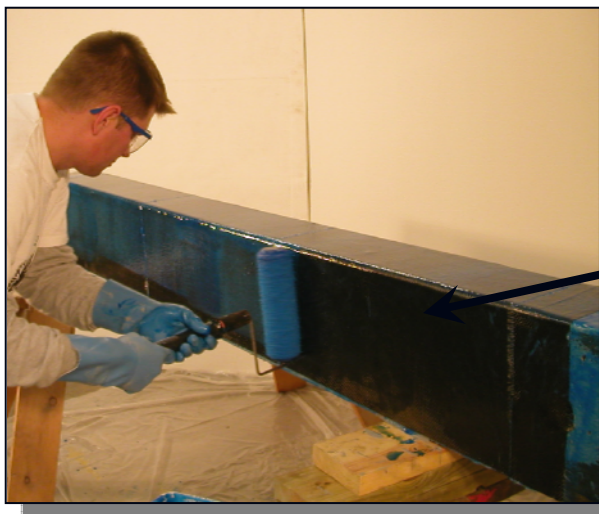
A 2nd layer of saturant was applied on top of the fabric. The saturant was applied generously to ensure that the fabric was fully saturated.

The second layer of carbon fiber fabric was applied on top of the fully saturated longitudinally oriented fabric.

A final layer of saturant was applied to the beams on top of the shear reinforcement fabric.

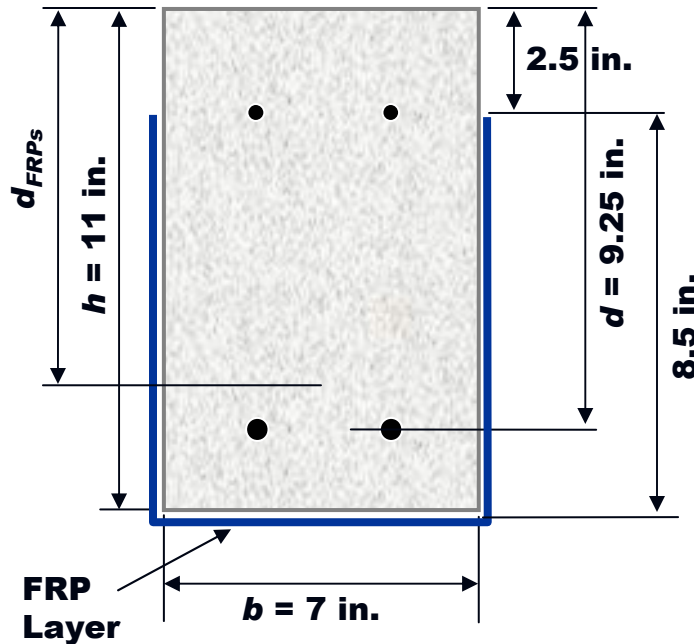
- Cross sectional area of FRP was 0.1560 in² but only 0.1495 in² was in tension
- Iterative process was used to determine increase in strength in beam due to FRP assuming beam was undamaged
- FRP results in an overreinforced section and provides a 40% increase in moment capacity for an undamaged beam

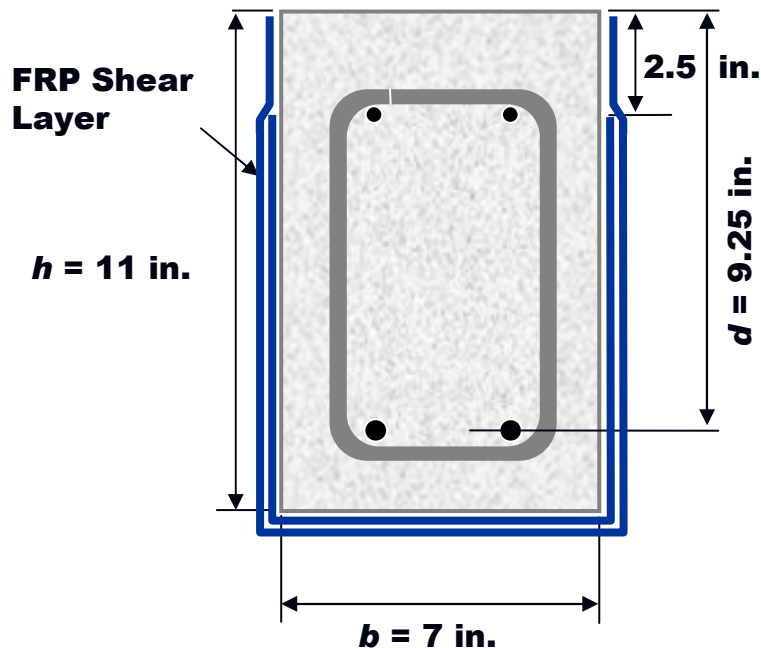
- The shear reinforcement was U-wrapped from the top edge on one side to the top edge on the other side

- With a calculated shear strength of 59.0 kips (262 kN), the shear strength did not govern the strength of the beams.

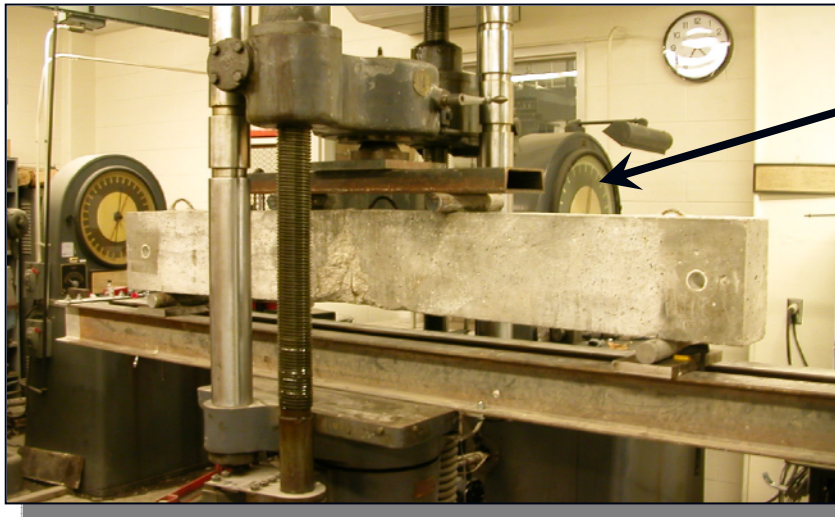
Beams were mounted in the third-point reaction frame on the 120 kip Baldwin Universal Testing Machine.

Displacement transducer measured the deflection of the centerline of the beam.

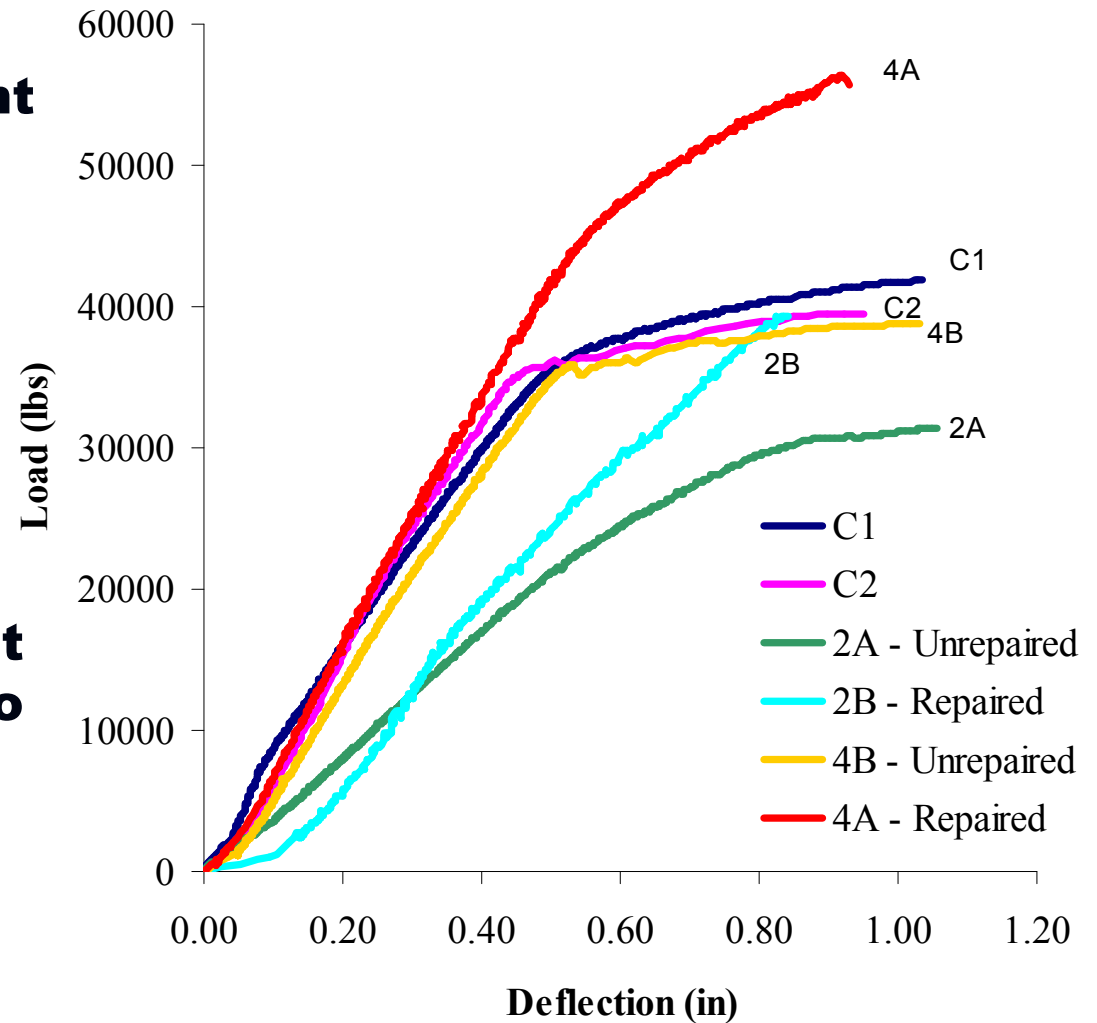
- **Both repaired beams demonstrated a significant improvement in strength**
- **All 6 beams ultimately failed when the concrete at the top center of the beam crushed**
- **Beam 2B did not experience any significant nonlinear behavior prior to yielding**
- **Beam 4B demonstrated very similar behavior to the control beams**
