***CATHODIC PROTECTION FOR
THE SOUTH POWER PLANT
REINFORCING STEEL,
DIEGO GARCIA, BIOT***

***THOMAS TEHADA, NAVFAC - NFESC
MIKI FUNAHASHI, CORRPRO COMPANIES, INC.***

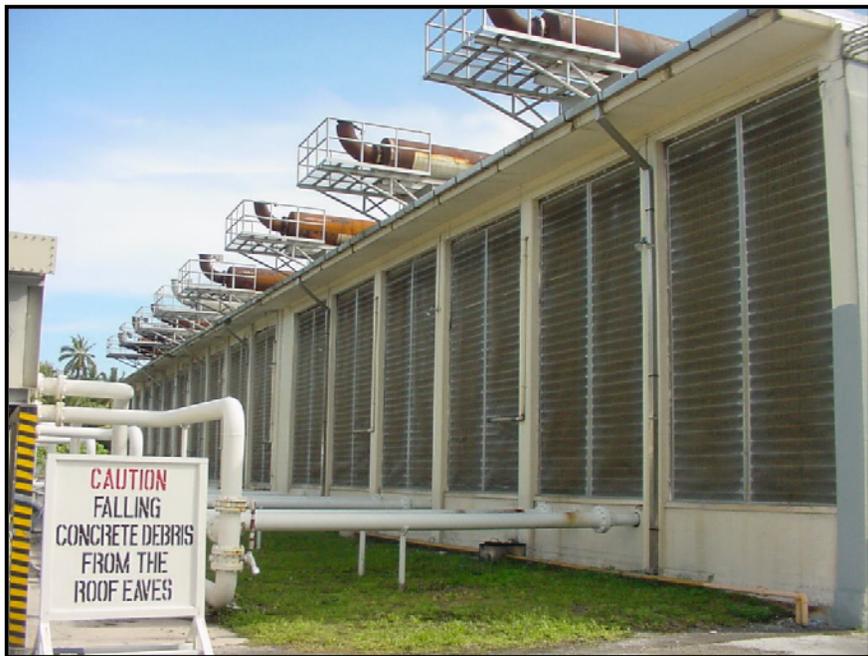
**Figure 1.
South Power Plant, view
from southwest. First six
bays are Ph. II construction**

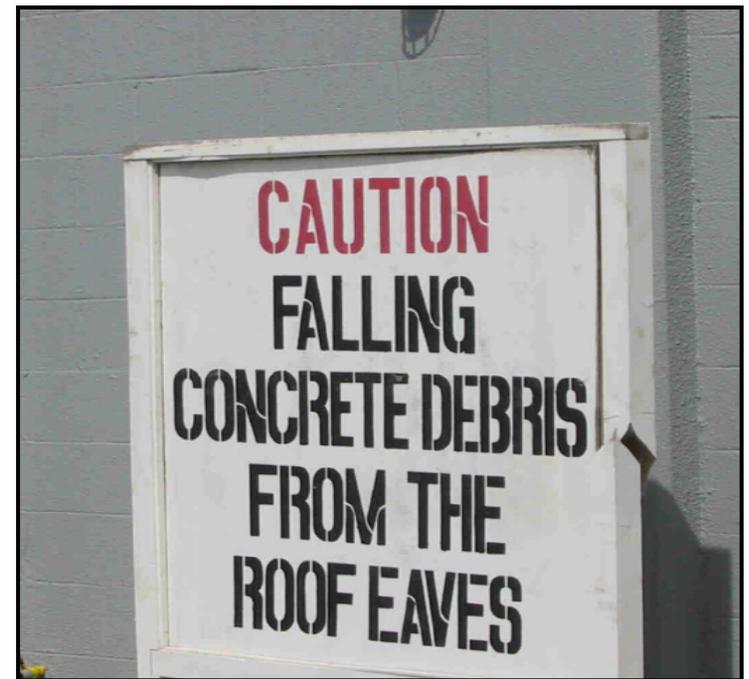
- **Deterioration at west spandrel beam can continue without significant degradation of roof structure's load capacity. However, there were aesthetic as well as a safety concerns about cracked and spalling concrete.**
- **Integrity of roof structure not yet significantly degraded by current stage of deterioration at concrete columns/supports along the west wall. However, continued deterioration would significantly degrade integrity, seriously jeopardizing support of roof trusses and creating an unsafe building.**
