***Grout Curtains at Arkabutla Dam  
Outlet Monolith Joints and Cracks  
using Chemical Grout,  
Arkabutla Lake, MS***

***Dale A. Goss, P.E.***

***August 3, 2005***

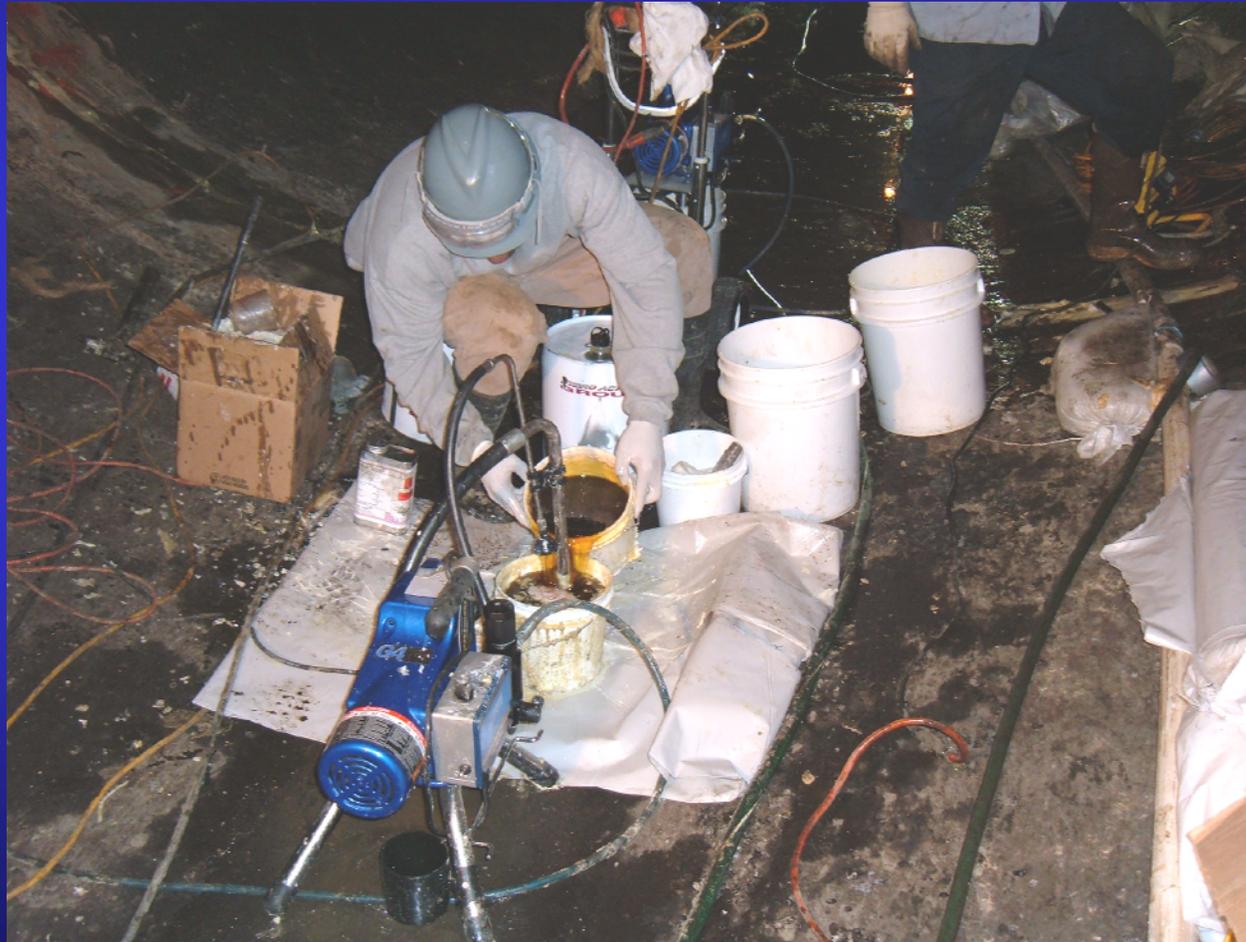
**Chemical grout has been measured in gallon bucket and catalyst was added and mixed by hand. Pouring grout into bucket so that it can be injected.**

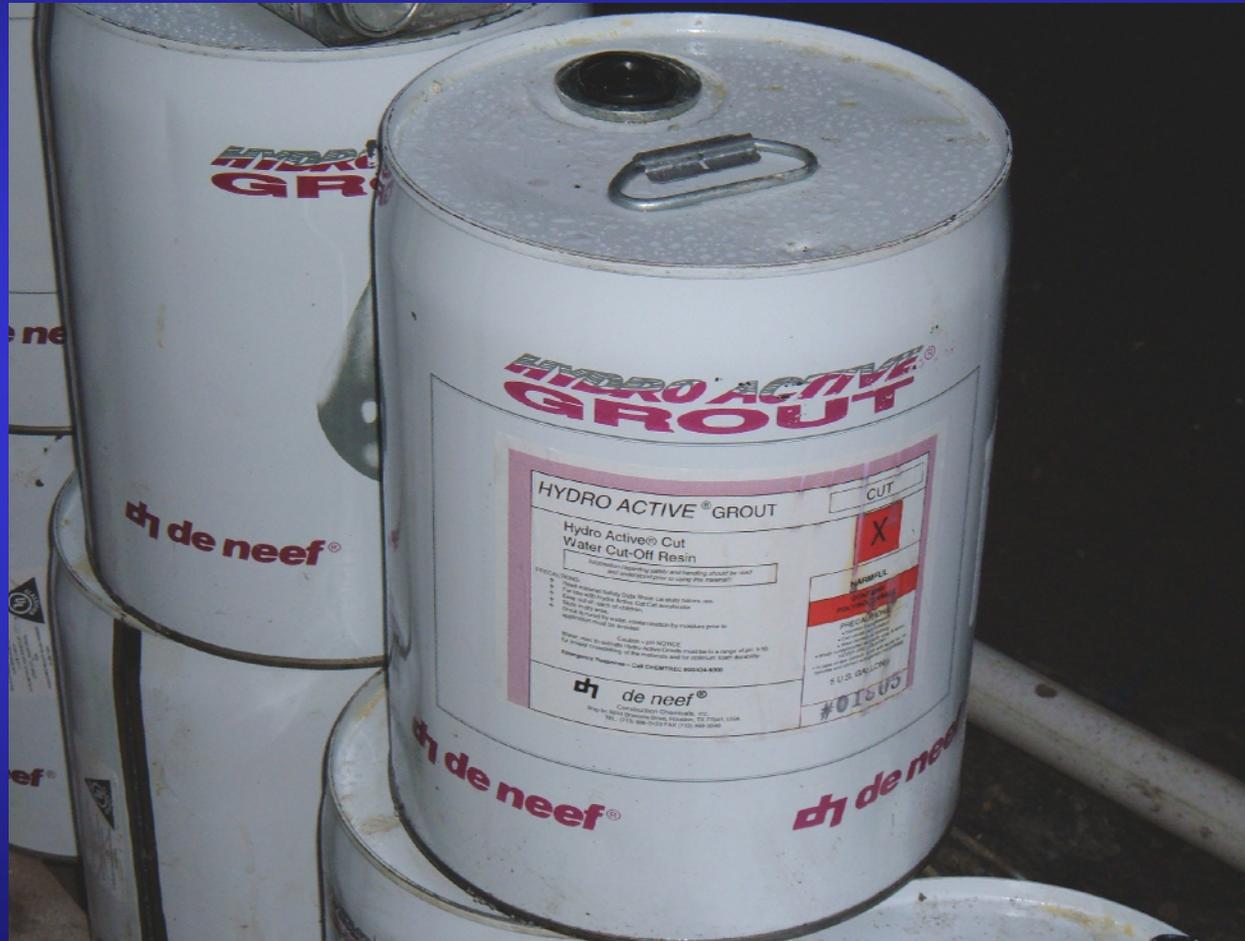
# Pails of Hydro Active Grout used for sealing joints and cracks and to bind foundation sands together beneath the conduit

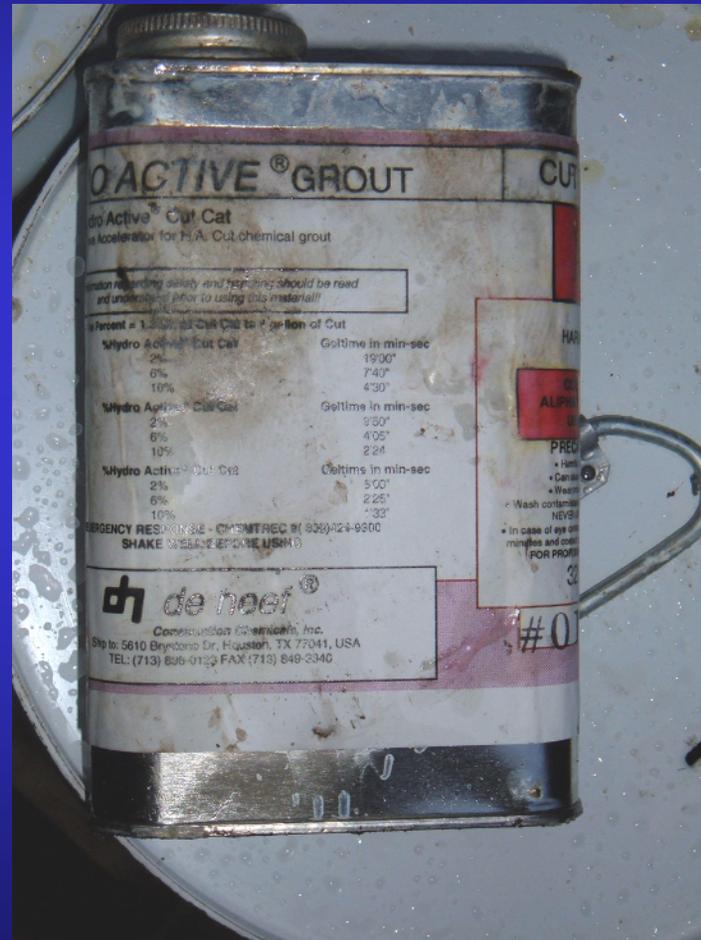
## Can of Hydro Active Cut Catalyst used to vary setting time of chemical grout.
