CLEARWATER DAM

Sinkhole Repair

Foundation Investigation and Grouting Project

Mark Harris, P.G. – USACE-SWL

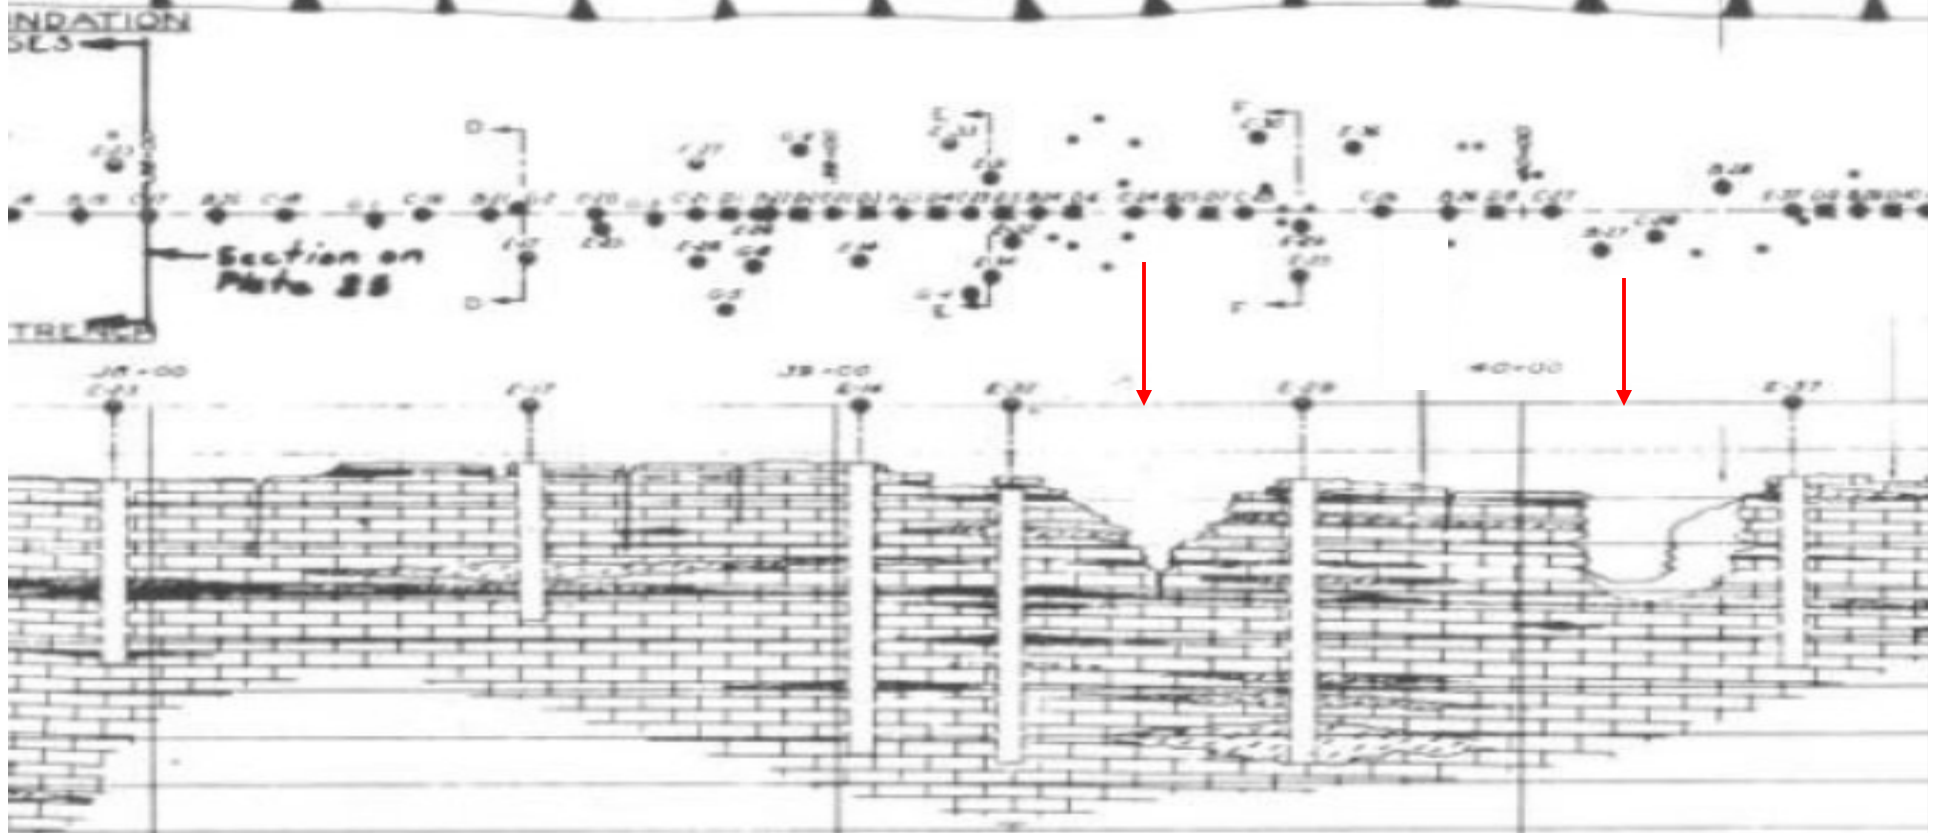
Looking NW from 35' U.S. of station 40 / 15: Open joint in cut-off trench foundation.

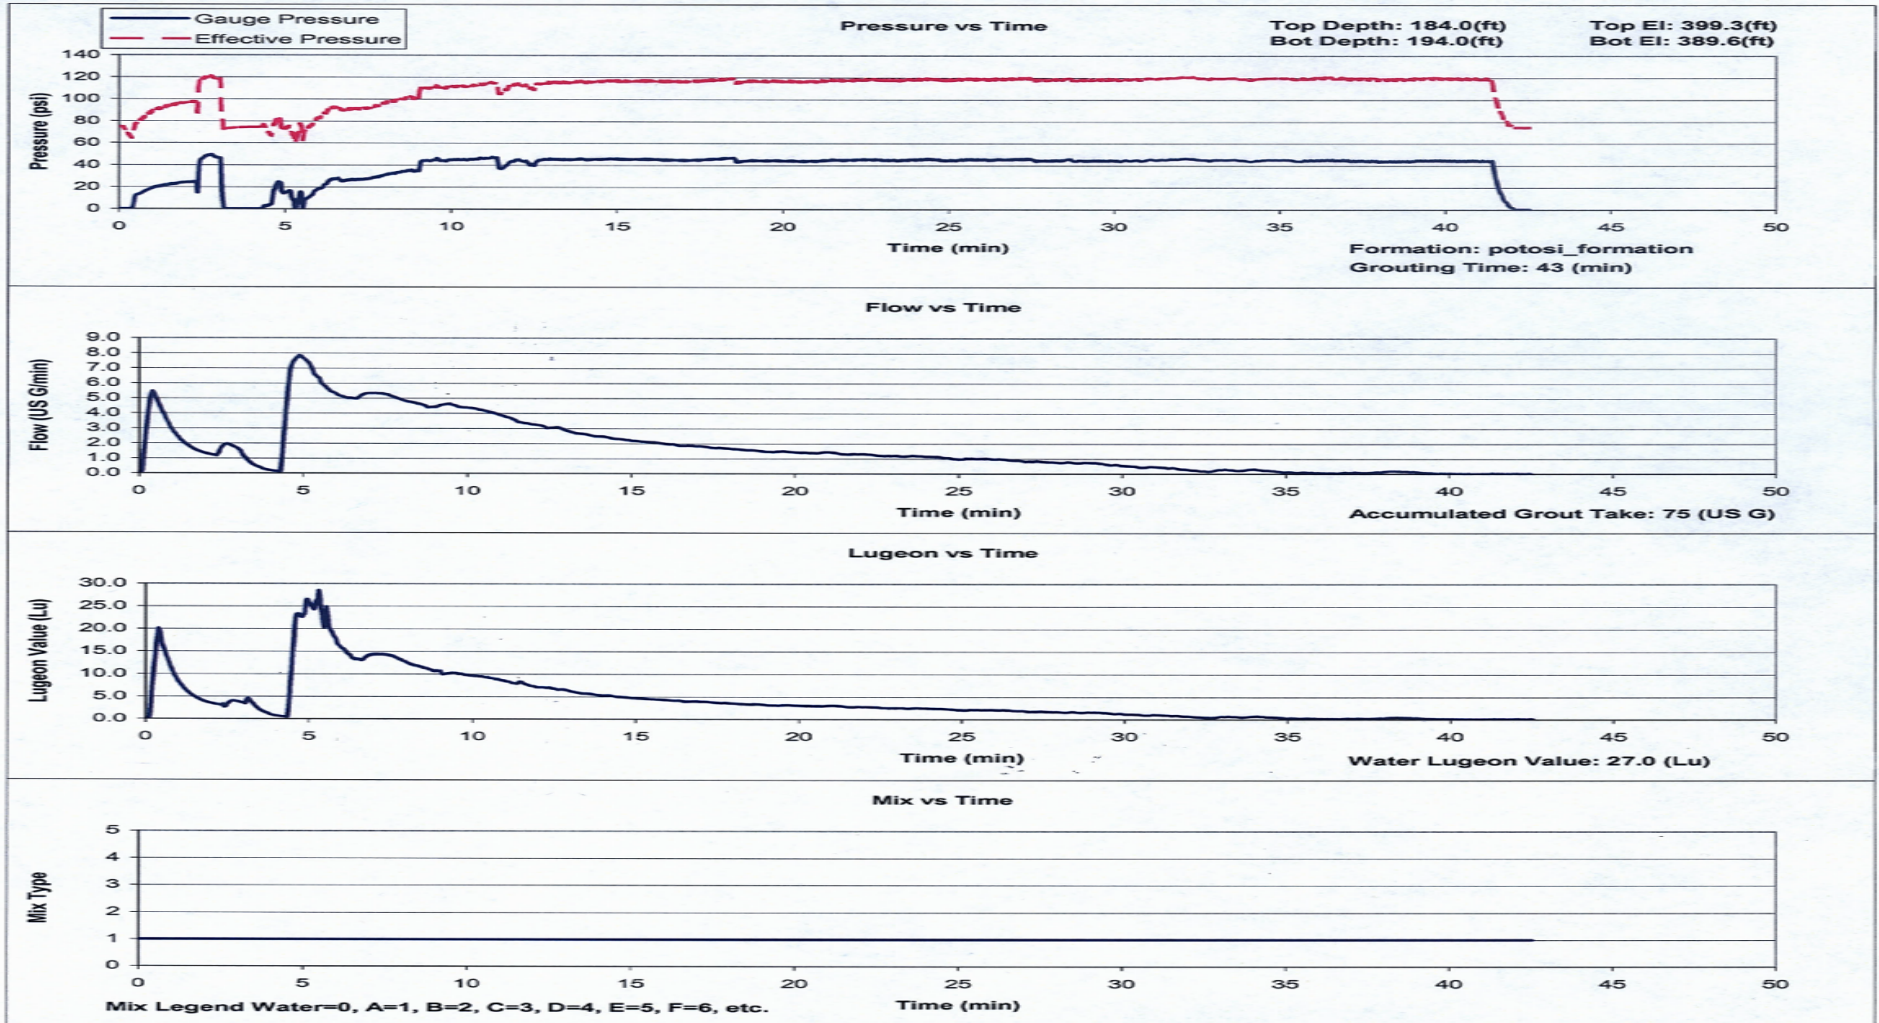
Trend Plots: Grouting Operation, Stage: AP10-7

Moderately High Lugeon

AP10-7	9/13/2004 07:41	Gator header station - Cart 1. Tremied 10 gallons. Packer set at 175'.
AP10-7	9/13/2004 07:41	Began pressure grouting at 4 minutes.
AP10-7	9/13/2004 08:18	Stage complete.

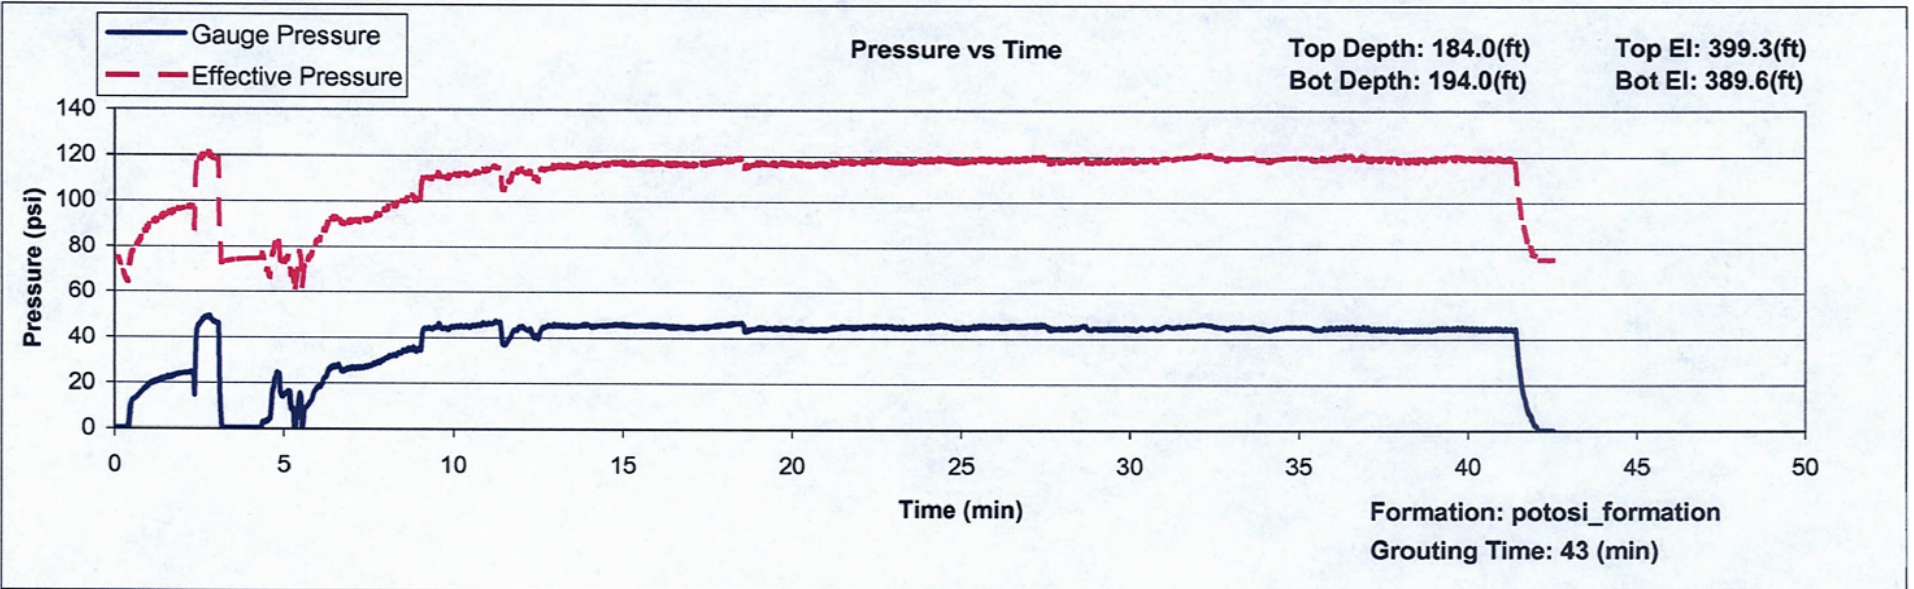
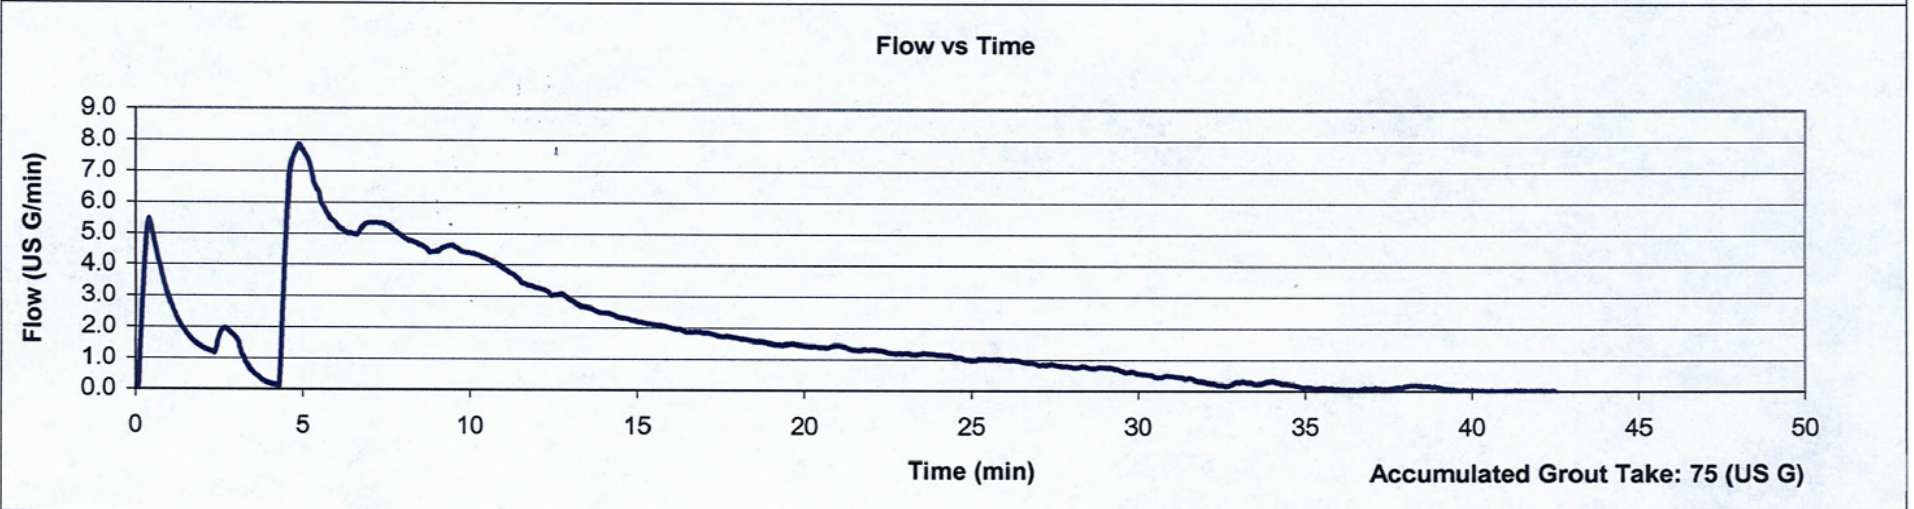
Trend Plots: Grouting Operation, Stage: AP10-7

Moderately High Lugeon

AP10-7	9/13/2004 07:41	Gator header station - Cart 1. Tremied 10 gallons. Packer set at 175'.
AP10-7	9/13/2004 07:41	Began pressure grouting at 4 minutes.
AP10-7	9/13/2004 08:18	Stage complete.

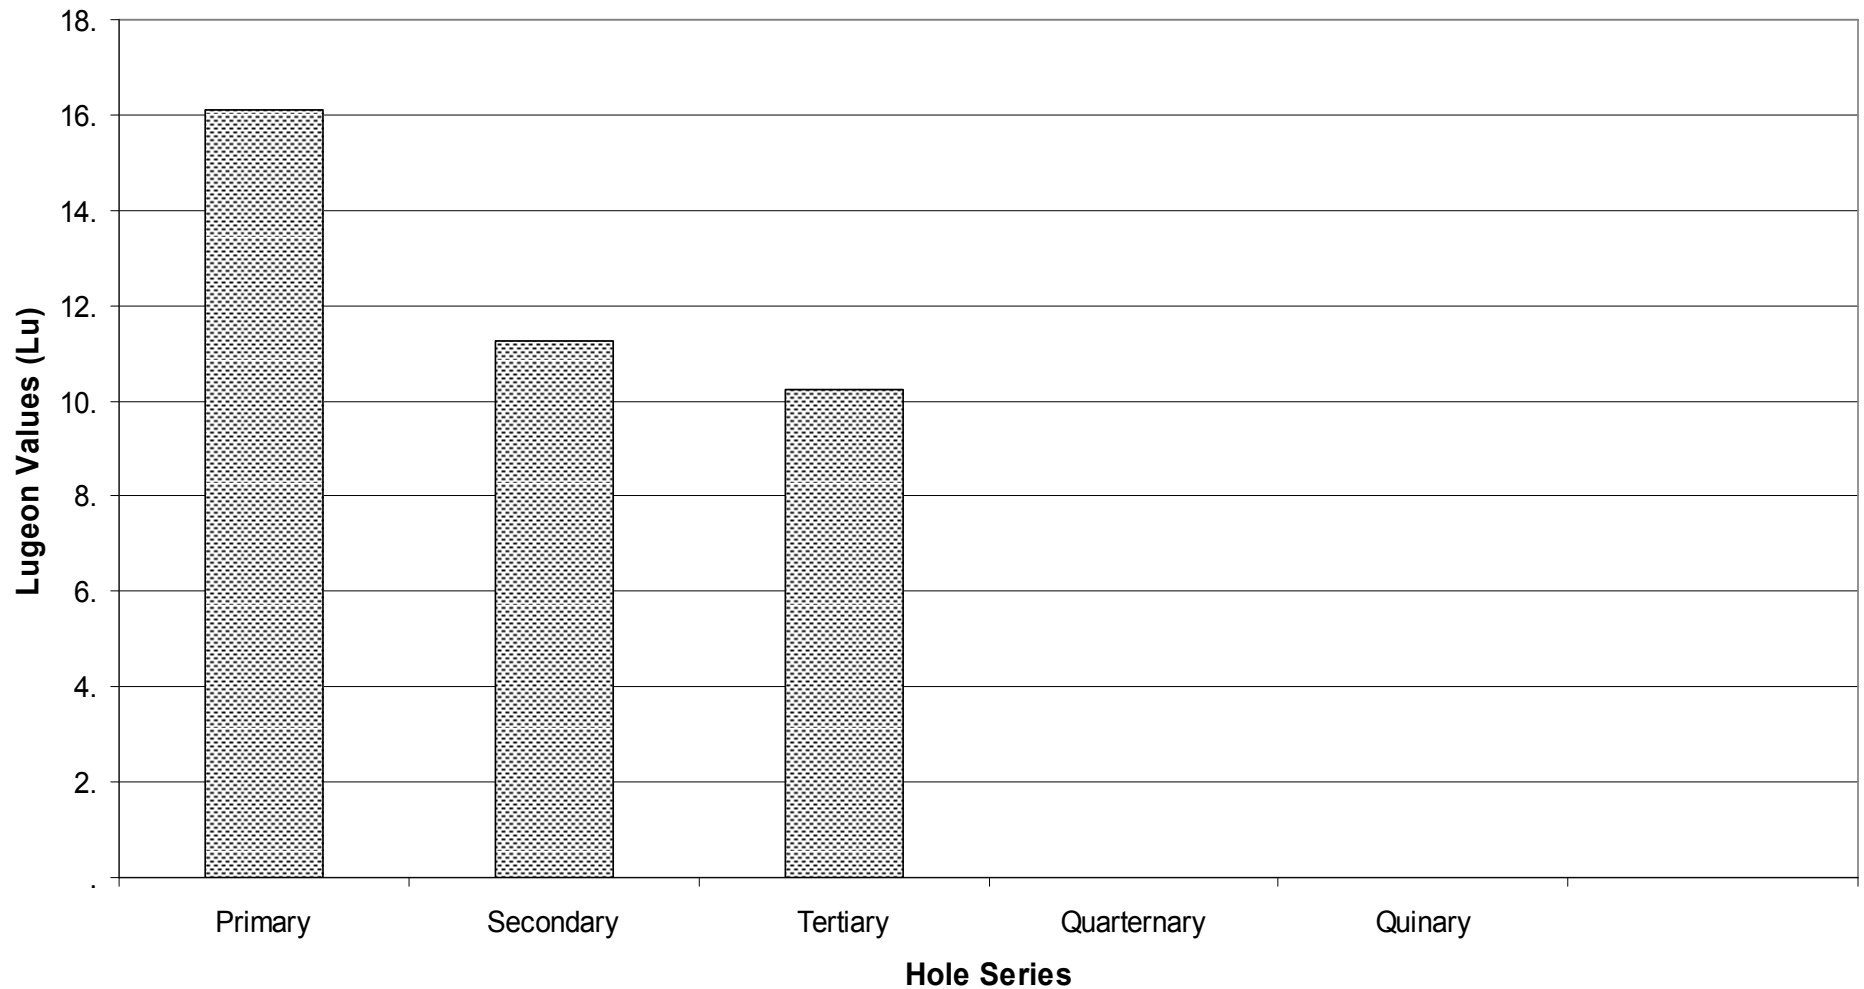
A - Line Closure Analysis

AP13 to AP17 - Elevation 390

Mean Water Lugeon Values Plot

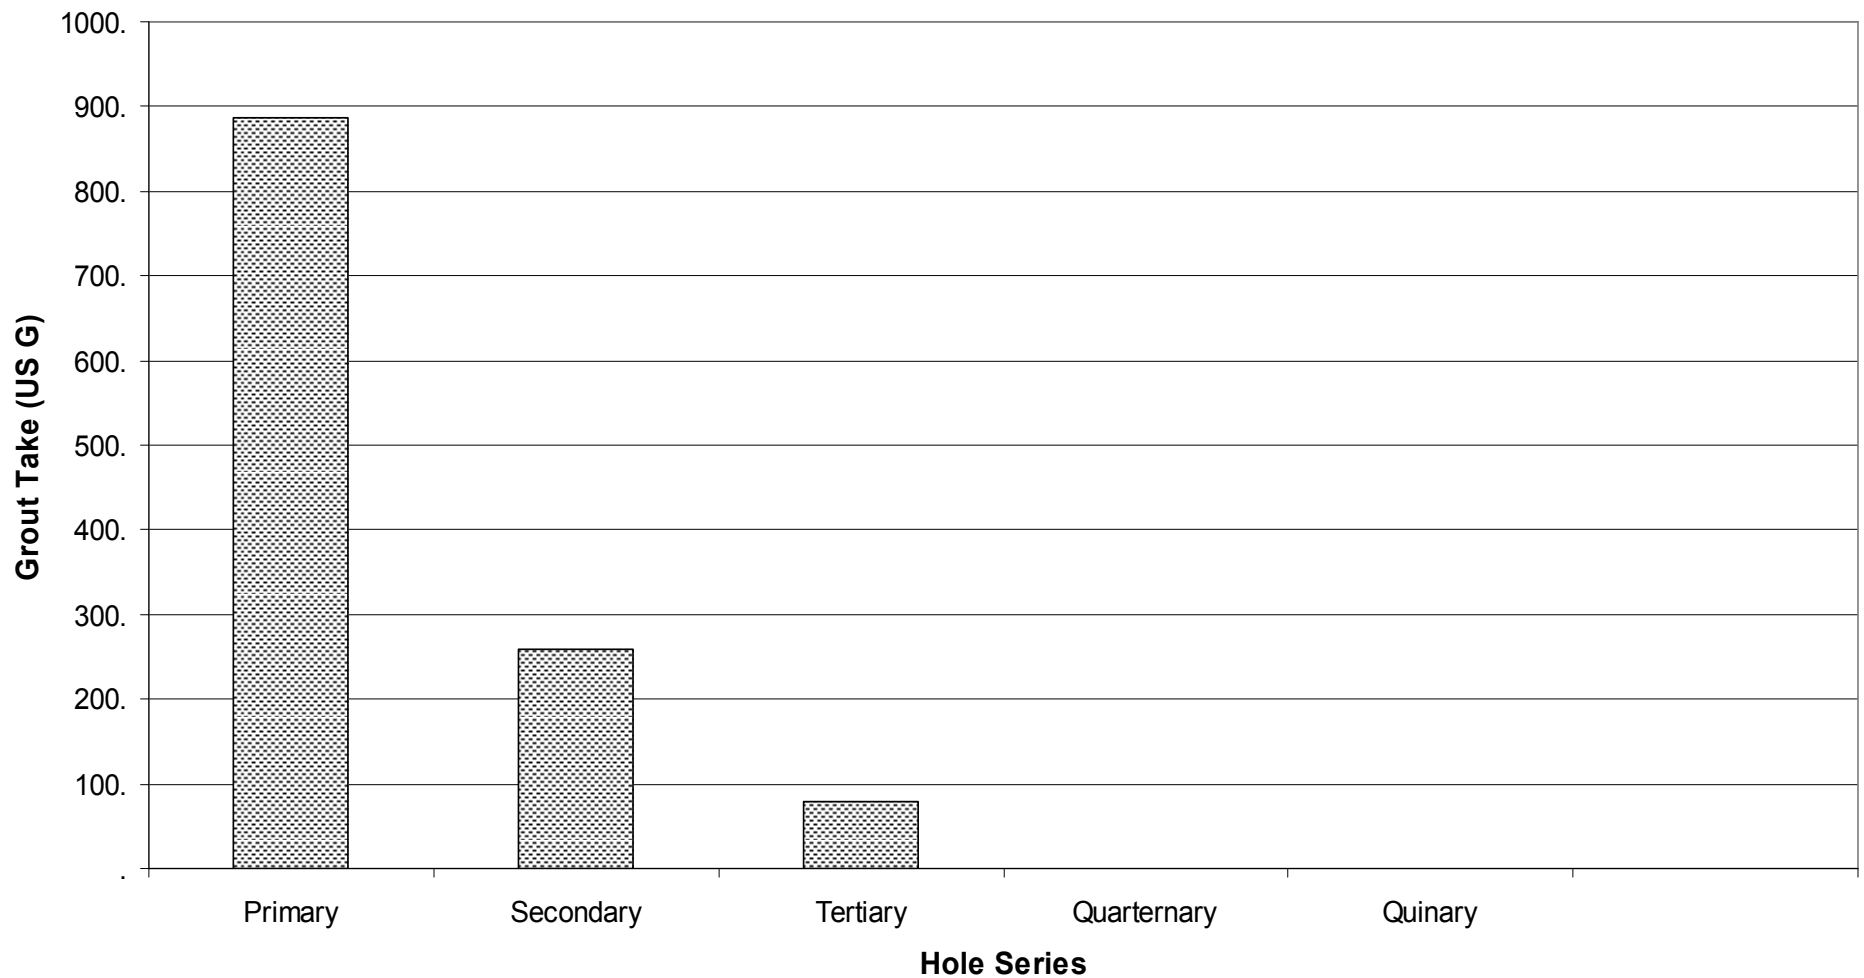
A – Line Closure Analysis

AP13 to AP17 - Elevation 390

Mean Grout Take Values Plot
Line: All , Hole Series: All , Hole ID: AP13 To AP17 , Elevation: 390
