Structural and Geotechnical Issues Impacting The Dalles Spillwall Construction and Bay 1 Erosion Repair

Jeffrey M. Ament, PE
U.S. Army Corps of Engineers,
Portland District
(503) 808-4950
Jeffrey.M.Ament@usace.army.mil

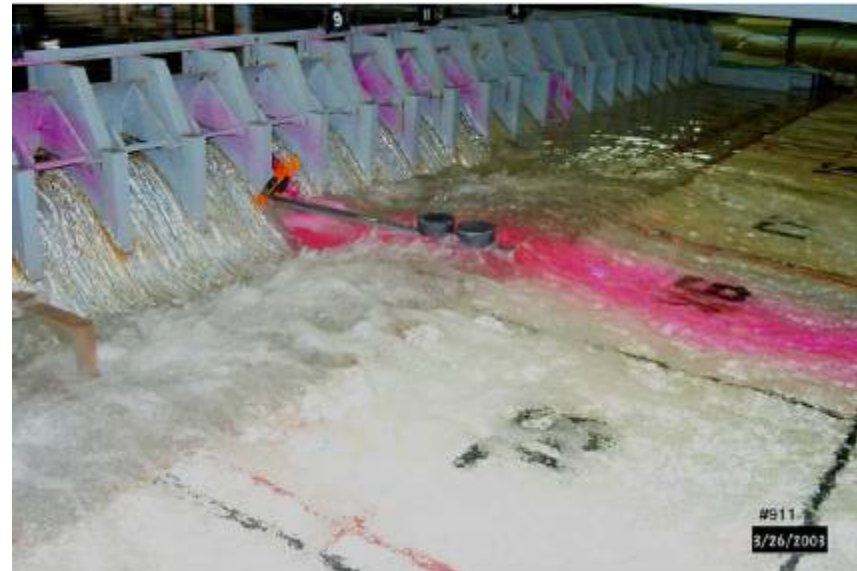
Structural Design

- Load
 - Design load occurred at a River flow of 1050 kcfs and assumed spill on only one side
 - Overturn Moment – 1083.6 ft-kips/ft of wall
 - Shear – 62.1 kips/ft of wall

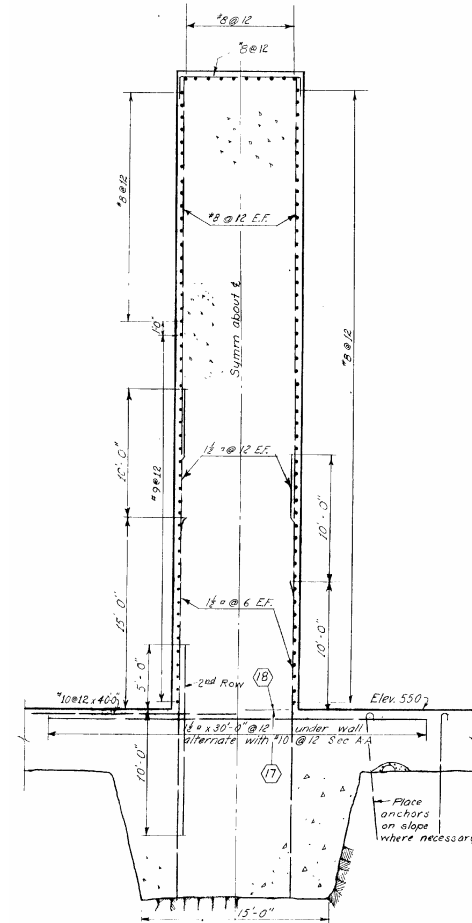
Typical Existing Wall

- Foundation below stilling basin slab
- Design would be very difficult to add to the existing structure

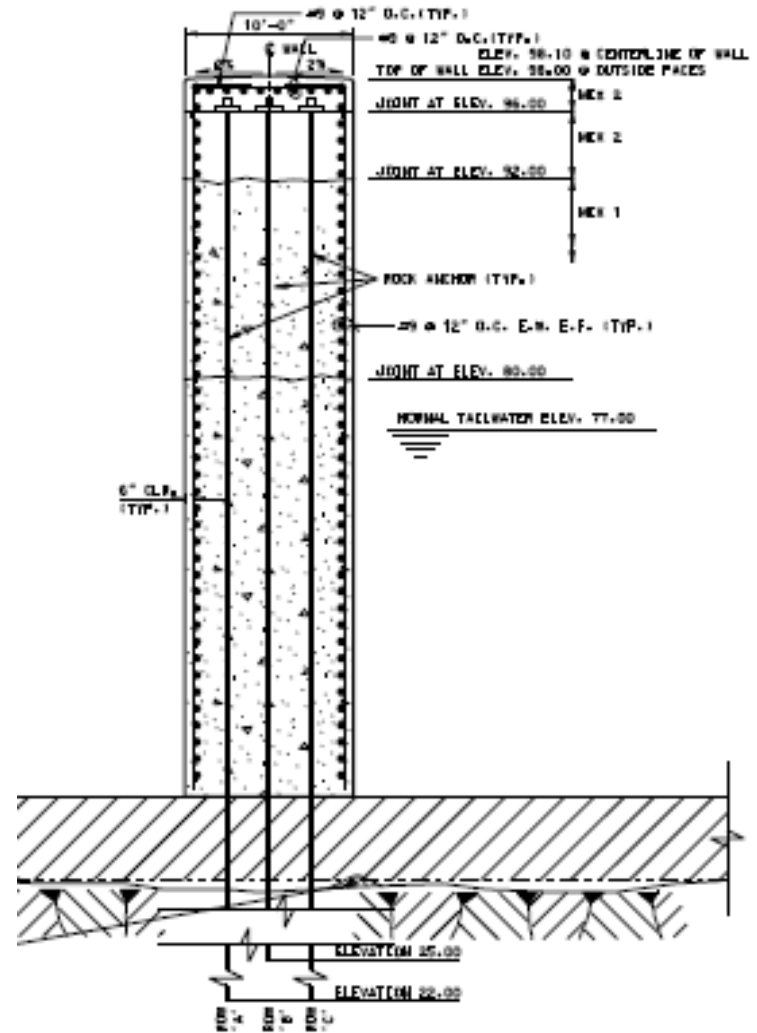
Construction Method

- Construct Wall first
 - Tremie placed concrete
- Construct Foundation last
 - Post-tension wall to rock using rock bolts
- Requires 3 rock bolts evenly spaced across the width (2.5' o.c.) every 3' o.c. the entire length
- Each rock bolt post-tensioned to 545 kips
