**US Army Corps
of Engineers**
Pittsburgh District

The Sliding Failure of Austin Dam Pennsylvania - Revisited

Brian H. Greene, Ph.D. P.G.

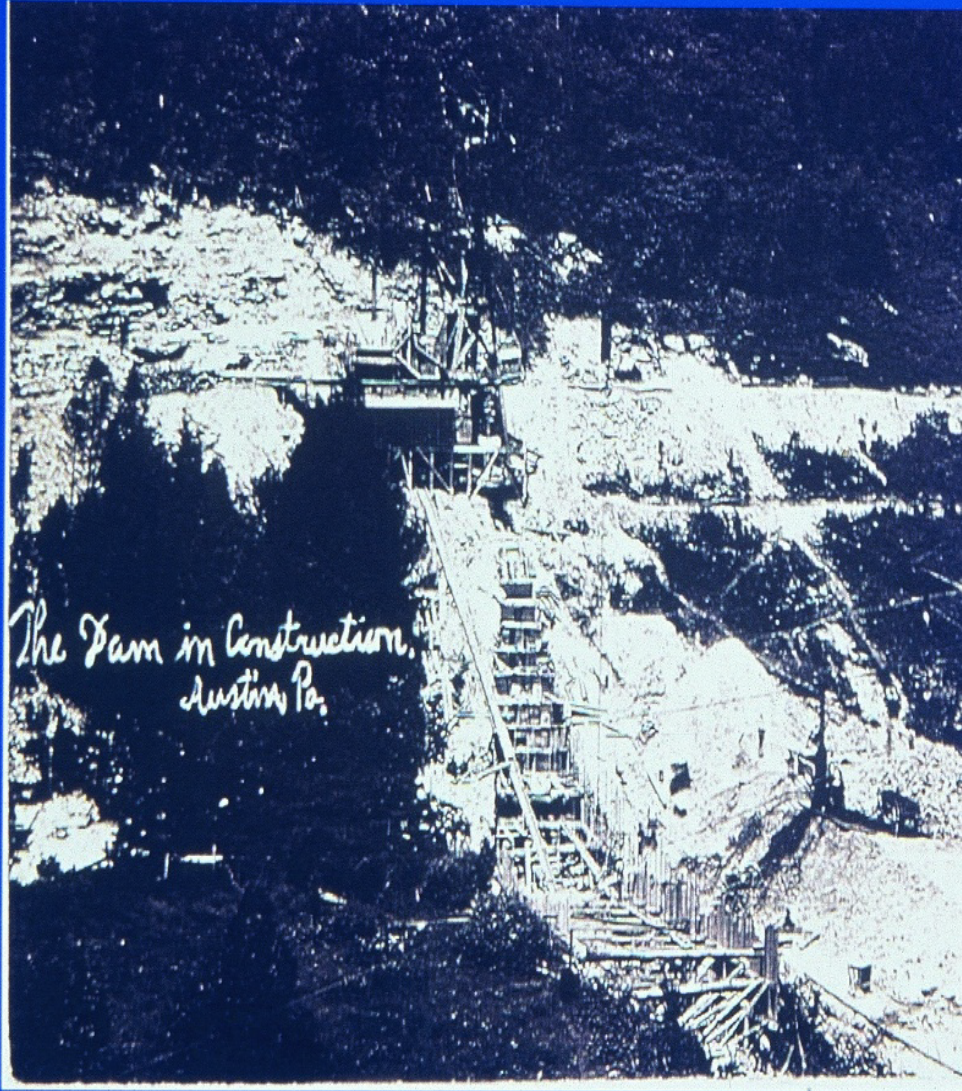
Austin Dam Statistics

- o 544 ft. long
- o 60 ft. high(bottom to top)
- o 30 ft. wide at base
- o Cut-off wall 4 ft.thick & 4 ft. deep
- o Designed for water depth of 42.5 ft
- o 1 ¼ inch steel rods installed 5 ft. inside the vertical face

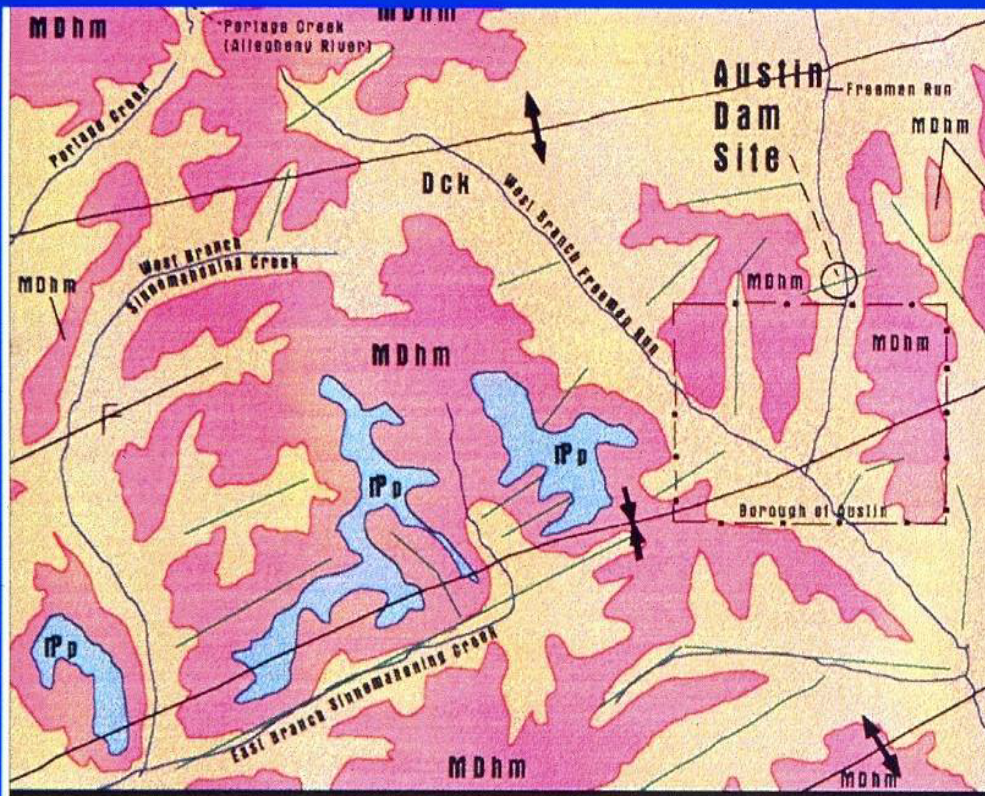
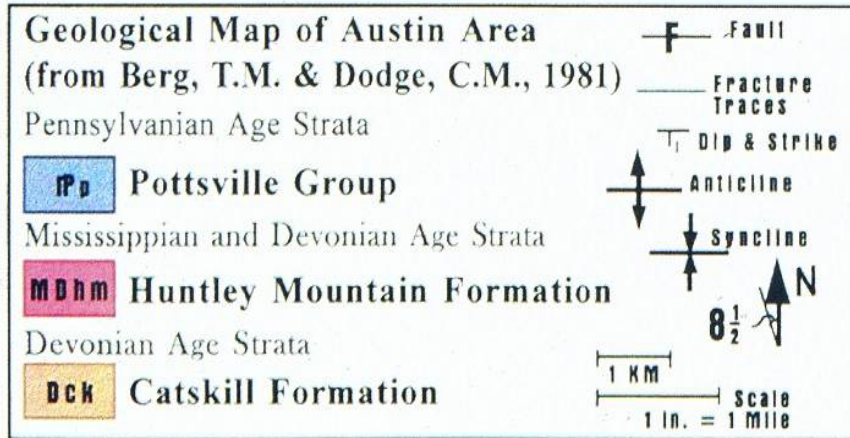
Subsurface (foundation)stratigraphy

- o Devonian-age sedimentary rocks
- o Main stream trends controlled by jointing
- o Tributary stream trends in trellis pattern, and believed to follow subsurface structure

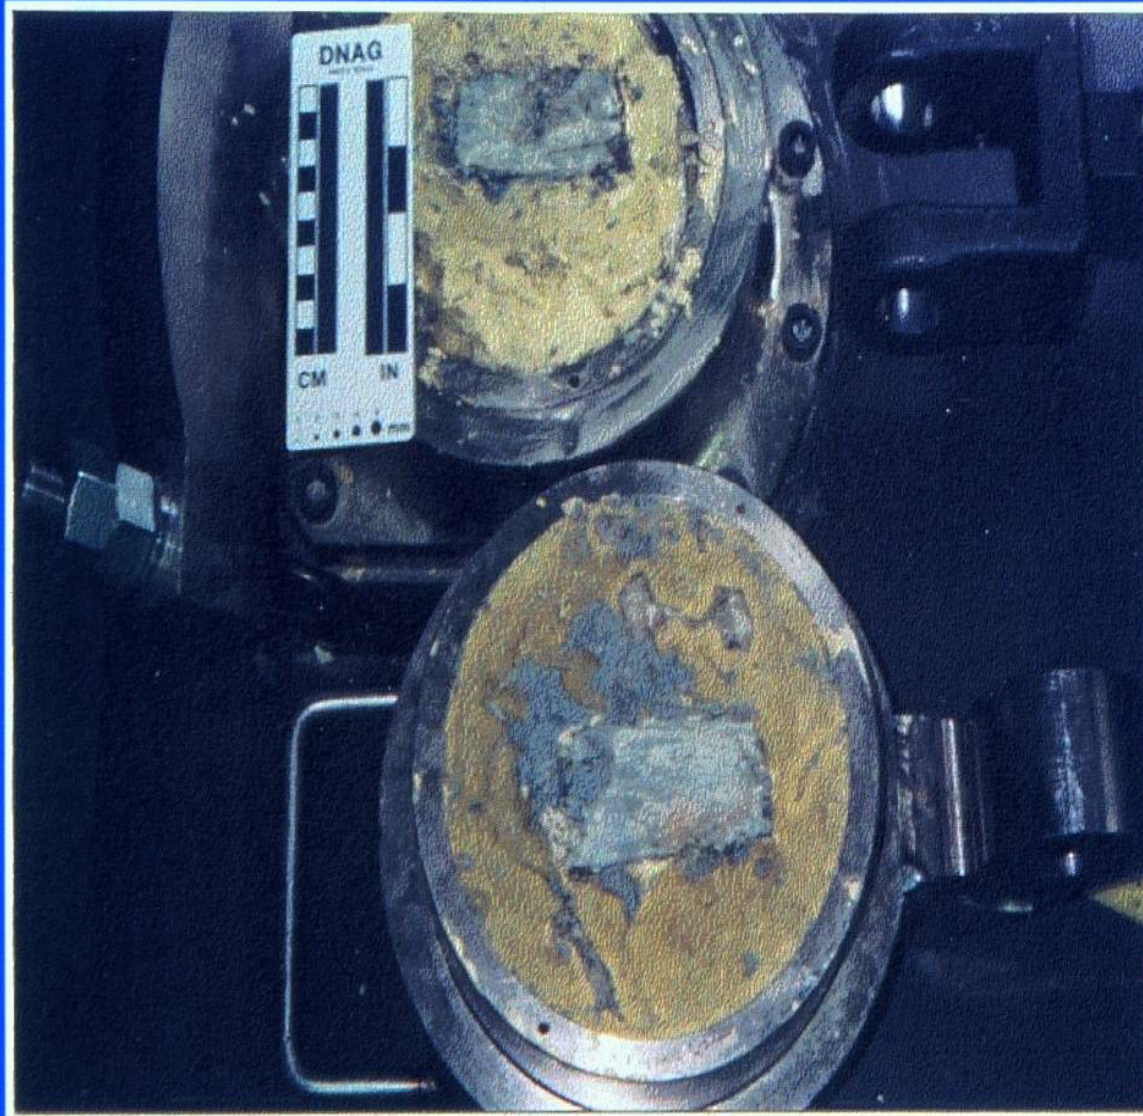
Direct shear sample preparation

Samples tested according to their stratigraphic order in the foundation of the dam

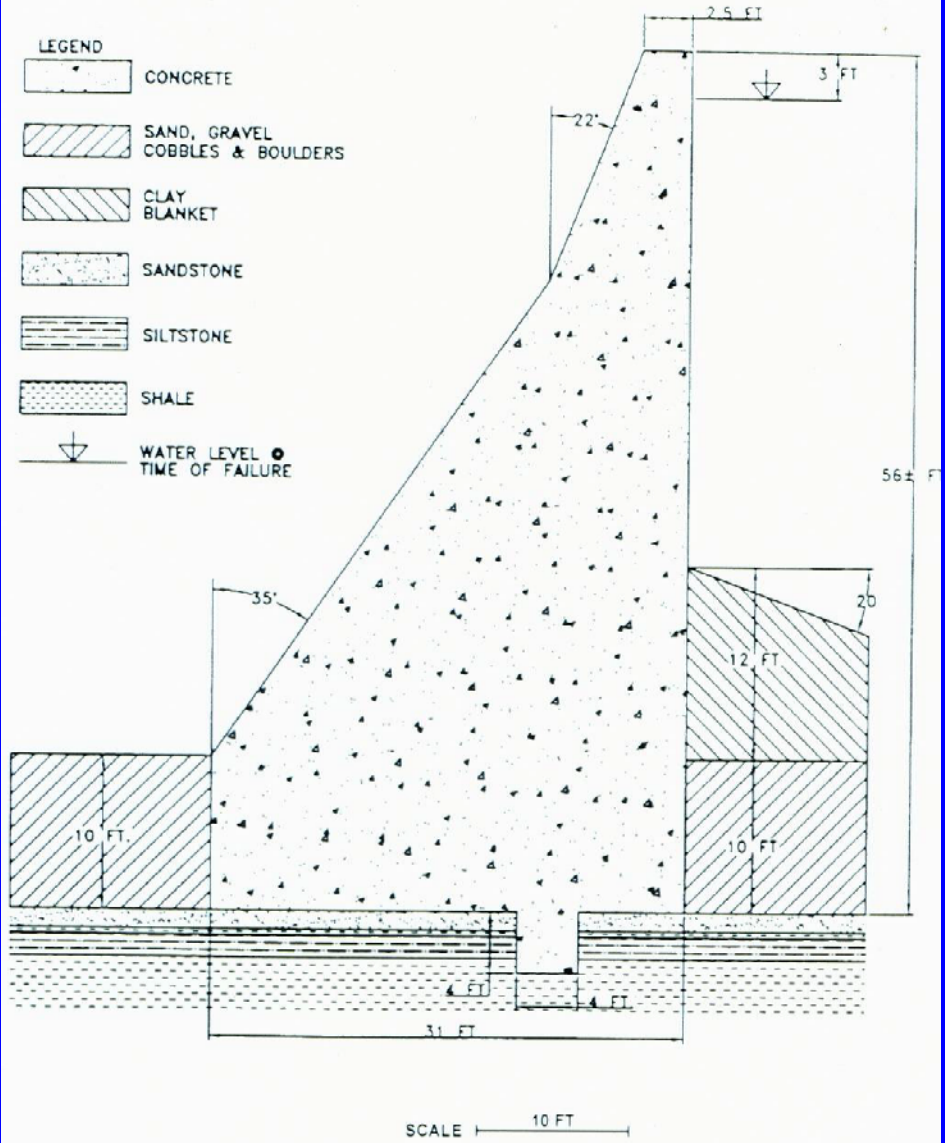
Results of stability analysis

Material	Cohesion (lb/ft²)	Friction Angle (°)	Factor of Safety (sliding)
Concrete over Sandstone	15000	25	8.3
Sandstone over Sandstone	5984	31	3.9
Sandstone over Shale	0	25	0.6
Shale over Shale	3371	25	2.4

- o The Austin dam failed on the weak shale layers beneath the foundation sandstone
- o The depth of water in the reservoir necessitated the provision of a deeper and wider key trench than was used
- o The tendency to overturn (F.S.= 0.88) probably contributed to the sliding failure of the dam
