# M789 LW 30mm HEDP Cartridge In-Bore Detonation Investigation

Mr. John Hirlinger, ARDEC  
&  
Dr. Scott Kukuck, ARL

26 April 2007

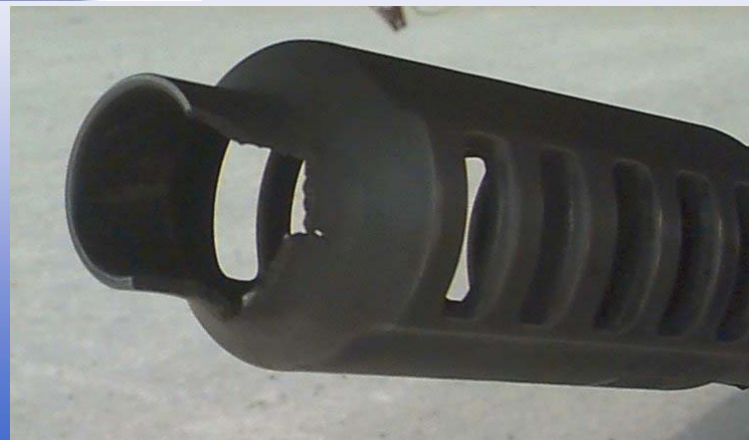
- Damage Similar to or Identical to Severe Hangfire/High Pressure Plus Barrel Cracking & Muzzle Break Impacts by Fragments

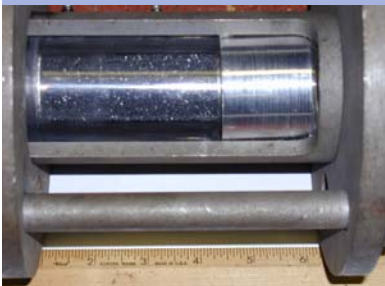
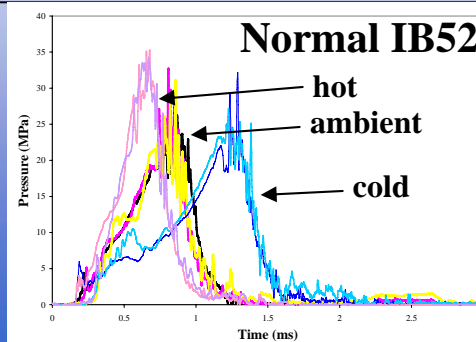
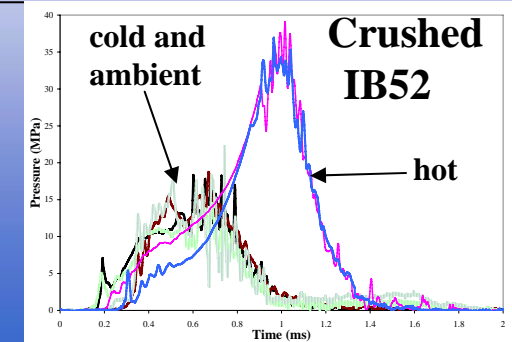
Live Propellant 30-mm Gun Simulator

WC855 in Flash  
Tube has Given  
Greater Than  
40 ms Ignition  
Delay

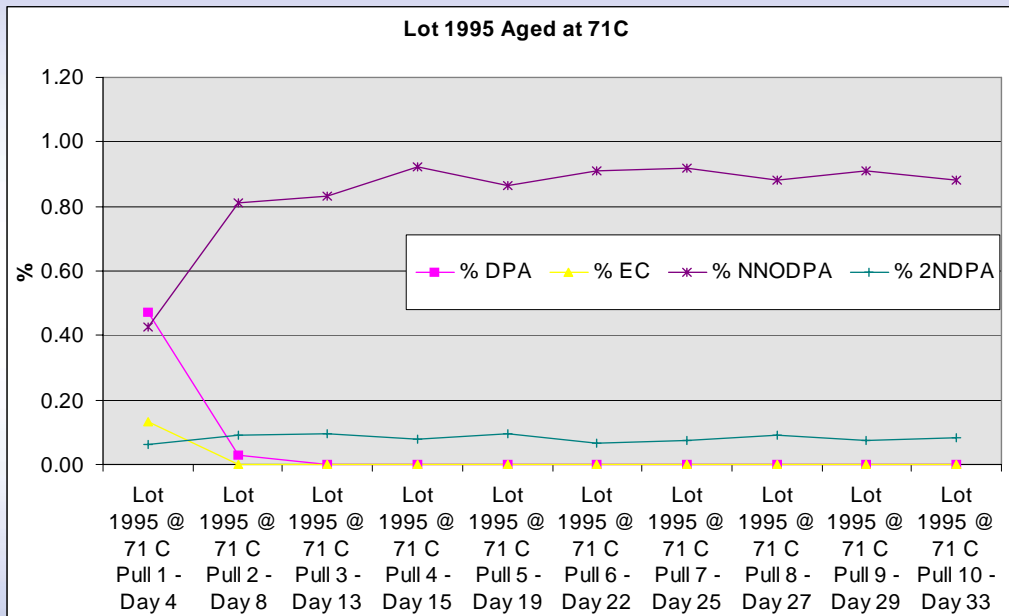
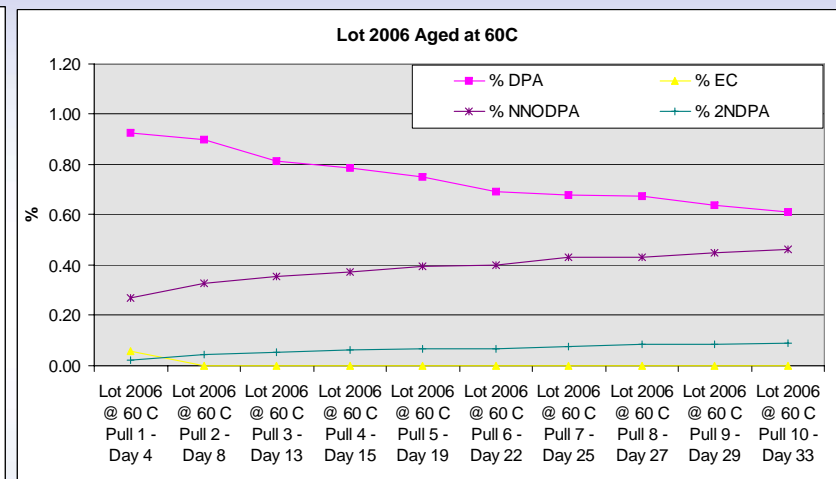
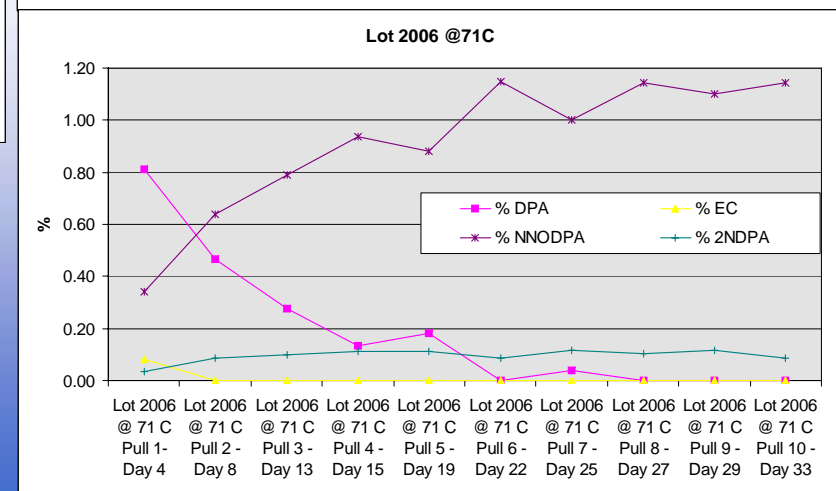
# Hot Temperature Storage Led to DPA Depletion

- Over time, the original stabilizer, DPA, depletes and converts to daughter products – 2NDPA, NNODPA ; DPA reaction rate increases as temperature increases

•DPA concentration of the 1995 Lot had depleted to half the concentration of the 2006 Lot at time = 0

•AT 71°C, DPA concentration depleted to 0 within 22 days of storage

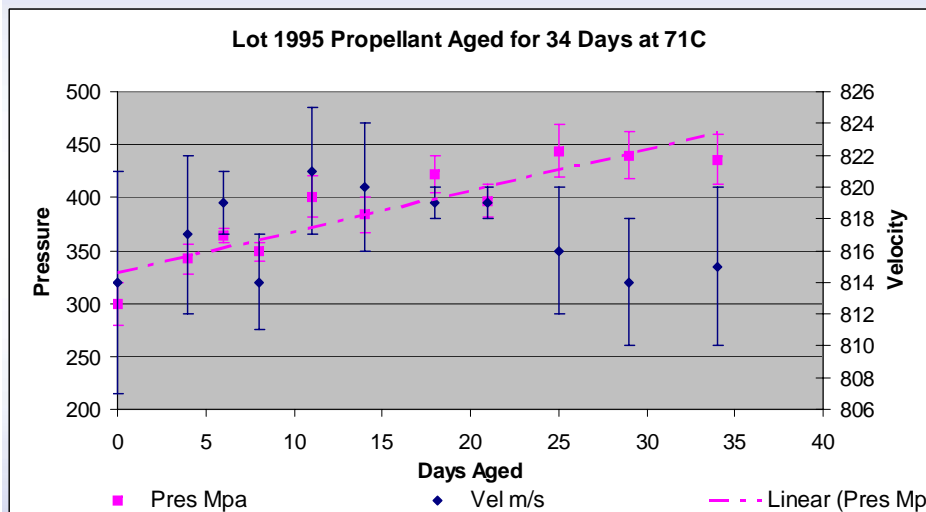
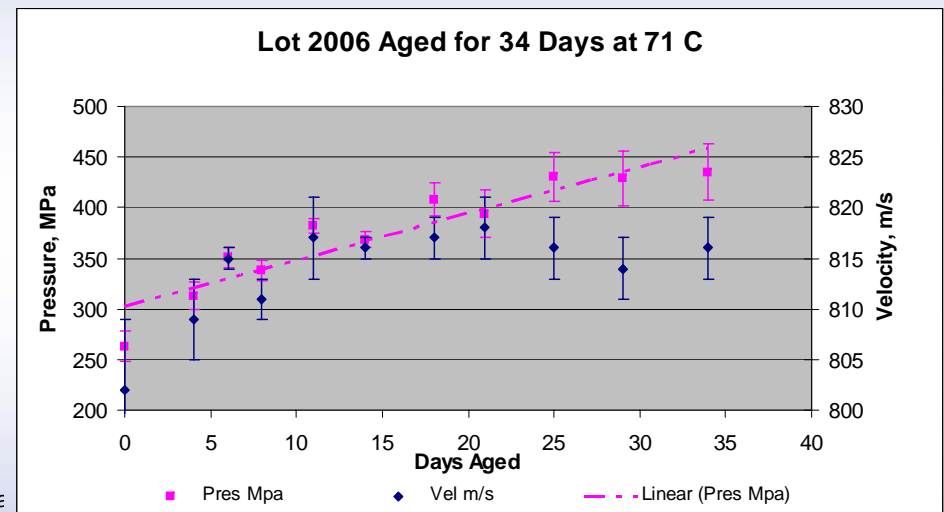
# Ballistic Pressure Increases With Days Aged

- Within 10 days of aging a new propellant lot at 71°C, the measured pressure was in excess of the upper specification limit of 335 MPa

- Ballistic testing conducted at ambient. All data corrected with reference ammunition. Data is the average of 5 shots.

- Variation in pressure performance attributed to migration of DBP deterrent

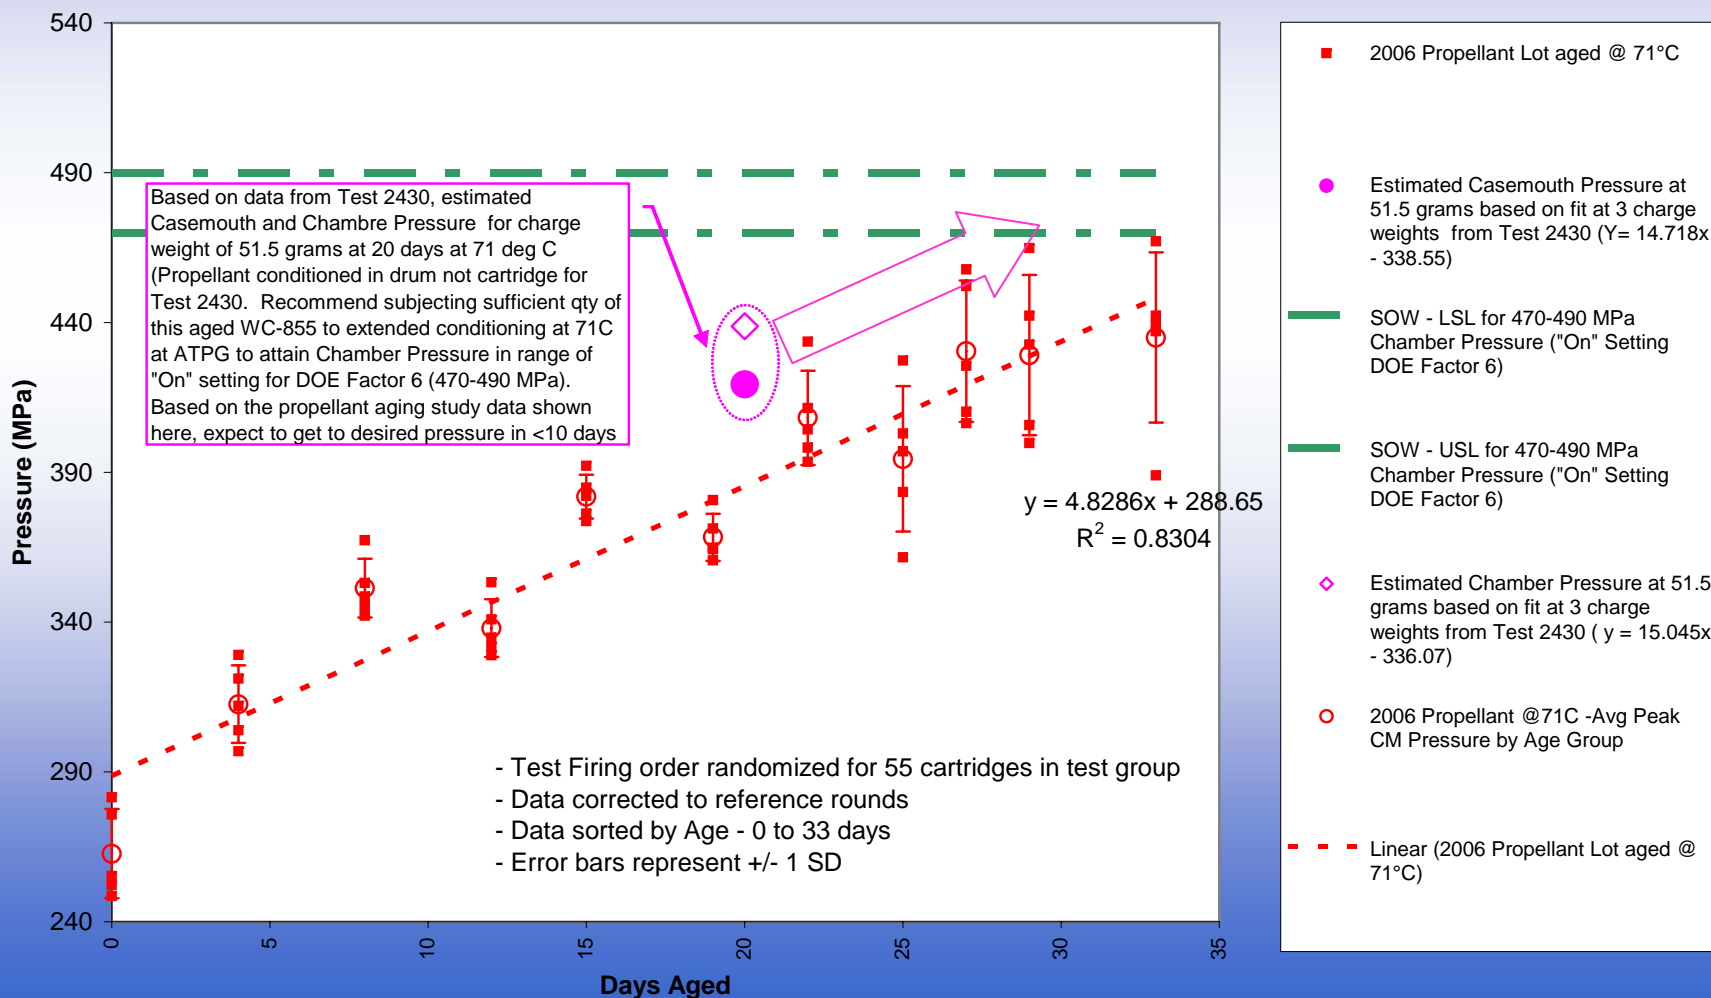
# Aged WC-855 for DOE Factor 6

Casemouth Pressure vs Days Aged - 2006 Propellant Lots Conditioned at 71 deg C  
 (Test RFAAP 07-004 & 005)  
 IHIT Propellant Aging Study - Ballistic Testing at Radford 4-5 January 2007

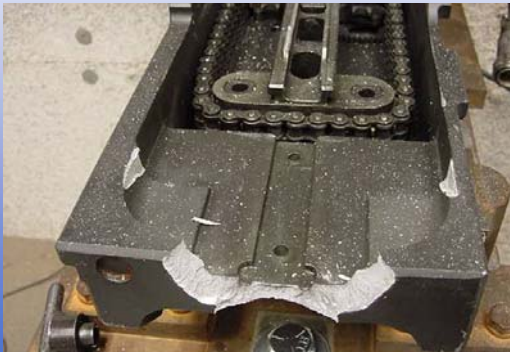
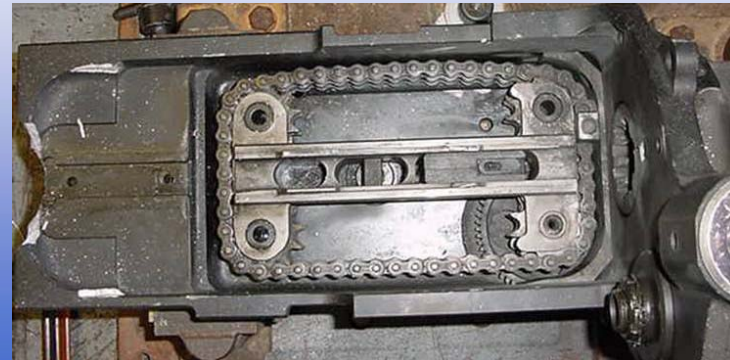
# Headspace DOE

- Hangfire signature has been replicated without an actual hangfire event.
    - Excessive headspace
    - Elevated pressure (~ 500 Mpa)
    - Hot barrel
  - Propellant gases vented from the chamber area can damage the operating group and receiver.
  - Damage created similar to that seen in HE-Inbore events, except no barrel bulge and generally no Blast Suppressor damage.
- Not all “hangfires signatures” are necessarily actual hangfires.**

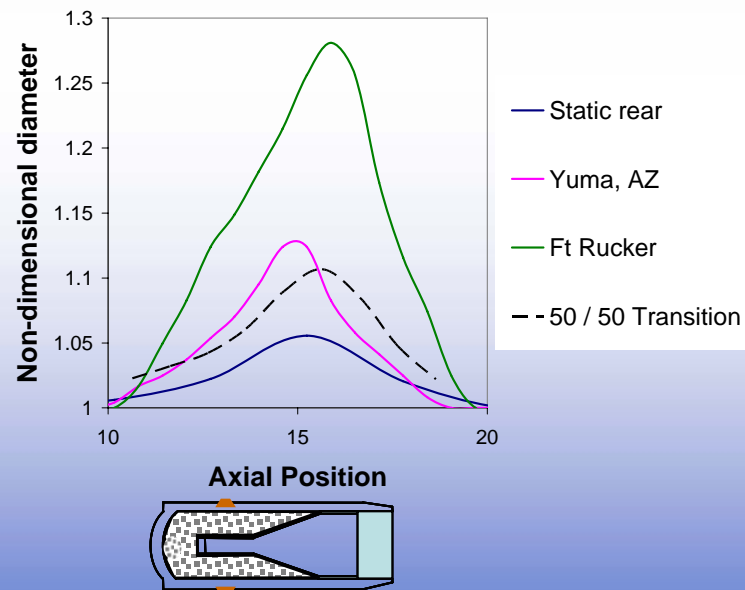
Data from Incidents, Experiment and Modeling

Signature matches an initiation at rear of warhead

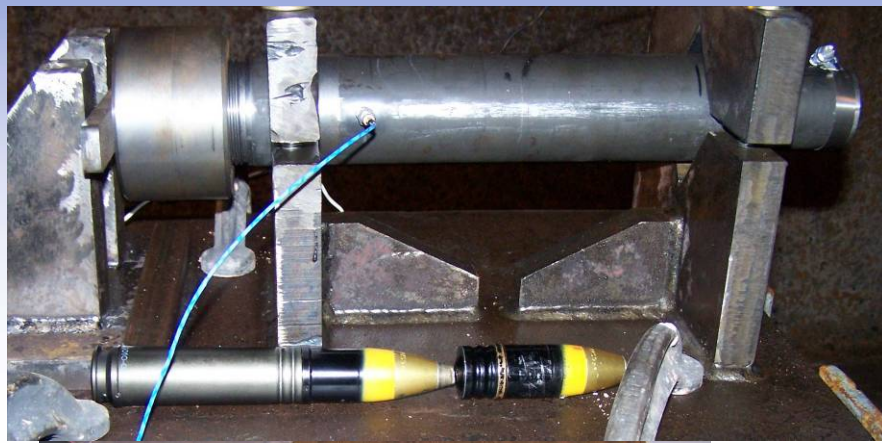
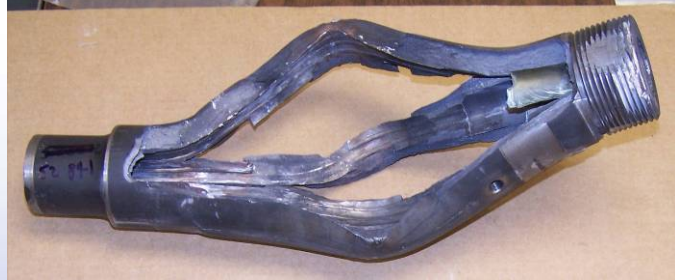
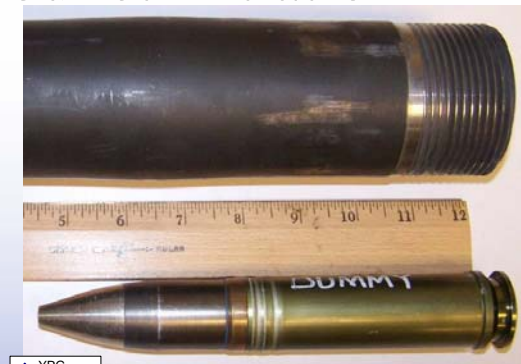
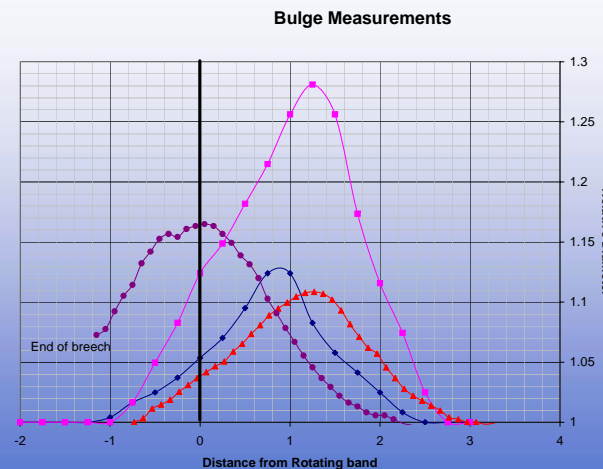
# Dynamic Signature Replication Bullet-on-Bullet

Violence and location reveal that bullet on bullet scenario not likely scenario for bulge...

Implies rear bullet initiation

Follow-on shot with solid fuze result was an in-bore with incorrect signature

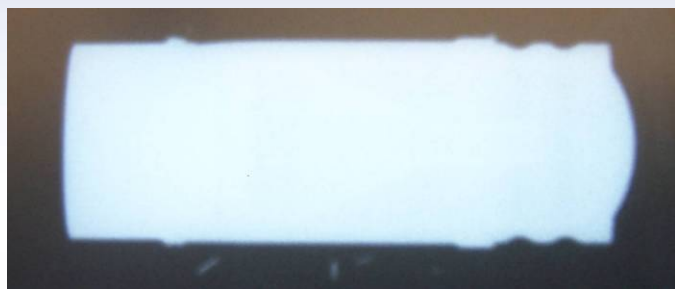
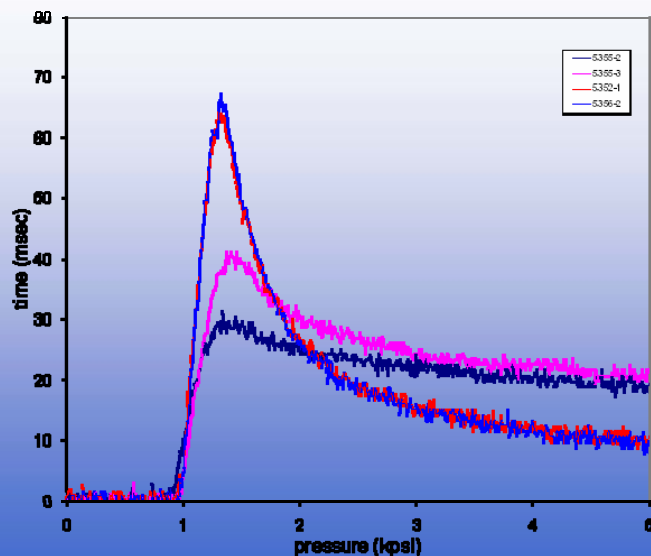
# Dynamic Signature Replication High Pressure (Body Failure)

- Structural analysis found weak area in rear
- Bullet-on-bullet tests at APG:
  - 4 out of 4 shots went low order
  - Initiation from rear of projectile

**Mass taken to over double (2.25x) of  
projectile with subsequent increase of  
base pressure – NO initiation of  
explosive**

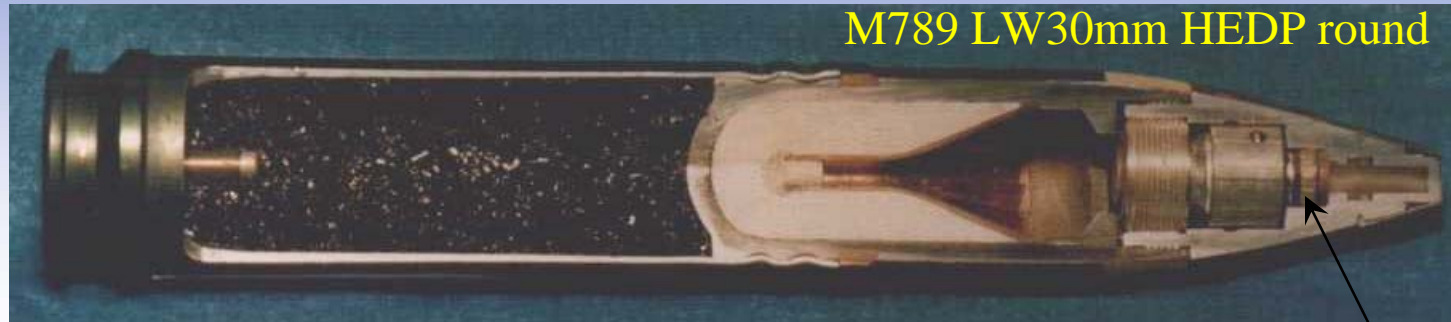
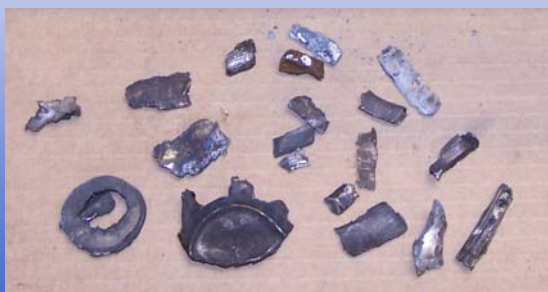
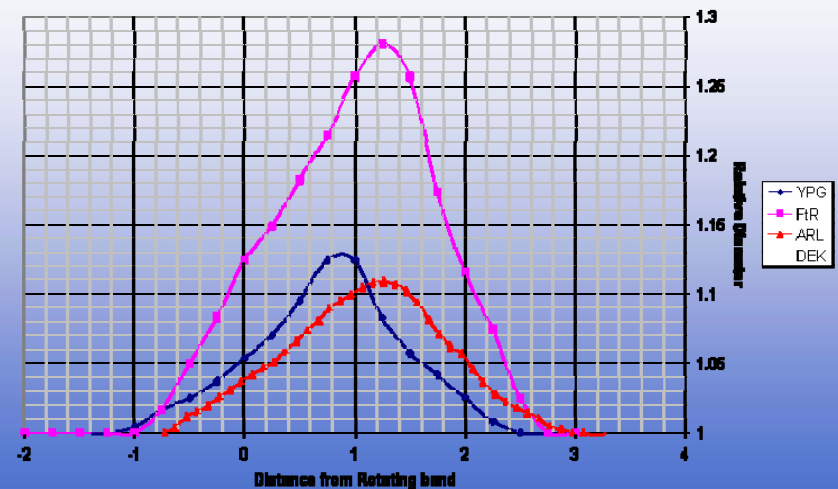
# Dynamic Signature Replication Foreign Material (aka Putty)

Bulged barrel centered at < 8 inches from breech

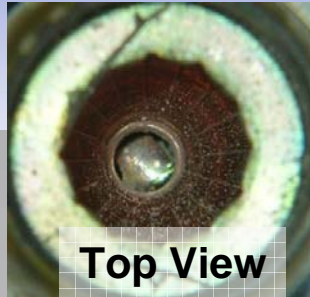
# Foreign Material in Liner Cavity

- Most Likely Causes
  - ★ Foreign Material from Manufacturing Process in Liner Cavity (Replicated)
  - ★ Thin Flange/Spitback Crimp (Replicated)
- Actions Taken to Date to Reduce/Eliminate Issue
  - 1980s Production Placed into Condition Code 'N'
    - Removed to Strategic Reserve in Kuwait Planned for Demilitarization When Stockpile has been Replenished
  - 1990+ Production
    - Thin Flange on Base Closing Plug Identified as a Critical Defect
      - **Additional Testing Added to Verify Design Margin**
      - **Double Automated Inspections Added to Manufacturing Line**
    - Affected Lots (Prior Inbore Detonations) Restricted from Use Until Screened
    - X-Ray Screening to Remove Defective Rounds Being Initiated
    - Manufacturing Process has been Modified to Eliminate Source of Foreign Material
  - AIN & ASAM Issued to Minimize Ammo Exposure to Extreme Temperatures

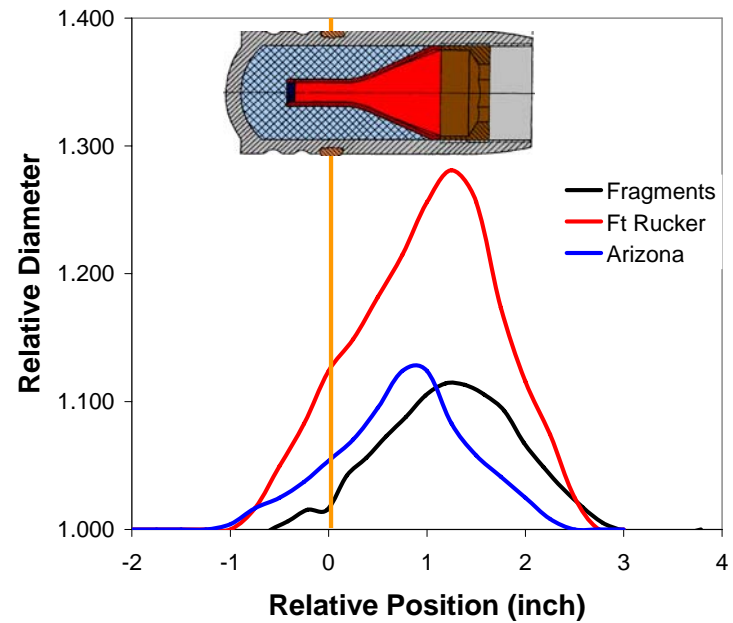
Arizona Barrel

Reference Line approx. 9.5" from end of barrel

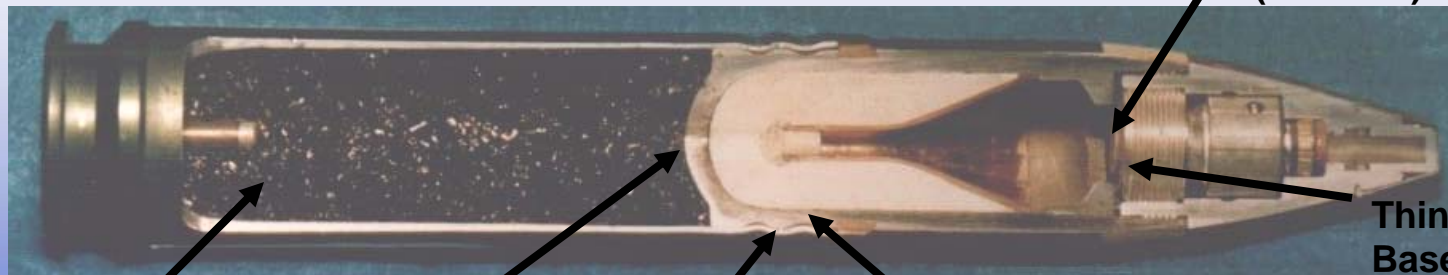
Loose Base Closing Plug in Fuze (Factor 1)

Propellant High Pressure (Factor 6)

Thin Dome (Factor 3)
