# Computer Modeling to Solve Problems with the T-38 Propulsion Modernization Program

Presented on October 25, 2007  
at the NDIA 10<sup>th</sup> Annual Systems  
Engineering Conference  
by Randy Wimer  
USAF Propulsion Engineer  
Co-author: Andy Hall  
USAF Propulsion Engineer

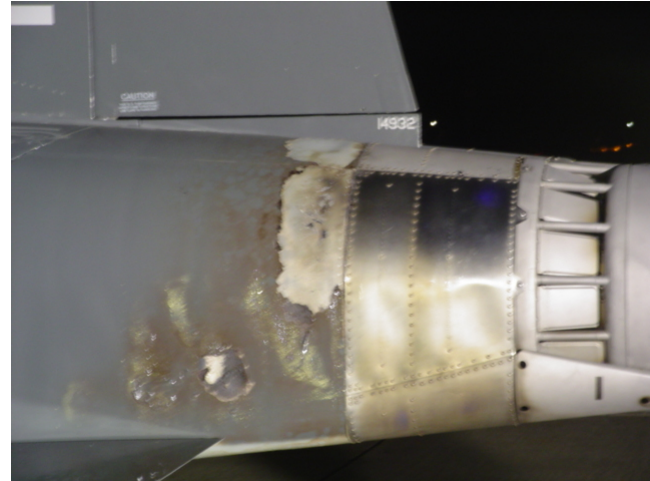
1. Engine bay overheating

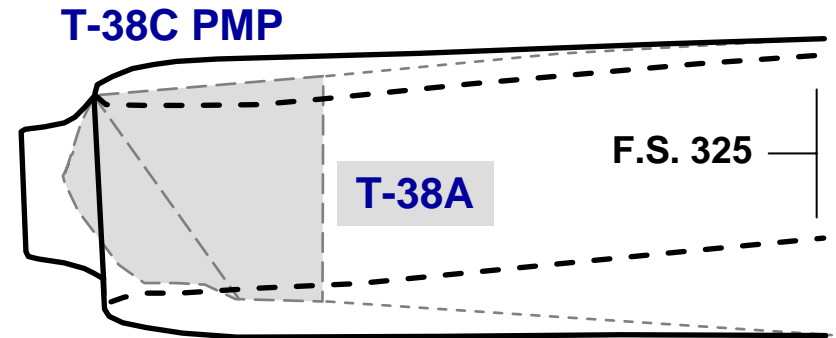
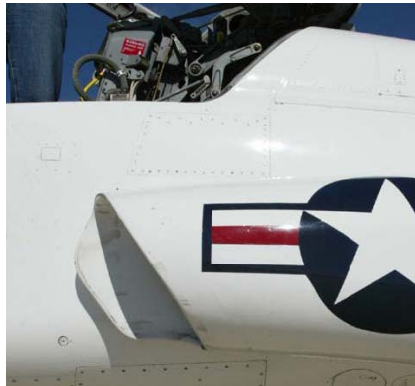
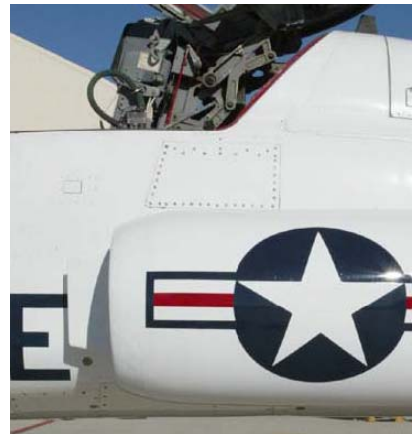
# T-38A / T-38C Inlet Comparison

From T-38A to T-38C:

- + 15% capture area
- + 5% throat area

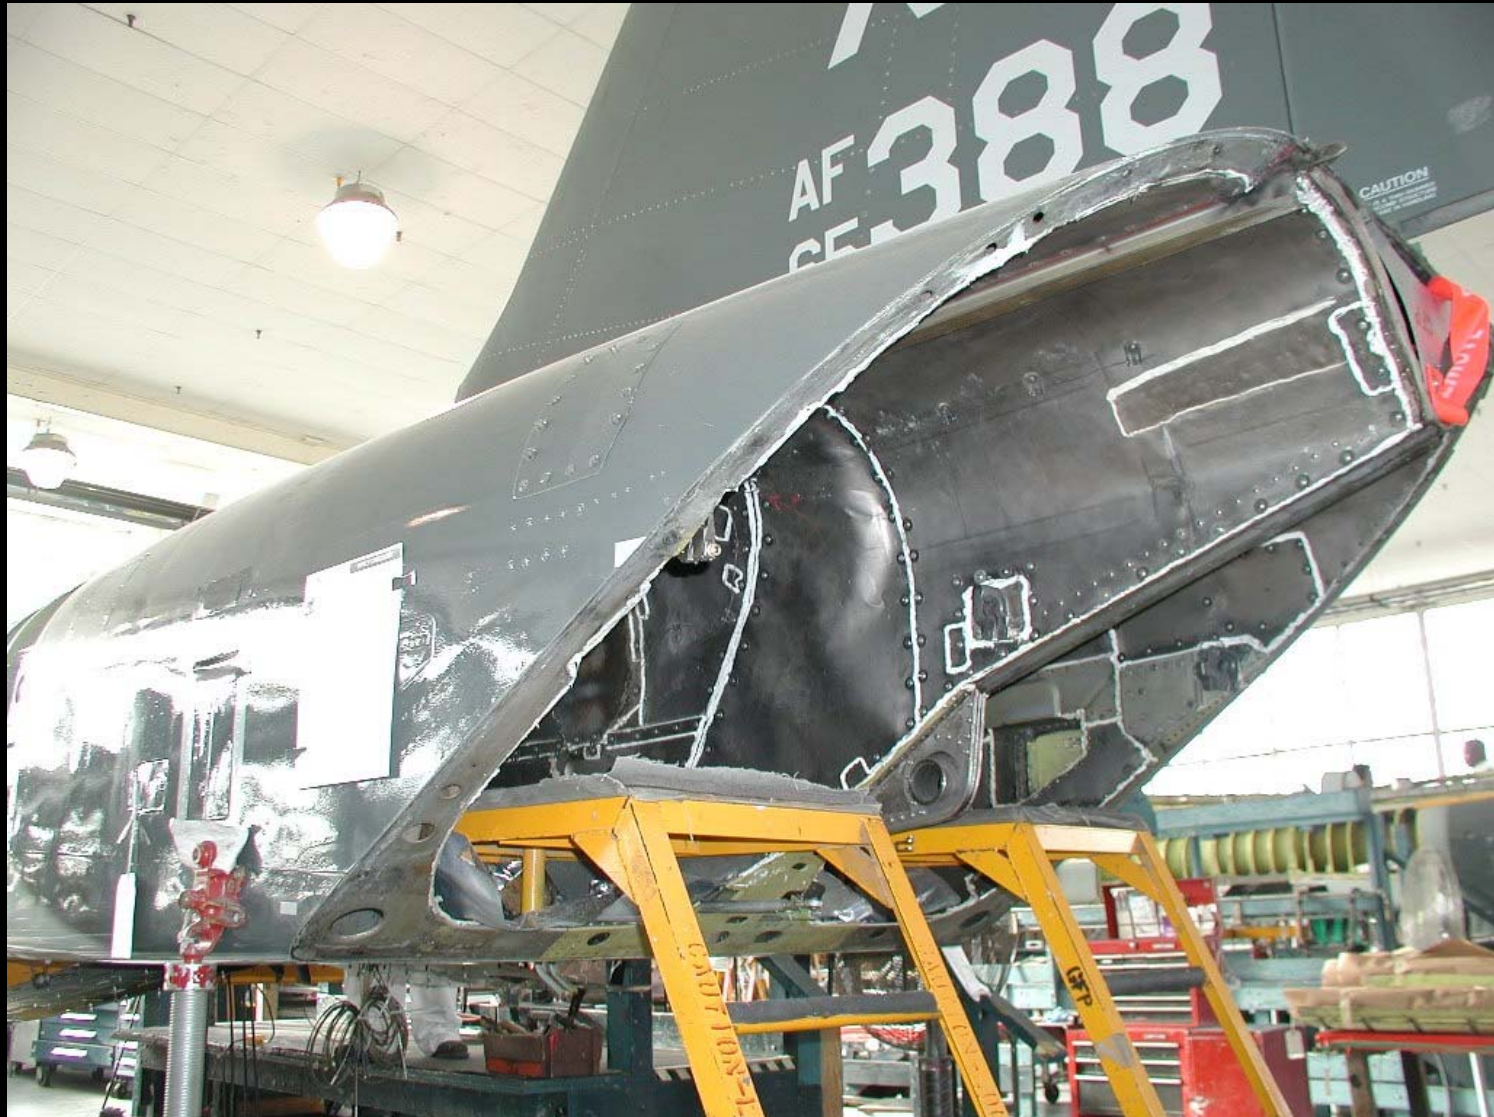
# Engine Bay with Boat Tail and Engines Removed

# Engine Bay Overheating Findings

- No Single Solution, No Smoking Gun
- System Problem With Multiple Contributions
  - New ejector reduced engine bay cooling airflow
  - New inlet reduced keel cooling airflow
  - Hot air leaks around Variable Exhaust Nozzle (VEN) assembly compounded problem
  - Engine bay cooling degraded over time due to old aircraft (“tired iron”) – several leak paths
  - Part to part variability
  - Air framer not initially involved

- Validate thermal model in order to determine optimum solution
  - Operational solutions (i.e. different FCF profile) need to be evaluated first and design solutions second
- Recalibrate trigger temperature for fire warning system
- Separate fire safety concerns vs overheat concerns
- Fire safety needs to be determined from validated model and design standards

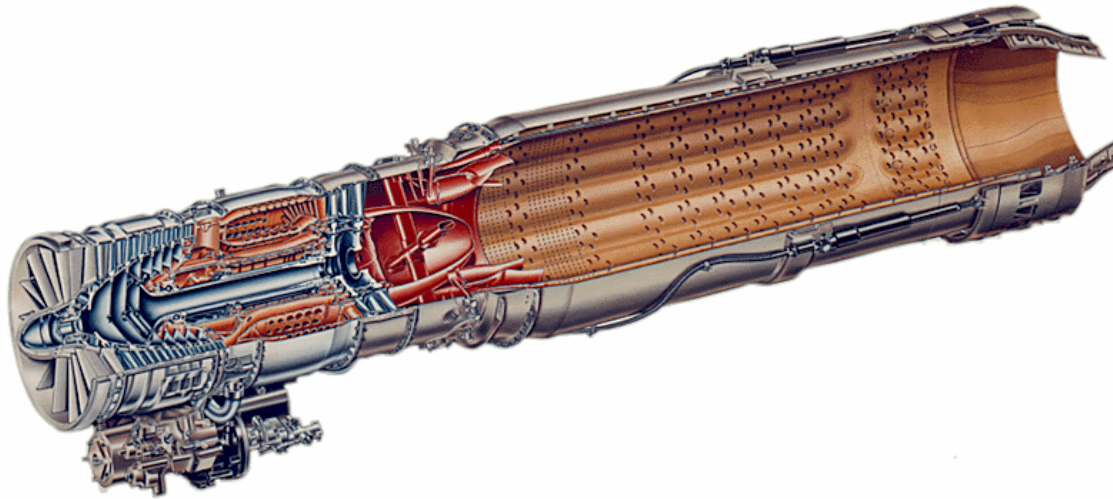
J85 engine did not meet 230-hour Mean Time Between Removals (MTBR) Operational Requirements Document (ORD) threshold

- Constant at 155 hours
- PMP upgrade focus was meeting maintenance intervals and shop cost reduction
- Will never get to 230 hours without additional work (never put on contract)
  - Engine controls not improved
- Maintenance model did not exist

- Solution: A J85 maintenance model was Applied to the J85 engine
- Recommendations:
  - Replace gear boxes with rebuilt units which have fuel pumps and fuel controls with design improvements
  - Improve igniter system
  - Implement ASAP to maximize return on investment
  - Investigate use of contractor performance base logistics (PBL)
