By: Ben F. Harrison IV, P.E., Technical Director, ABS Group, 140 Heimer Rd., Suite 300, San Antonio, TX, 78232, USA.

Abstract

1 Introduction

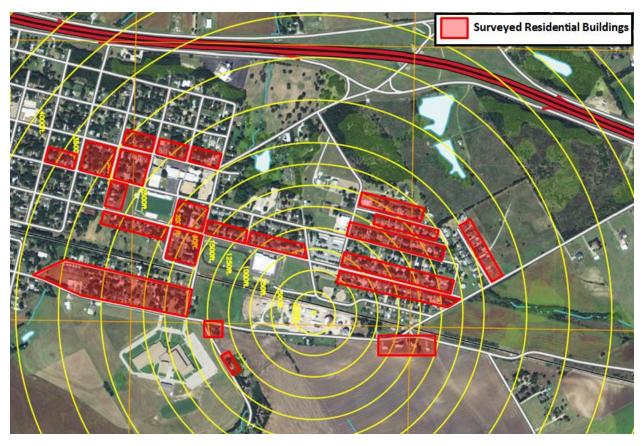
Figure 14. Extent of Surveyed Residential Buildings

A total of 190 single family residential buildings were assessed as depicted in Figure 14. Window breakage, façade damage, and structural component failure (i.e. wall, roof system) were documented during the survey. The shock wave caused significant damage by breaking windows, failing roof trusses, and damaging exterior walls. An example of one heavily damaged home observed in the community of West are shown in Figure 15 and Figure 16.

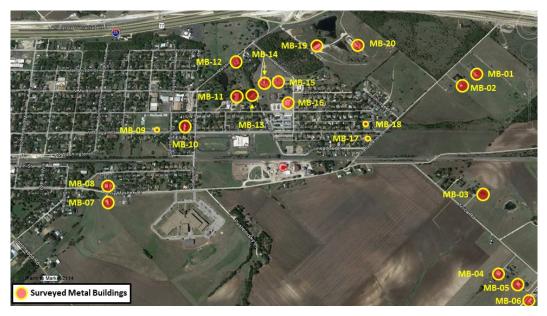
Figure 17. Surveyed Metal Buildings

Twenty different metal buildings (which are identified in Figure 17) were surveyed during the site inspection, and permanent deformations of building components were documented. The measured permanent deflections of the structural components were analyzed to determine the minimum charge weight necessary to cause the observed damage.

For each component, a standoff distance is measured to its centerline from a scaled aerial map. Using the standoff and angle of incidence, the charge weight is varied in an iterative analysis until the predicted deformation matches the observed deformation. The permanent deformation of a given structural component is obtained from the member's resistance-deflection curve as shown in Figure 18. Deformations measured in the field were all permanent plastic deformation, which occurs after the member achieves maximum inbound deflection and undergoes elastic rebound. This procedure was repeated for each component and a minimum TNT charge weight required to cause the measured damage was obtained for each structure.
