Sponsor: New Hampshire

(Pease Development Authority, Division of Ports and Harbors)

- Design: New England District
- Construction: Reed & Reed, Inc.,
 Maine
- Composite Sheeting: CMI, Inc.
- Geogrid Marine Mattresses: Tritton
- Instrumentation: Geokon, Inc.

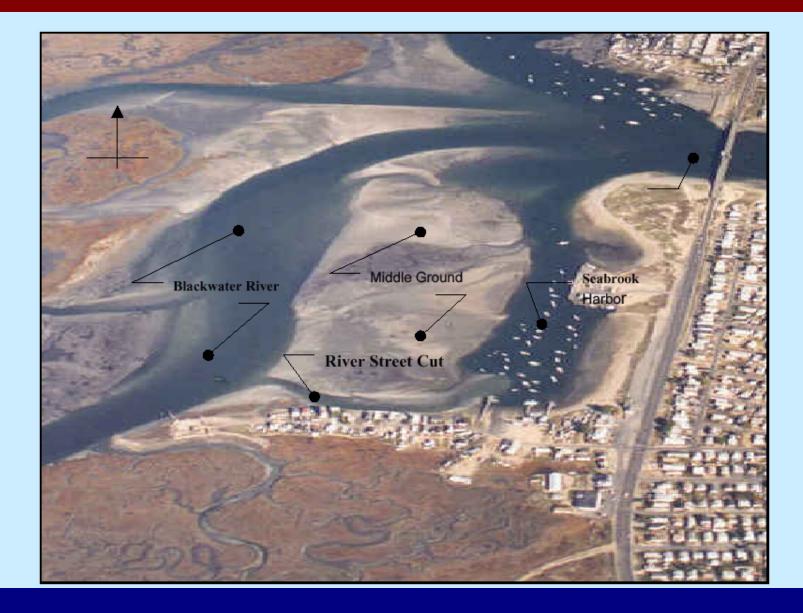
Objectives:

- Replace lost intertidal sands
- Reduce sand migration into the Harbor
- Prevent shoreline erosion
- Solutions:
 - Install two cofferdams (bulkheads) across the eroded channel
 - Dredge sand from the shoaled areas of the River to encourage flow
 - Use the dredged sand to fill between the cofferdams to restore the sand flats

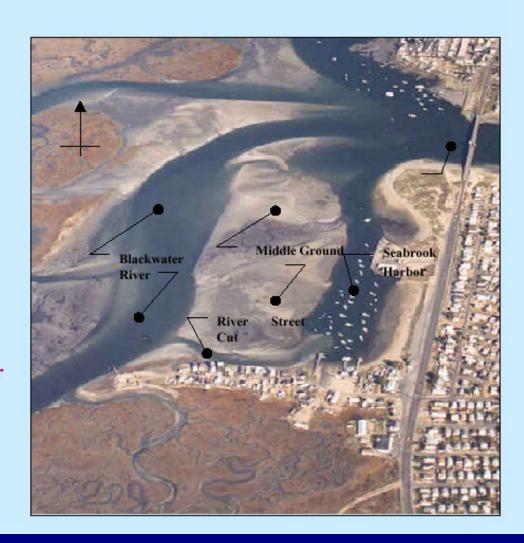
Design

- Synthetic sheeting:Corrosion, Cost
- Galvanized steel tiebacks and wale: Reliability
- Double Rows of sheets:
 No cantilever
- Single Wale: No diving (winter)
- Scour protection:Protect toe
- Drainage: Reduce loads

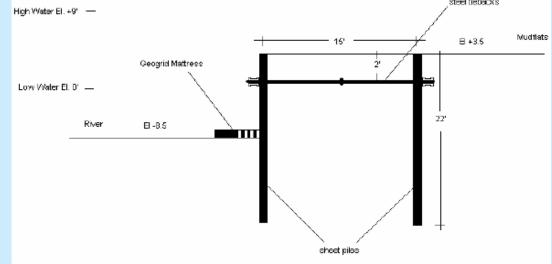
Design Parameters

- 50-year low tide
- 50% drainage in fill
- 12' depth to mudline
- 2 tons horizontal Load per linear foot
- Tiebacks 6' spacing
- 200 psf surcharge

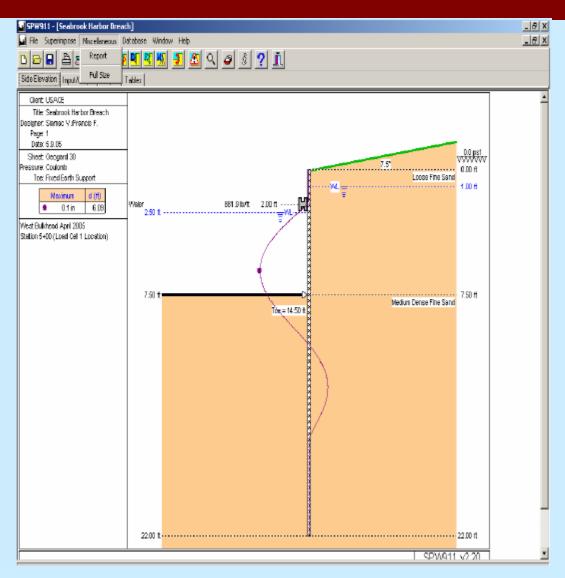
Other Components

Wale: 2X 10" galvanized steel
 Channels on the outside

Drains: 2 x 2" dia holes with wire mesh/geotextile backing, located under water to prevent freezing
