# Ultrasonic Characterization of Explosively-Bonded Concentric Tubes

#### Presented by: Chris Jerred Acknowledgements: Dr. Fred Delfanian, Dr. Jikai Du, & Dr. Tao Huang

Materials Evaluation and Testing Laboratory (METLab) Mechanical Engineering Department, Box 2219 SCEH 214 South Dakota State University, Brookings, SD 57007-0294 Phone: (605) 688-4300, Fax: (605) 688-5878, http://www.sd-metlab.org

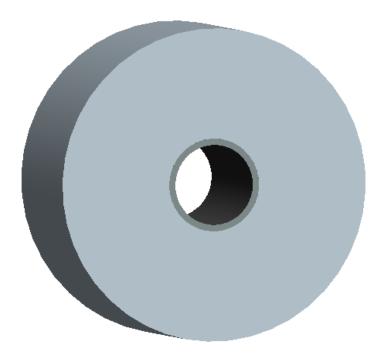
# **EB** Specimen

- Steel major tube
- Alloy donor tube
- ~ 3" length
- ~ 4" OD, 1" ID
- 1 "poor" PEBS
- 1 "good" GEBS

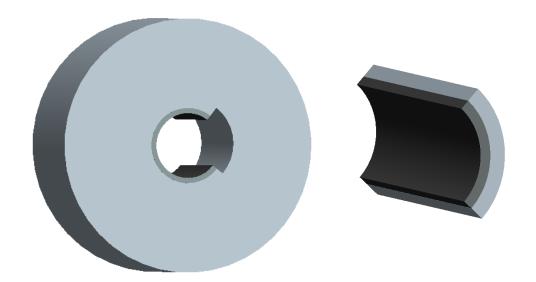
# Machining

- EDM samples
  - Destructive tests
  - Microscopy
  - Hardness tests
  - Alloy analysis

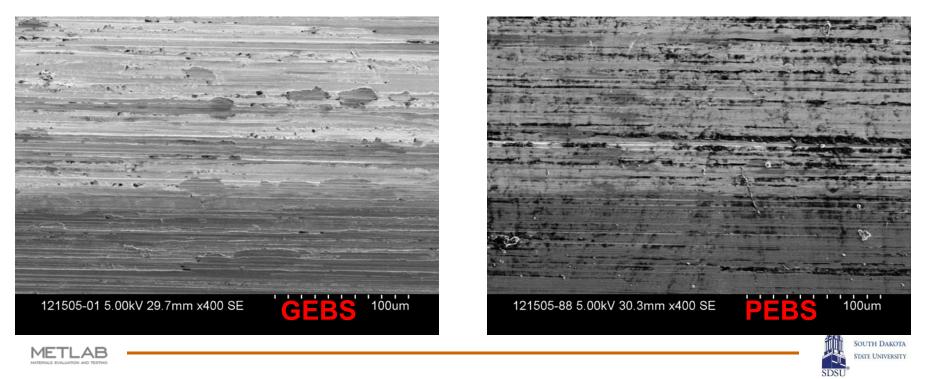
# Microscopy

- SEM
  - Destructive, time consuming, small sampling area
  - Looking for "wavy interface" and "material mixing"

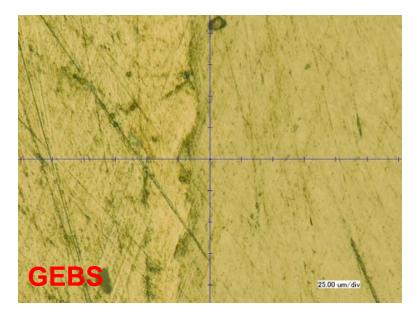
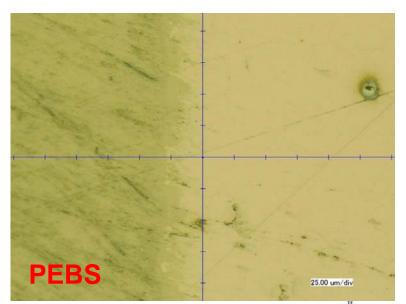
# Microscopy

- Digital Microscope
  - Quick, little preparation, color

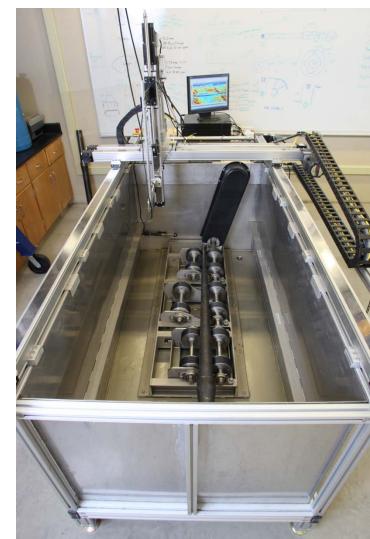
Immersion Scanner
- Resolution 0.0001"
- Max 20 in/sec
- 2,000 lbs max load
- 3-10" diameter tubes
- Up to 5' length

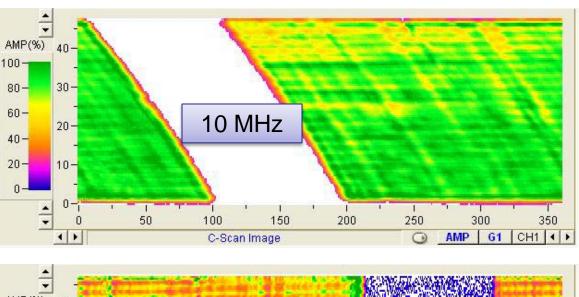
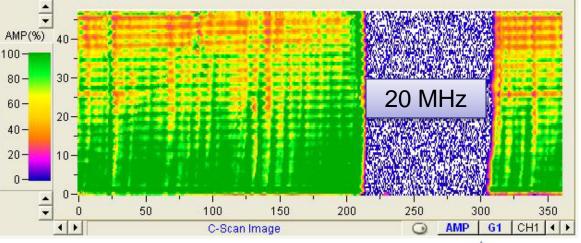
# **Frequency Optimization**

- High frequency
  - Inc. resolution
  - Same settings
- 20 MHz selected
  - On hand
- Gap = Removed
- Slant = Tuning

Higher (20MHz) is Better Due to scan method

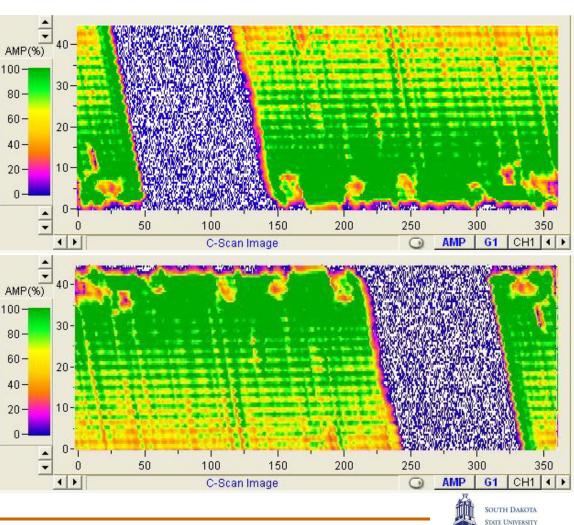
# Gradient

- Caused by ?
  - $-\Delta$  bond
  - Scan method
- Reversed part
  - Same scan
  - Same trend
- Δ bond is cause

Less obvious GEBS

- Poor vs. Good
   Distinguishable
- Observed Gradient Due to bond
- Frequency Effects
- Stripes

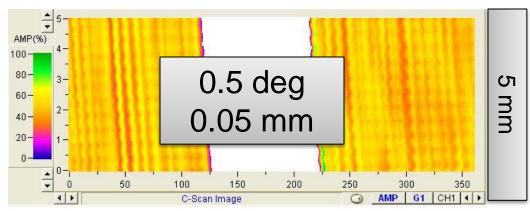
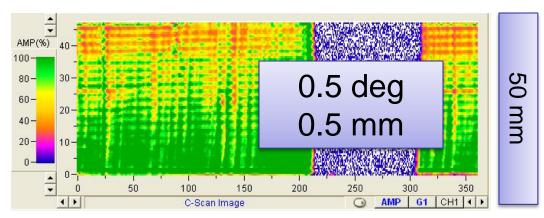
# Stripes

- Caused by ?
  - Wavy axial bond
  - Scan method
- Changed step size
  - Same results
- Scan method

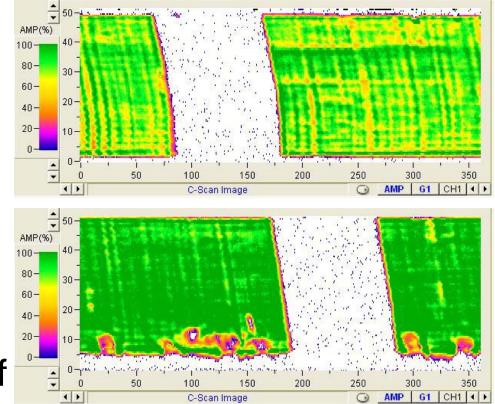
# Good vs. Poor

- GEBS
  - Lower reflection amp.
- PEBS
  - Higher reflection amp.
- Good bond provides easier transmission of acoustic energy
