Geotechnical and Dam Safety Section
MISSISSINEWA DAM

Mississinewa Dam Foundation Rehabilitation

Jeff Schaefer

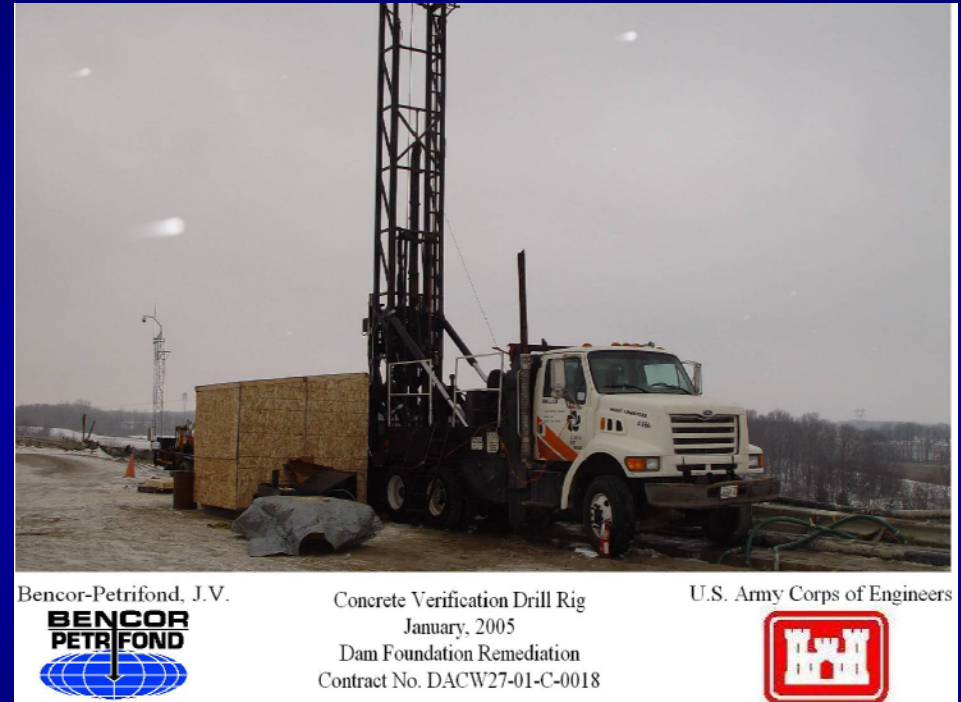
Verification Drilling

- Purposes:
 - Concrete Quality
 - Panel Contact/Joint Quality
 - Cutoff-Wall---Rock Bottom Contact
- Techniques:
 - 4 inch core for Panels
 - 6 inch core for Panel Joints

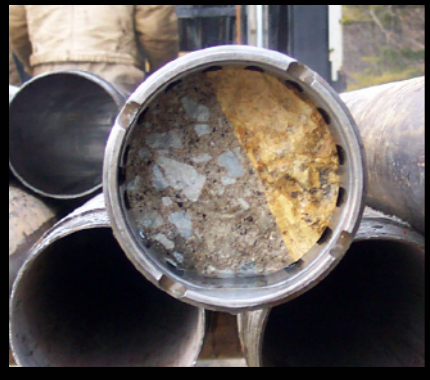
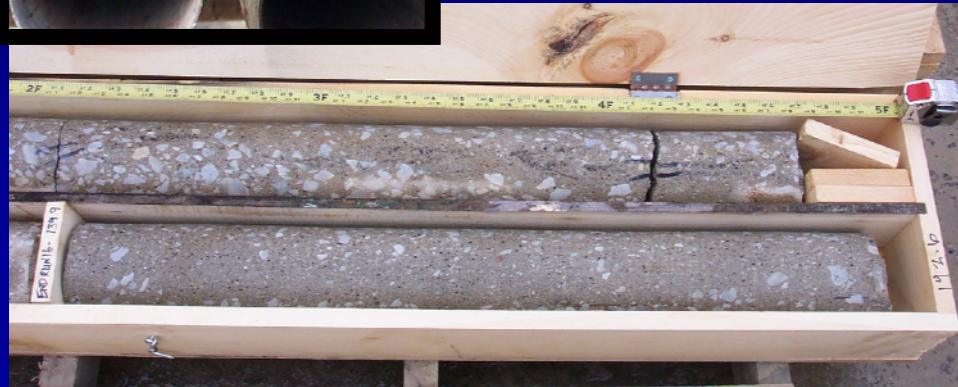
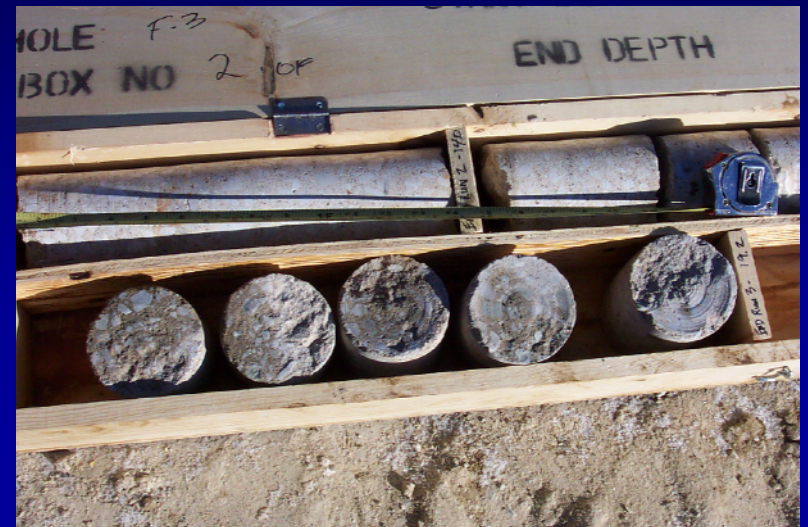
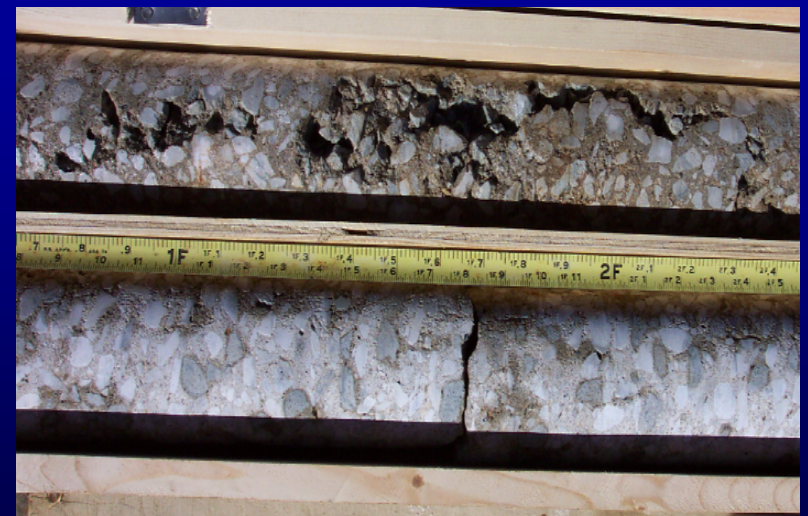
What we don't want!
