#### Mel Price – Auxiliary Lock Downstream Miter Gate Repair

## Mel Price Accident 3 October 2004

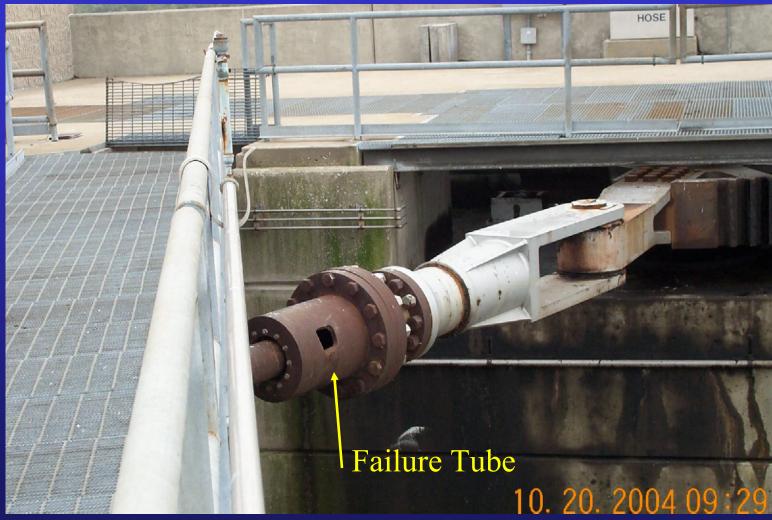
## Gate Operating Arm

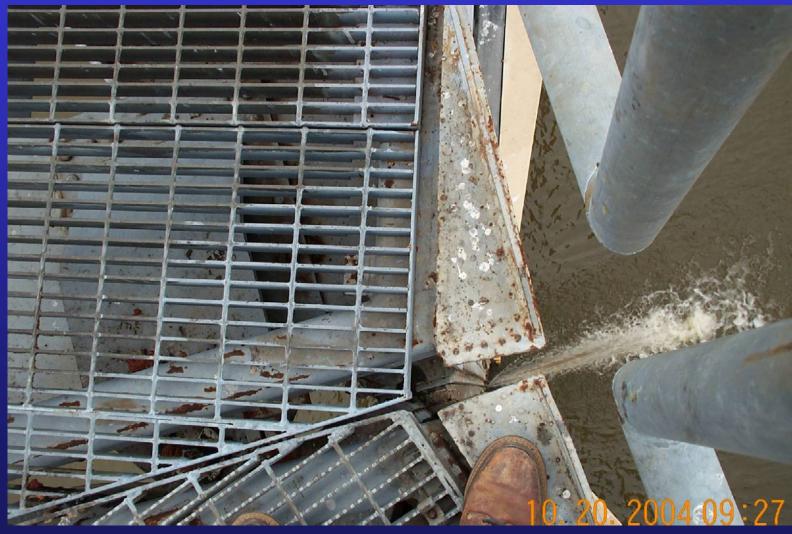
#### Normal Miter Block Position

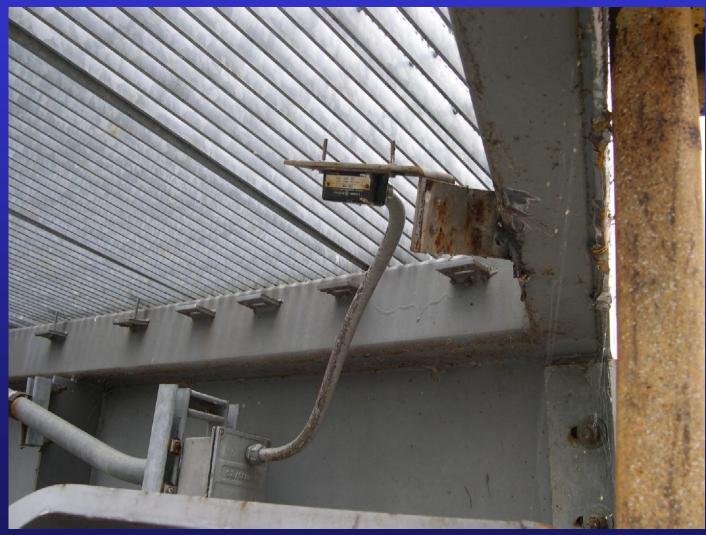
#### Magnetic Proximity Switch on Gate

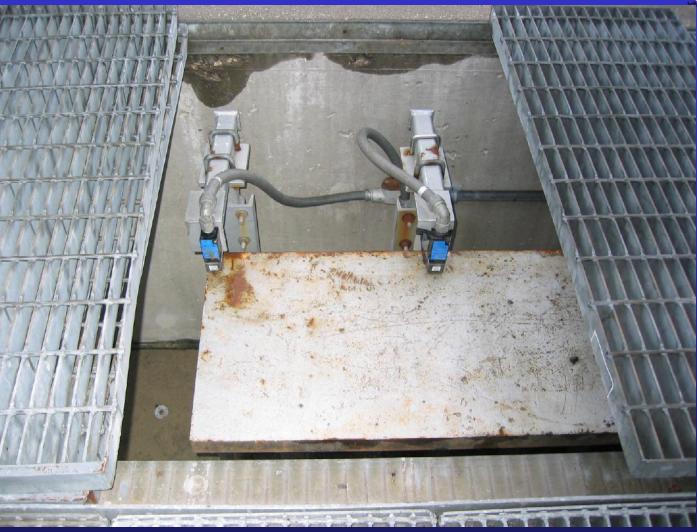
## Switches on Machinery Rack

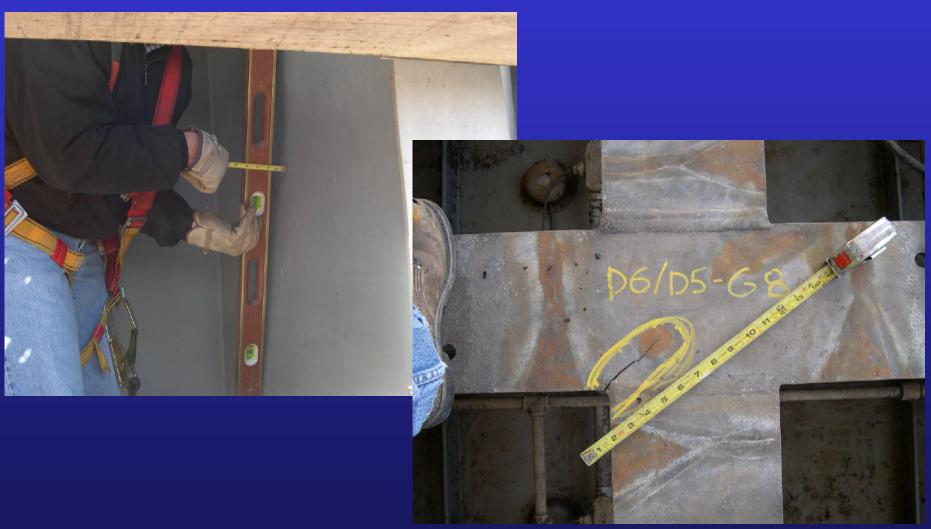
# Damage Inspection

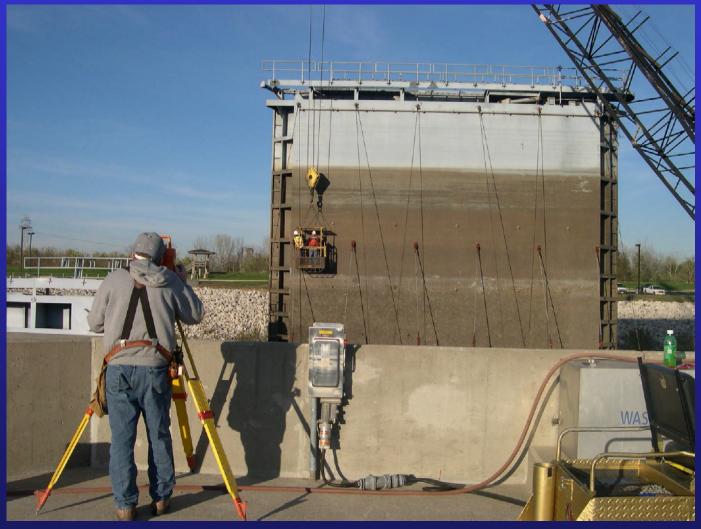
### Surveying Damaged Gate

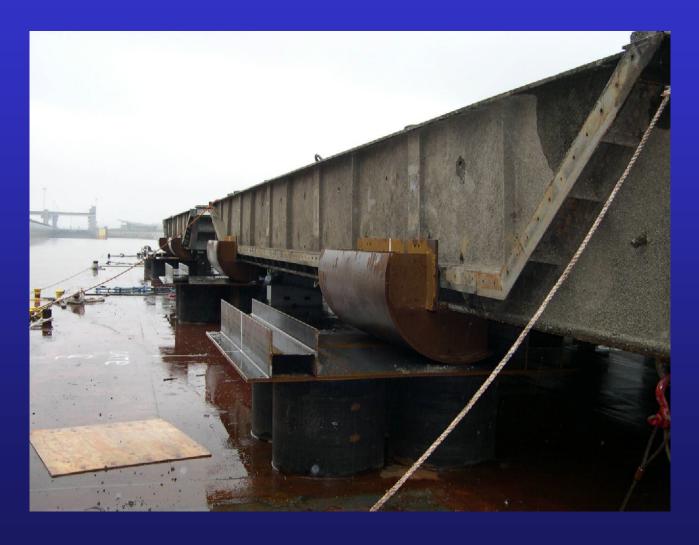
# US Army Corps Gate Leafs in Horizontal Position

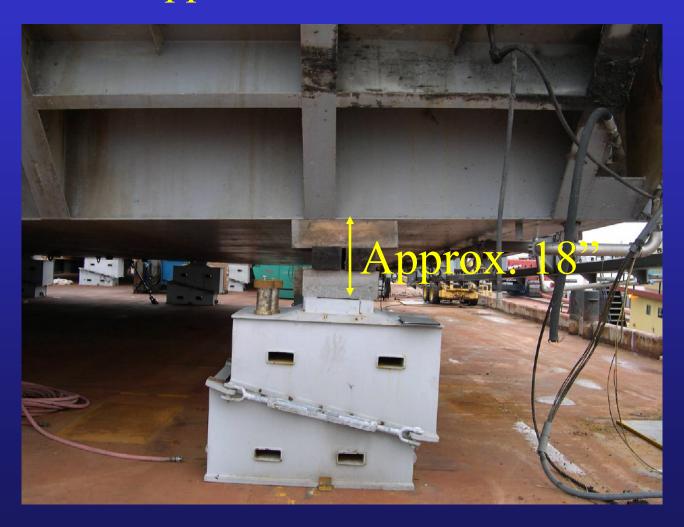
# Leaf Supported In Deflected Position

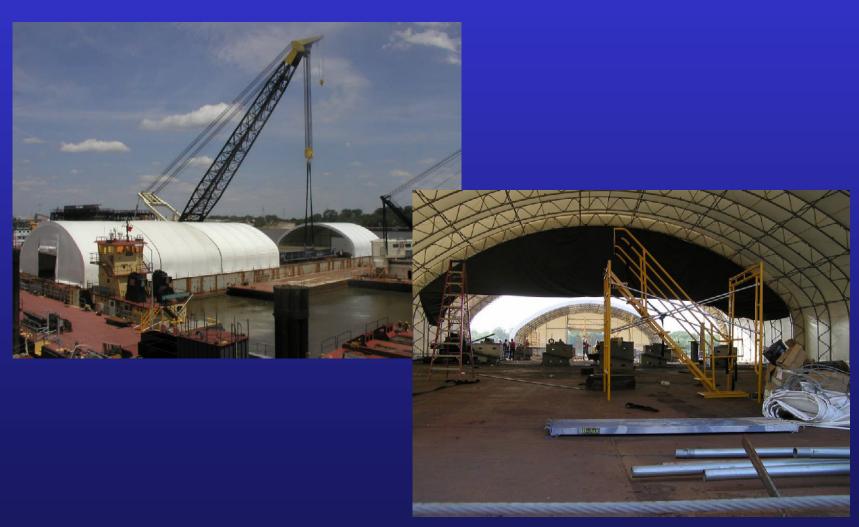
### Enclosure on Delong Barge at Service Base

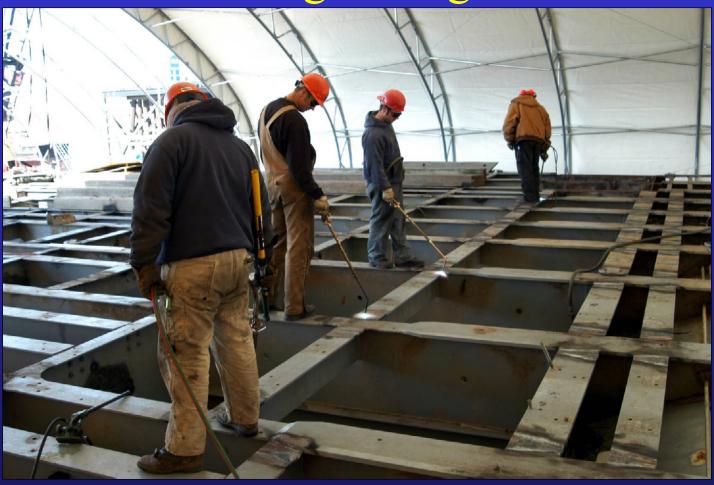
# Heat Straightening Crew

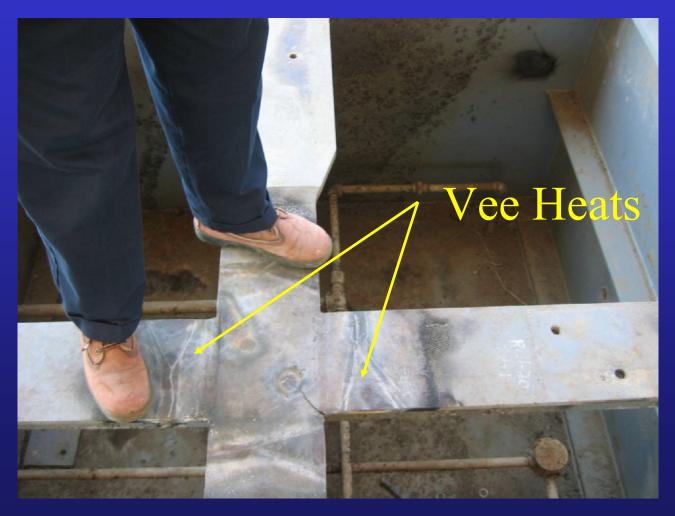
# Heat Straightening

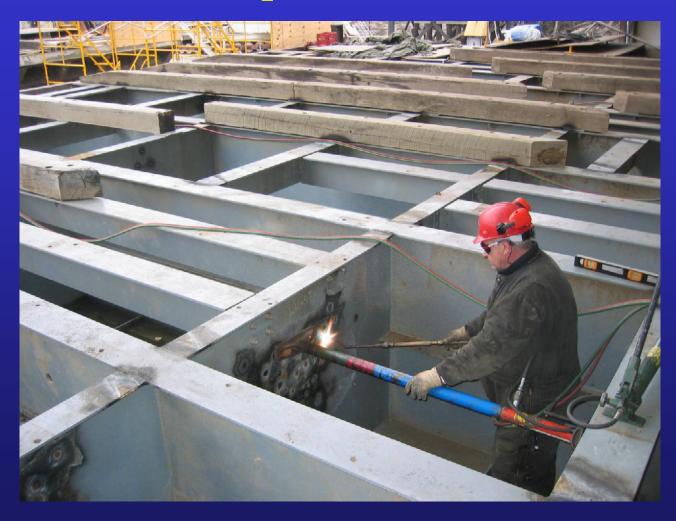
# Spot Heats

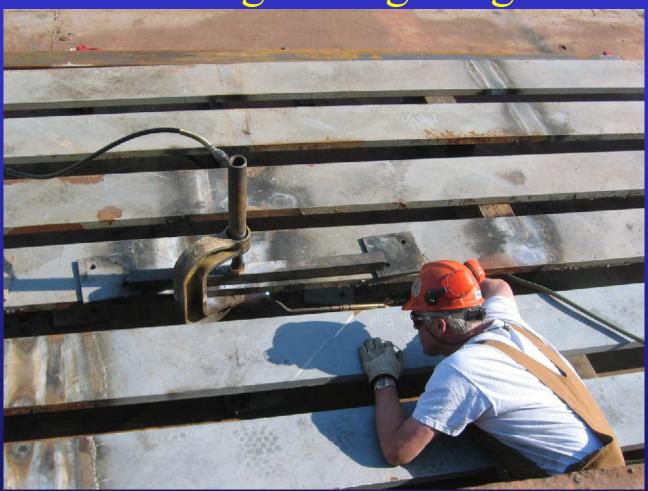
# Heat Straightening Diagonals

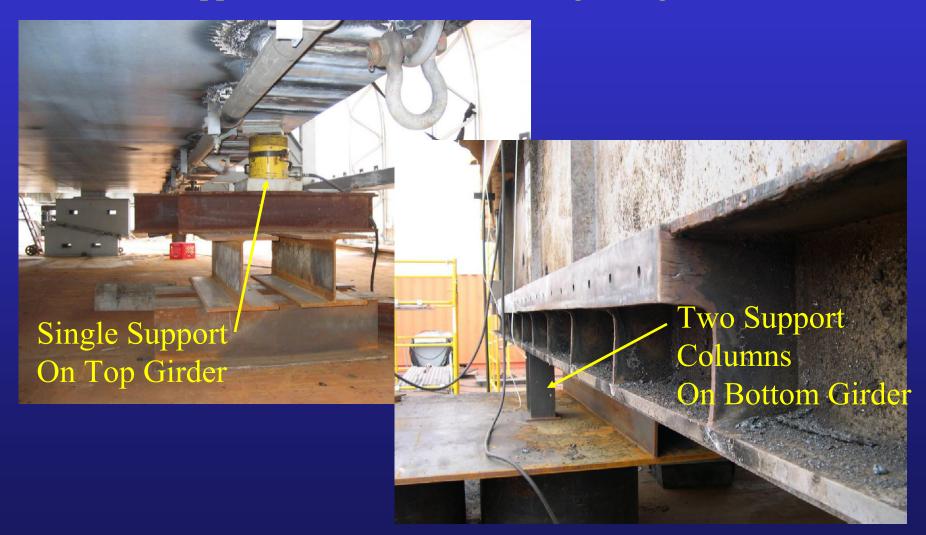
#### Support Condition For Checking Straightness

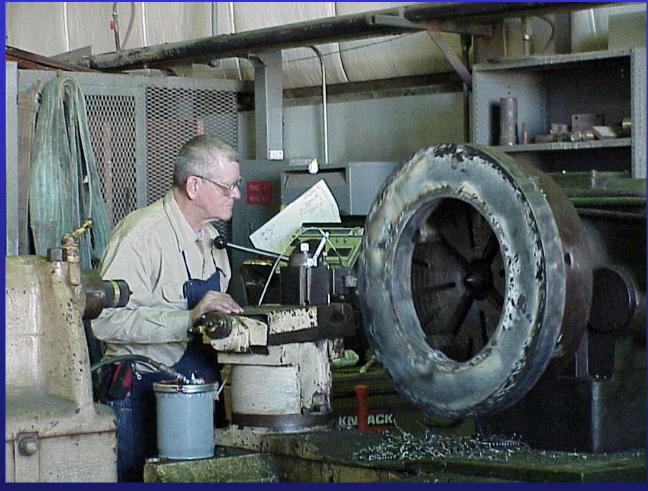
#### Machining Strut Arm at Service Base

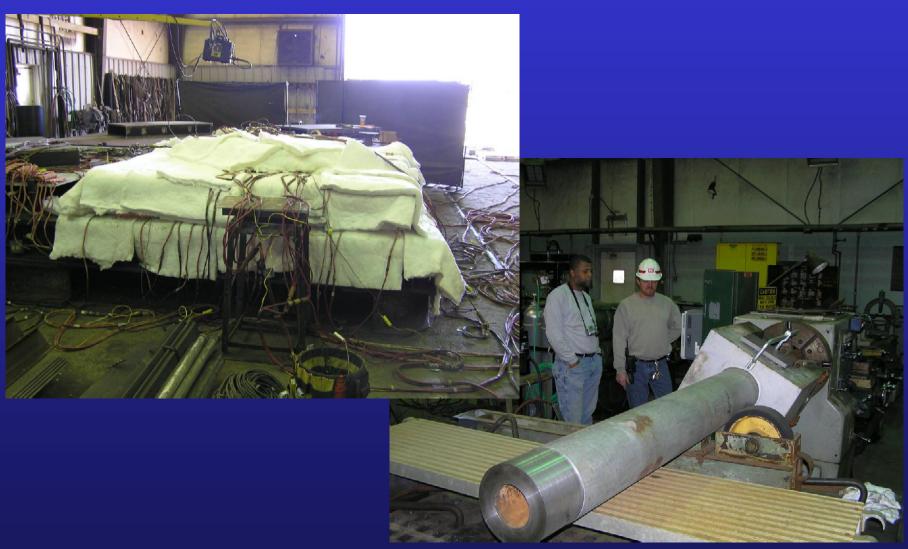
#### Fabrication Work at Service Base

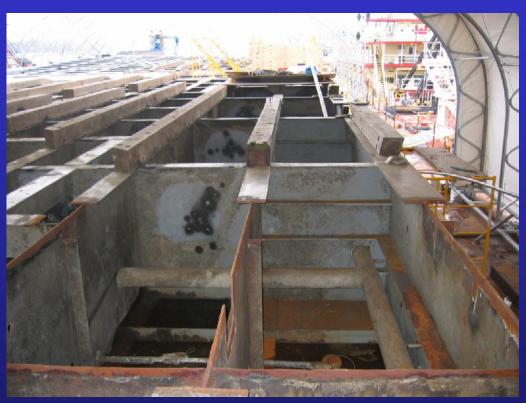
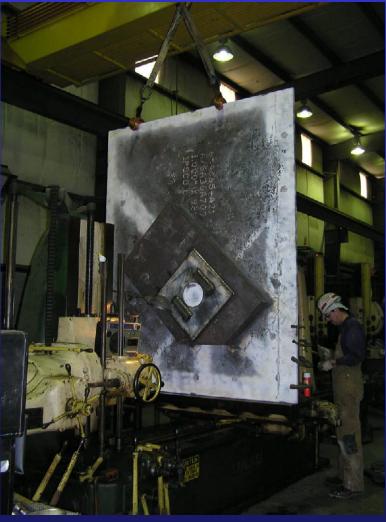
### Modified Bottom End of Diagonal

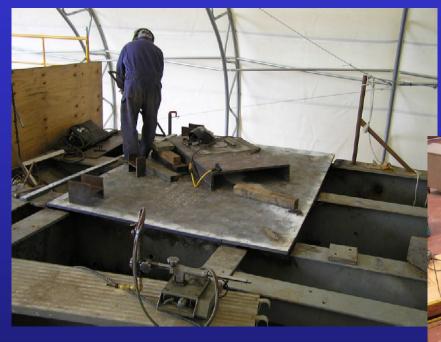
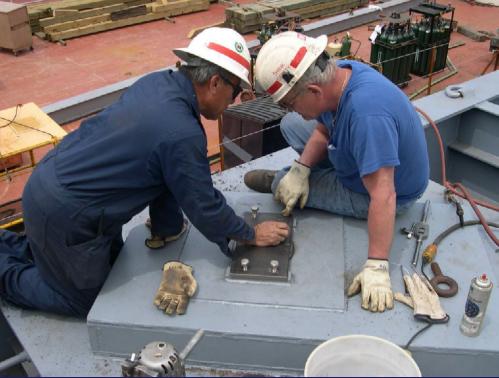
### Modified Bottom Diagonal Gussets

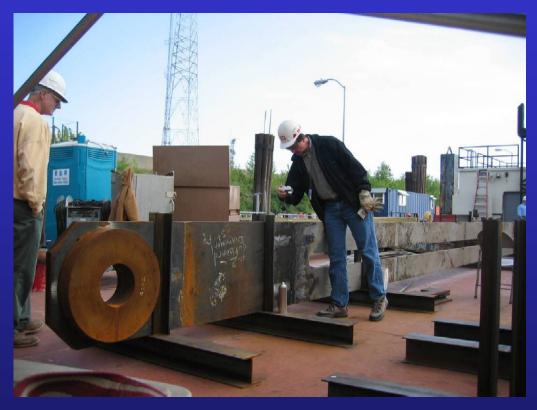
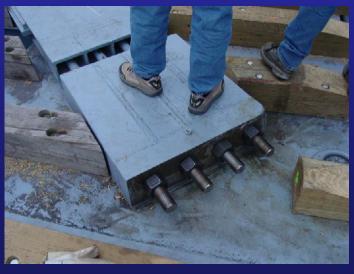
# Modified Bottom End of Diagonal

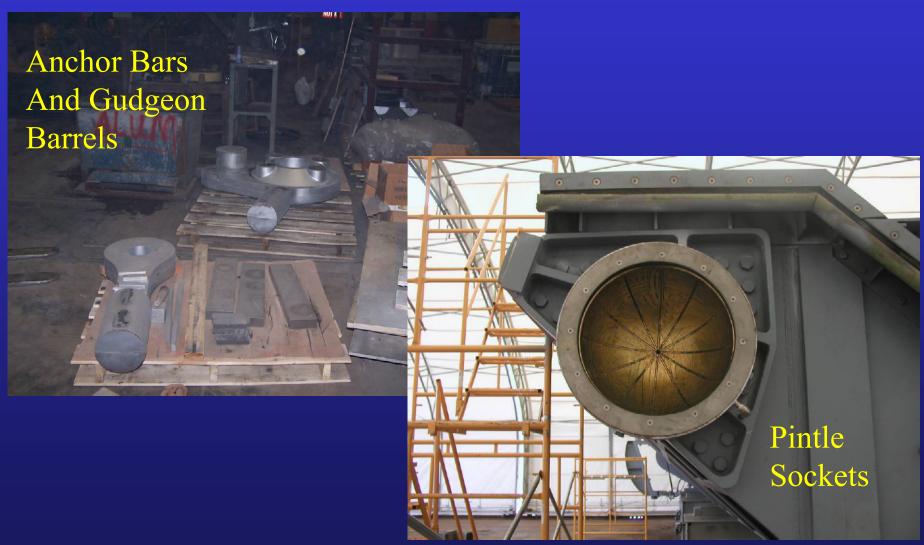
#### Castings Supplied By Rock Island Arsenal

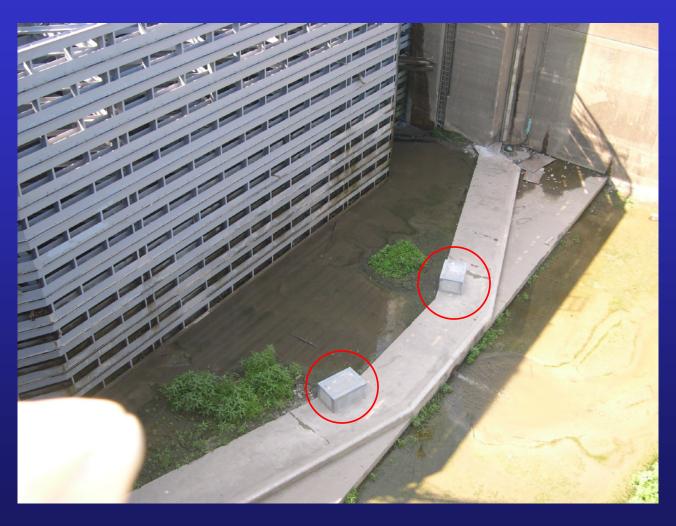
# Gate Stops on Miter Gate Sill

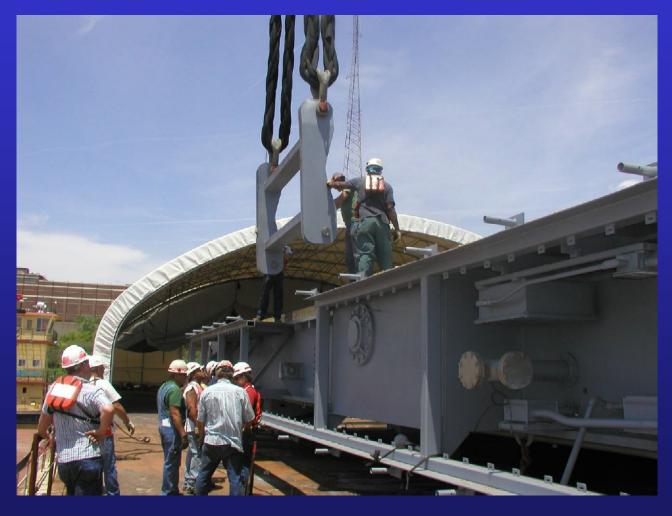
# **Installing Lifting Device**

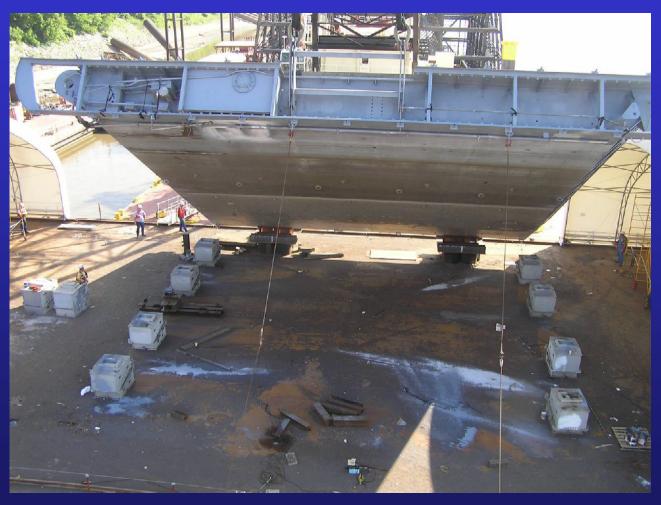
# Shreve Lifting Leaf Vertical

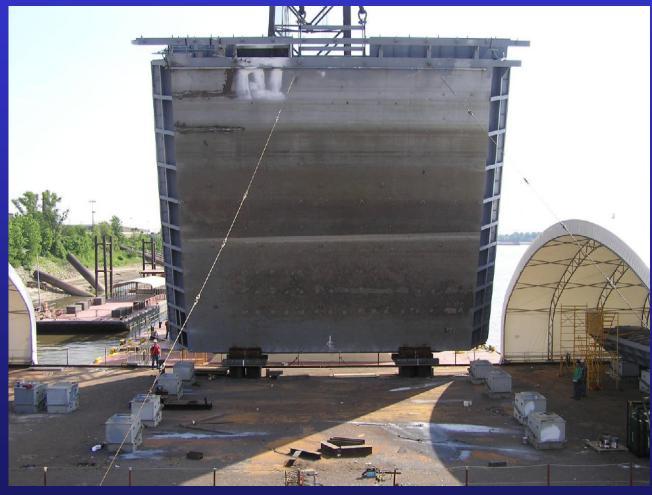
### Shreve Lifting Leaf Vertical

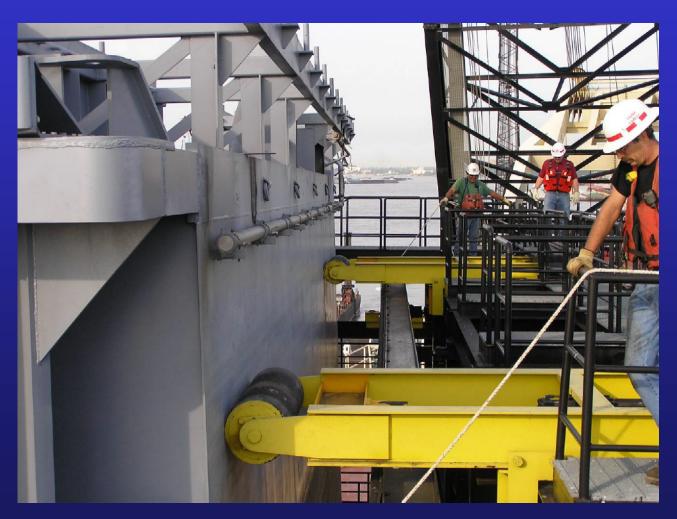
### Placing Leaf In Toaster

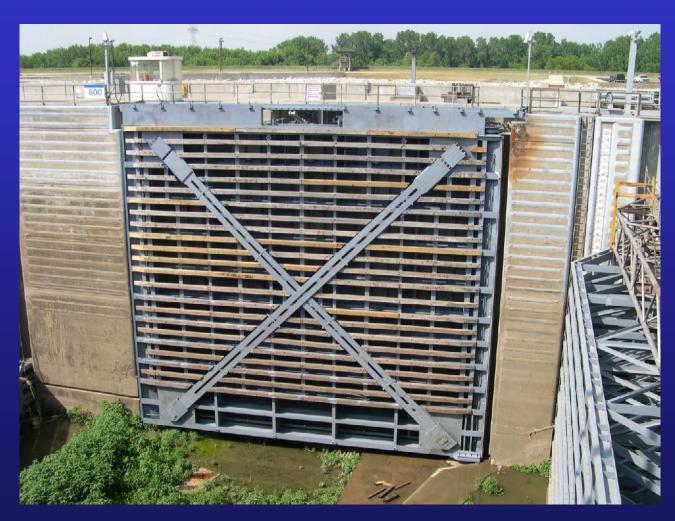
#### Repaired Illinois Leaf in Place

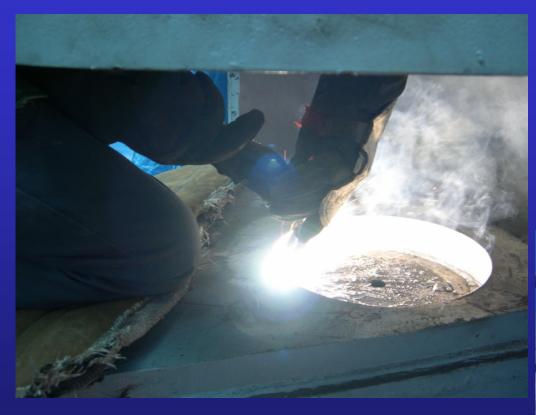
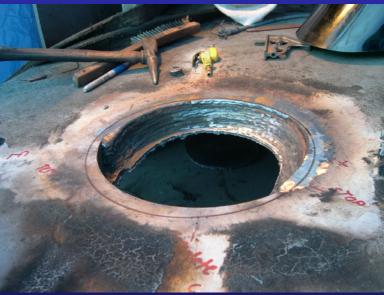
#### Welding & Boring Gudgeon Pin Plates

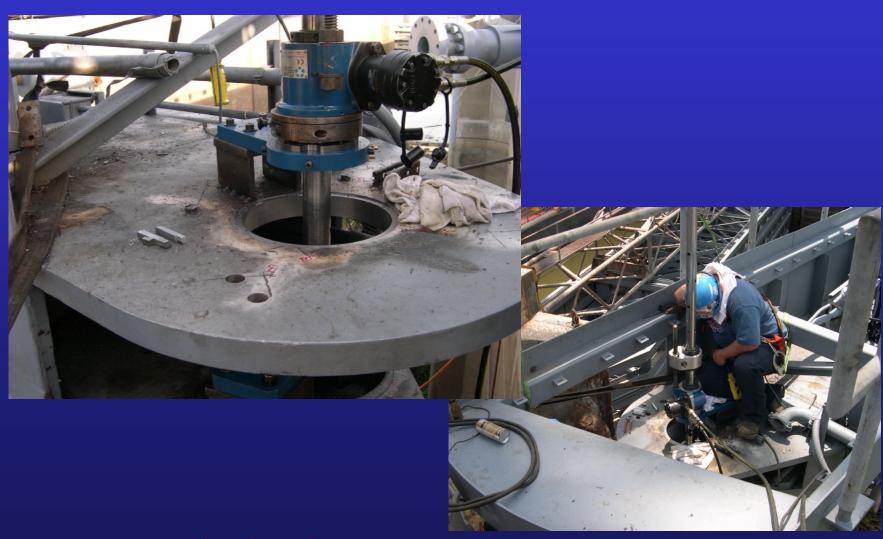
#### Welding & Boring Gudgeon Pin Plates

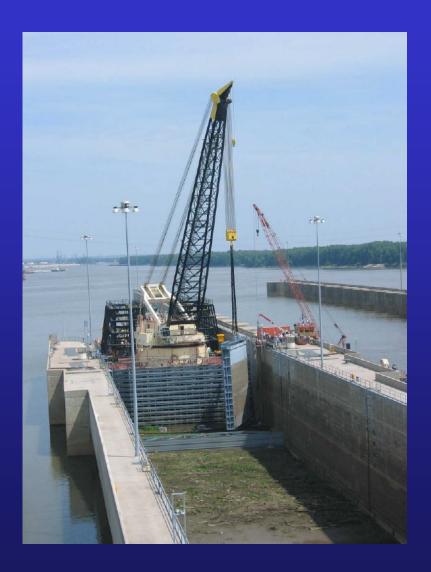
# Installing Missouri Leaf

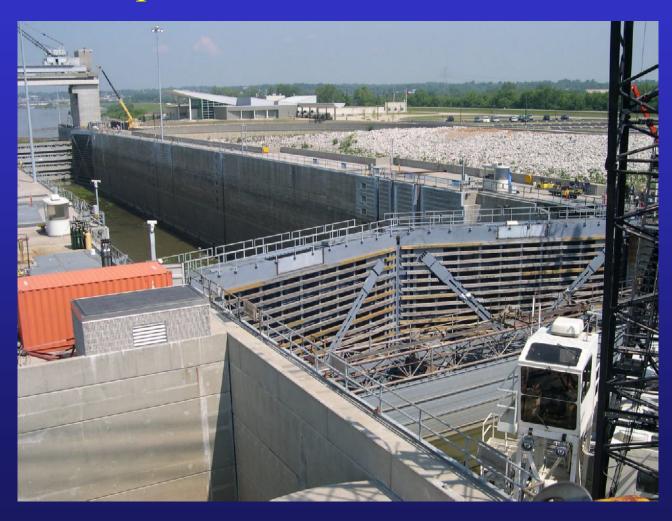
#### Repaired Gate Leafs in Place

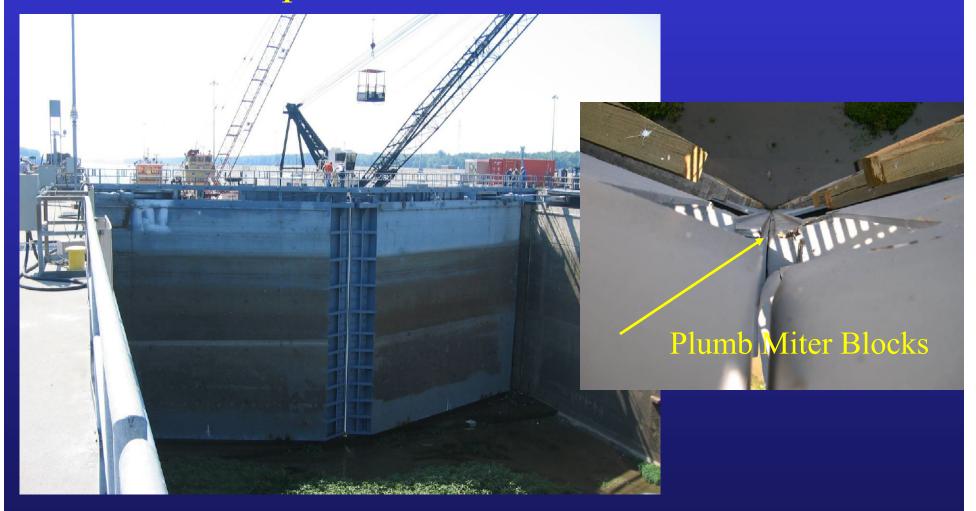
#### Repaired Gate Leafs in Place

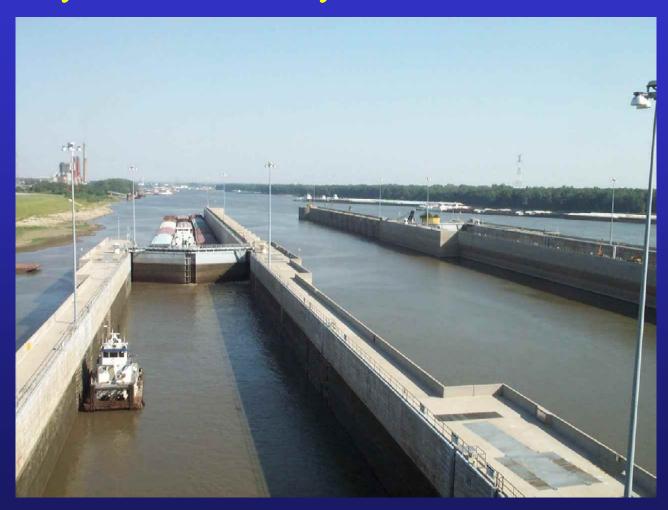
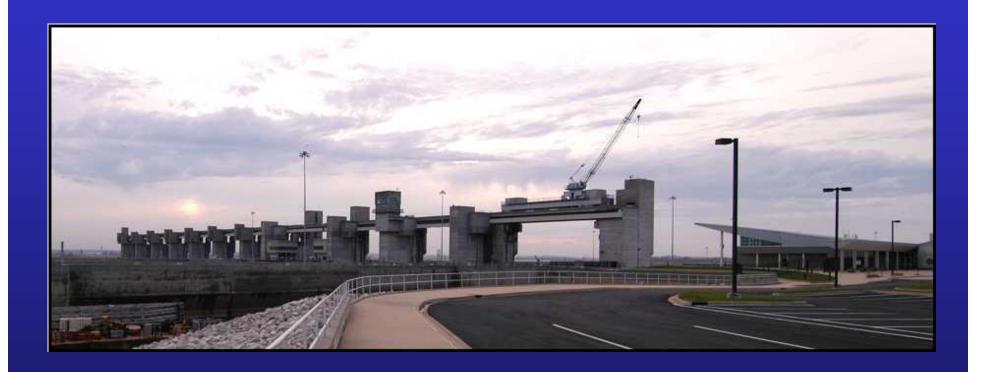
# of Engineers<sup>®</sup> July 2005 - Auxiliary Lock Back In Service
