McAlpine Lock Replacement Project

Foundation Characteristics and Excavation

**Presented to 2005 Tri-State Infrastructure
Systems Conference & Exposition
August 3, 2005**

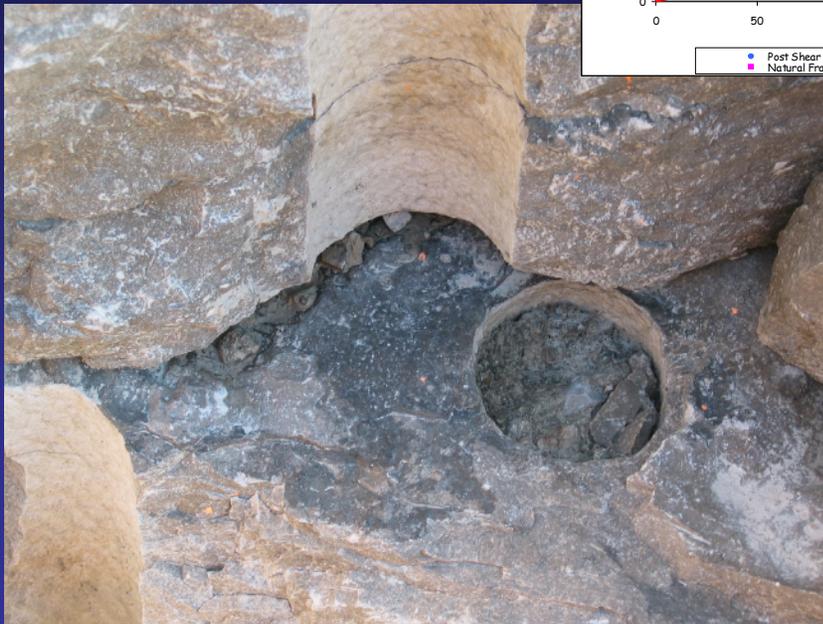
What kind of strength do you give to a seam
which has been damaged and shifted?

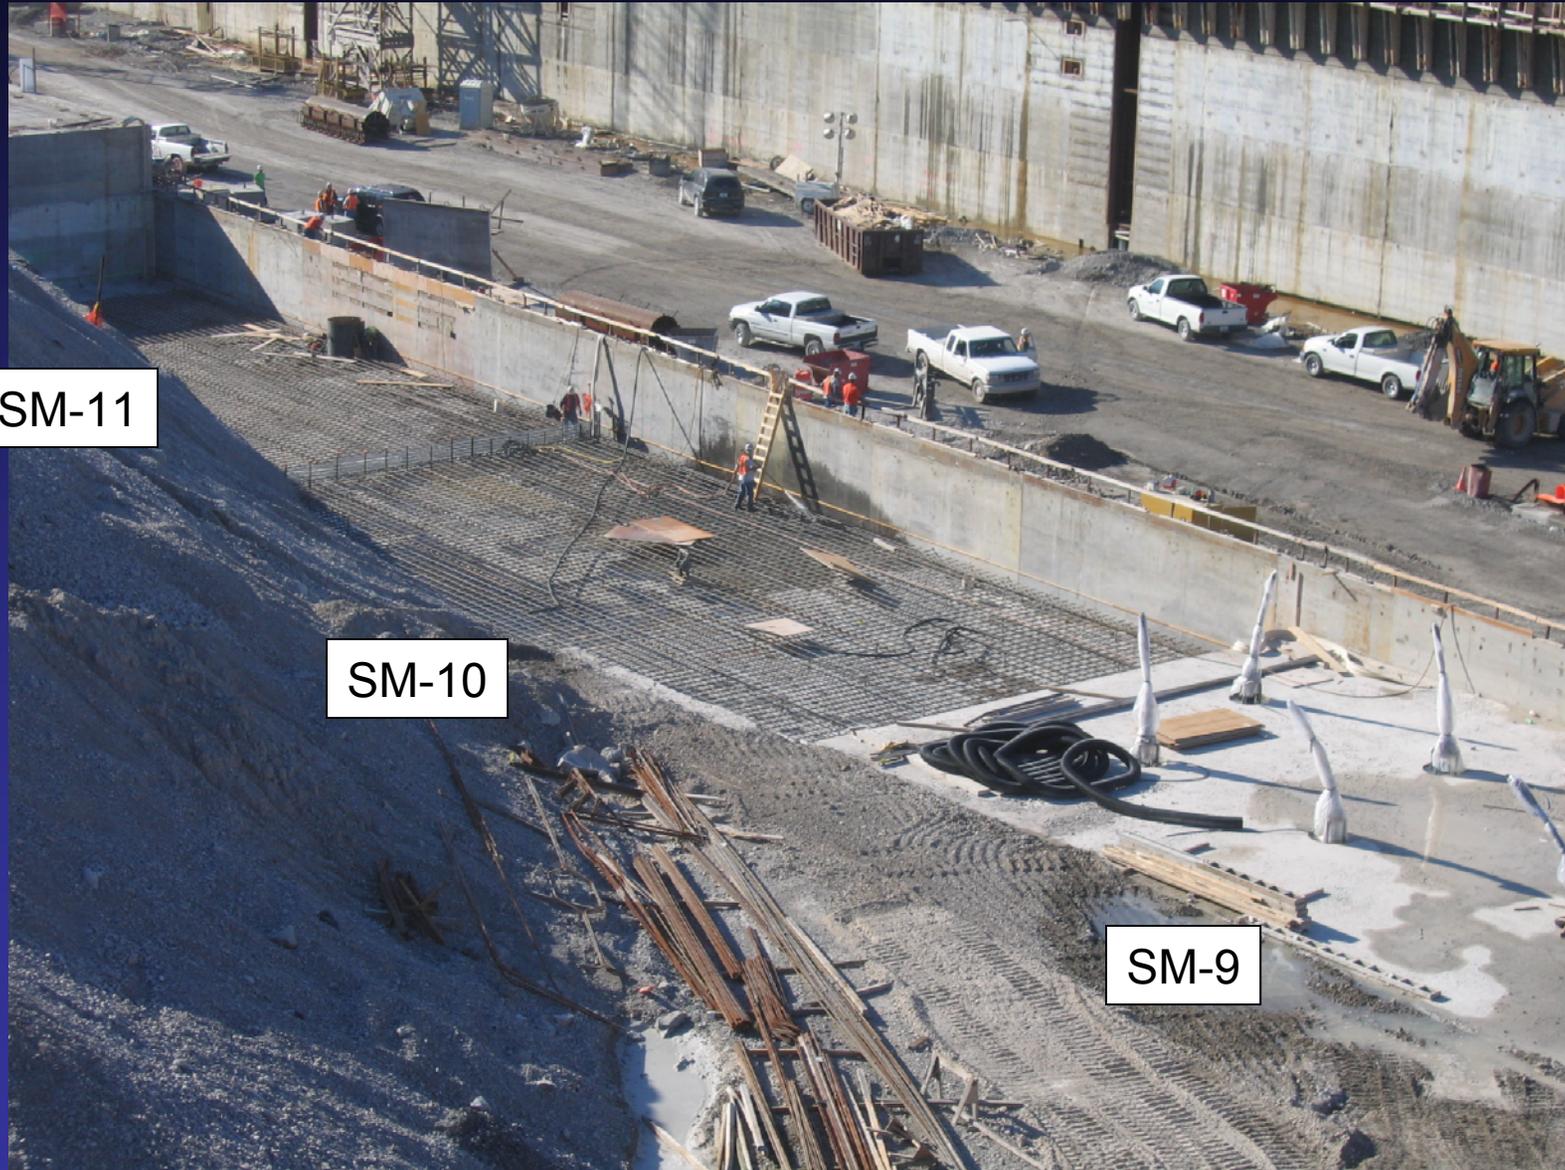
SM-11

SM-10

SM-9
